# Technical Service Bulletin

## 97 Electrical concerns in the rear trunk area

97 19 64 2043968/4 July 8, 2019. Supersedes Technical Service Bulletin Group 97 number 19-63 dated April 12, 2019 for reasons listed below.

Model(s)	Year	VIN Range	Vehicle-Specific Equipment
A3	2015 - 2016	All	Not Applicable

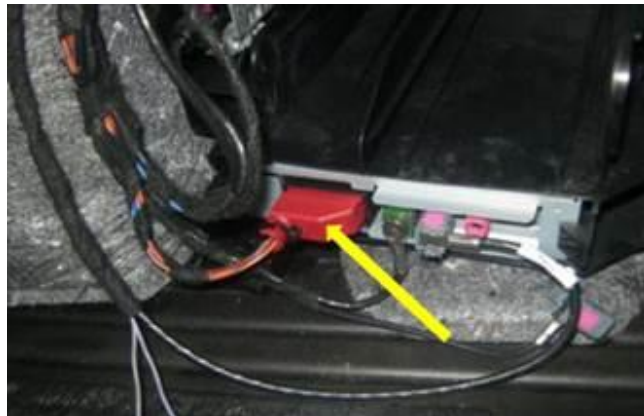
**Figure 8.** Loosen red connector T20i.

7. Loosen the red connector T20i on the reversing camera control module (Figure 8). Remove the cable tie on the connector.

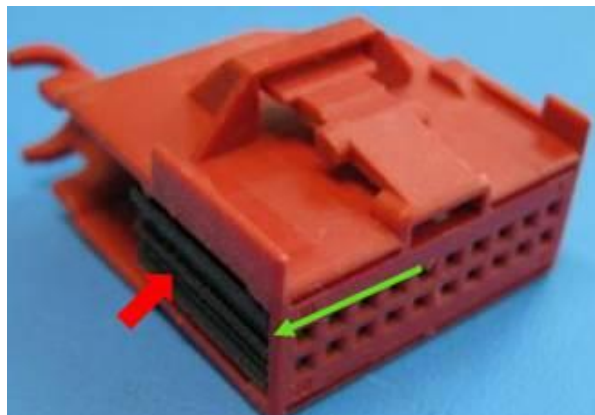
**Figure 9.** Pull black bar (red arrow) out of housing in direction of the green arrow.

8. Pull black bar out of the housing (Figure 9).

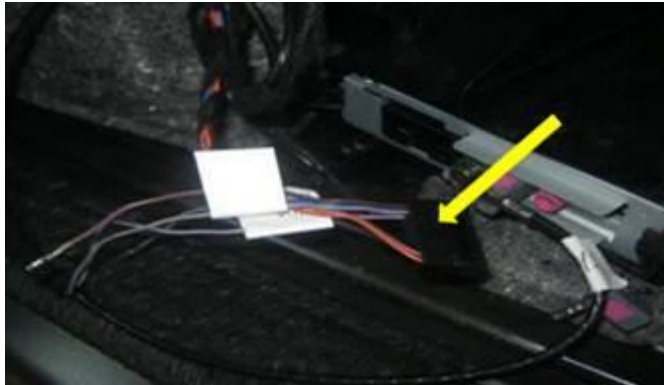
**Figure 10.** To unlock the contacts, position VAS 1978/29 on the side.

9. Use VAS 1978/29 to remove the contacts (pin 9 (grey/brown) and pin 19 (grey/red)). To unlock the contacts, position VAS 1978/29 on the side (Figure 10), then the contacts can be removed.

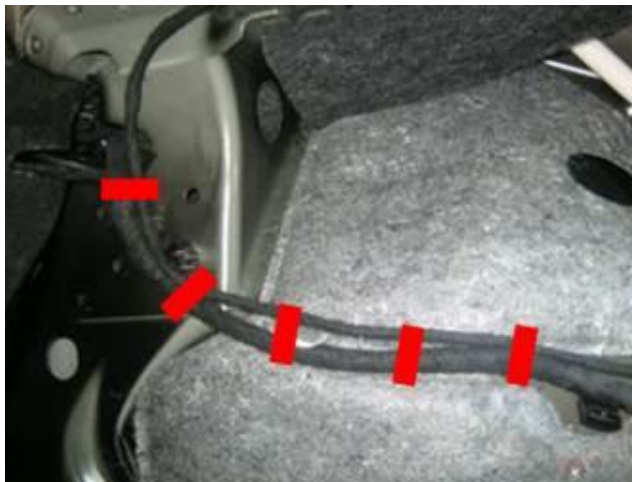
**Figure 11.** Wrap the wiring harness with textile adhesive tapes at red marks.

10. Cut off the removed cables and insulate ends with textile adhesive tape.
11. Lock the contacts of the new wiring harness in chamber 9 (grey/brown) and chamber 19 (grey/black). Then, lock the black bar in connector T20i and secure the cable with a cable tie on the connector collar.
12. Unplug and cut the grey aerial plug off of the reversing camera cable. Insulate the cut-off aerial cable with textile adhesive tape.
13. Connect the grey aerial plug of the service wiring harness on the reversing camera control module.
14. Connect the battery and check the function of the reversing camera.
15. Wrap the wiring harness with textile adhesive tape on the main wiring harness (Figure 11).

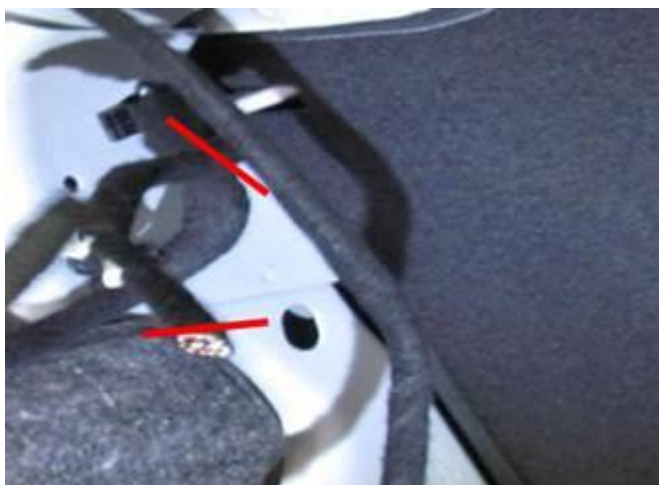
**Figure 14.** Open the winding of the cut-off vehicle wiring harness to the junction of the main harness on the separable area (red marks).

6. Open the winding of the cut-off vehicle wiring harness to the junction of the main wiring harness on the separable area (Figure 14).

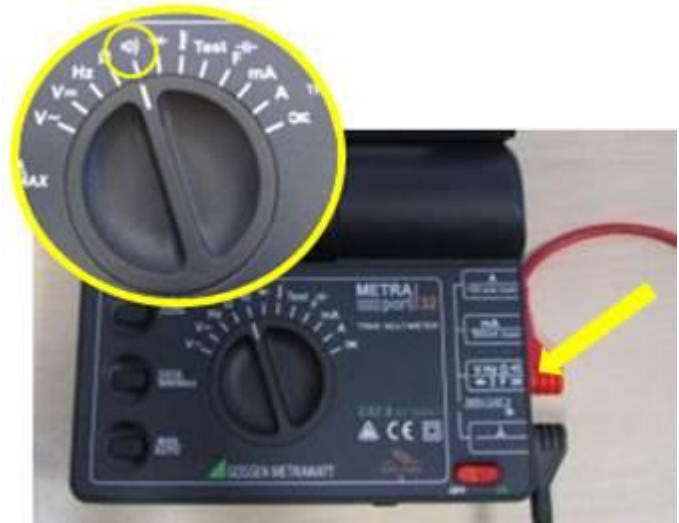
**Figure 16.** Set the VAG 1526 C to current flow check and connect the probe cables.

9. Set the VAG 1526 C to current flow check and connect the probe cables to the VAG 1526 C (Figure 16).

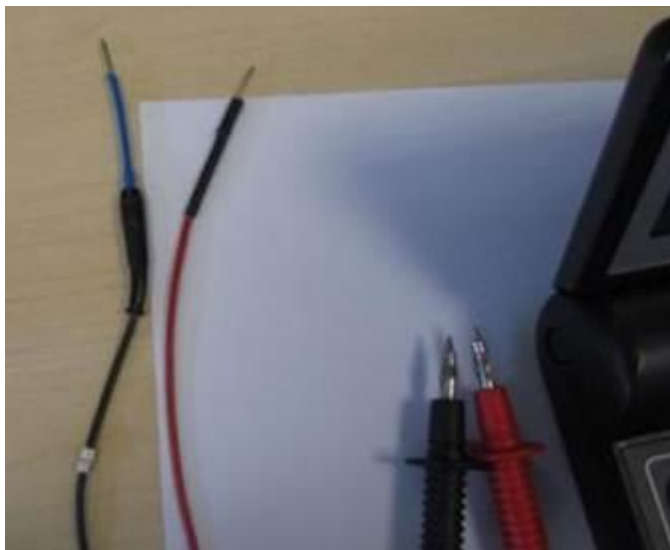
**Figure 17.** Required meter probes from VAG 1594 C.

10. Connect the meter probes of the VAG 1594 C to the probe cables of the VAG 1526 C. The required meter probes from VAG 1594 C are number 18 and number 12 (Figure 17).

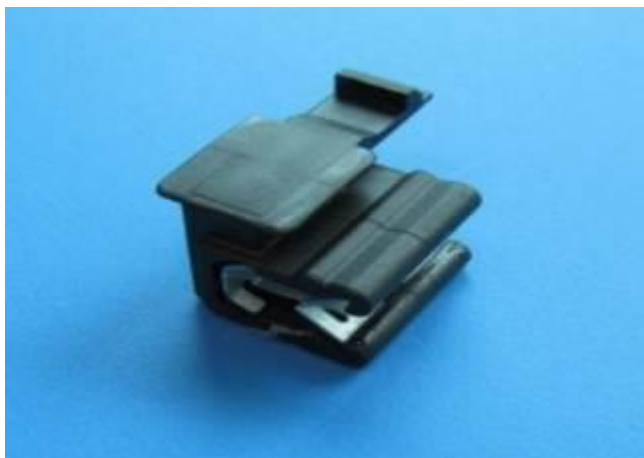
**Figure 19.** Clip supplied with wiring harness.

16. Fit the service wiring harness. For correct routing, refer to the photographs taken in step 4.
