June 2019  
SF587A

## Subject: Freightliner Cascadia Pre-Wired Airbags

**Models Affected:** Specific Freightliner Cascadia vehicles manufactured October 24, 2018, through May 23, 2019 and pre-wired for a steering wheel airbag.

Daimler Trucks North America LLC, on behalf of its Freightliner Trucks Division, is initiating Field Service Campaign SF587A to modify the vehicles mentioned above.

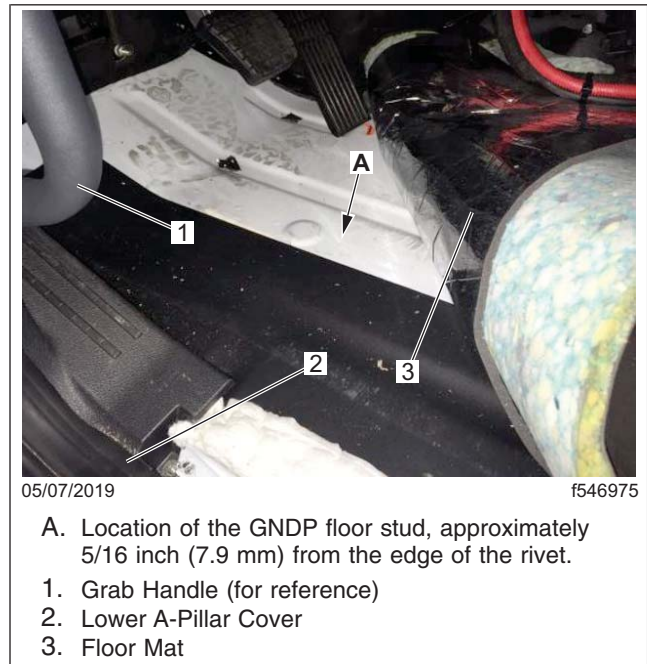
**Fig. 4, GNDE Floor Stud Location**

- 10.1 Remove the driver's-side sill cover, the lower A-pillar cover, and the lower steering wheel cover. See **Fig. 4**.
- 10.2 Roll back the driver's-side floor mat far enough to access the center floor area above the stud, where the bolt is installed.
- 10.3 Locate the mounded area on the floor, directly above the GNDE stud location.

- 10.5 Use a cutoff wheel or suitable tool to cut the damaged stud off flush with lower floor skin.
- 10.6 Using a 5/16 x 1.25 bolt, install the A/C line support Z bracket, and secure it with a washer and nut. Torque to 14 lbf-ft (18 N·m).
- 10.7 Position the driver's-side floor mat in the vehicle and install the-driver's side lower steering cover, the lower A-pillar cover, and the sill cover.
11. Inspect the GNDE pass-through stud on the engine side of the frontwall. See [Fig. 6](#) and [Fig. 8](#). Verify that the GNDE pass-through stud on the engine side frontwall is clean and torqued correctly. Disassemble and inspect the stud for overspray on the flat surfaces. Torque the stud 7 lbf-ft (9.5 N·m). Repaint the connection as necessary.
