SERVICE BULLETIN

APPLICABILITY: All 2015-17MY Vehicles with Fujitsu TEN (F10) 7in. Multimedia Navigation (AVN) & Display Audio Units
NUMBER: 15-177-14R
DATE: 10/16/14
SUBJECT: “Gen 2” & “Gen 2.1” Operating Tips
REVISED: 07/26/17

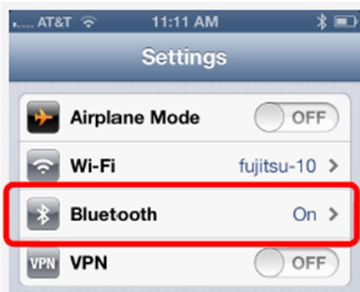
CONDITION #1: Cannot receive incoming text messages on the head unit when using an iPhone.

“Show Notifications” is not activated in the iPhone’s Bluetooth Settings menu.

- From the Settings menu, select “Bluetooth”.

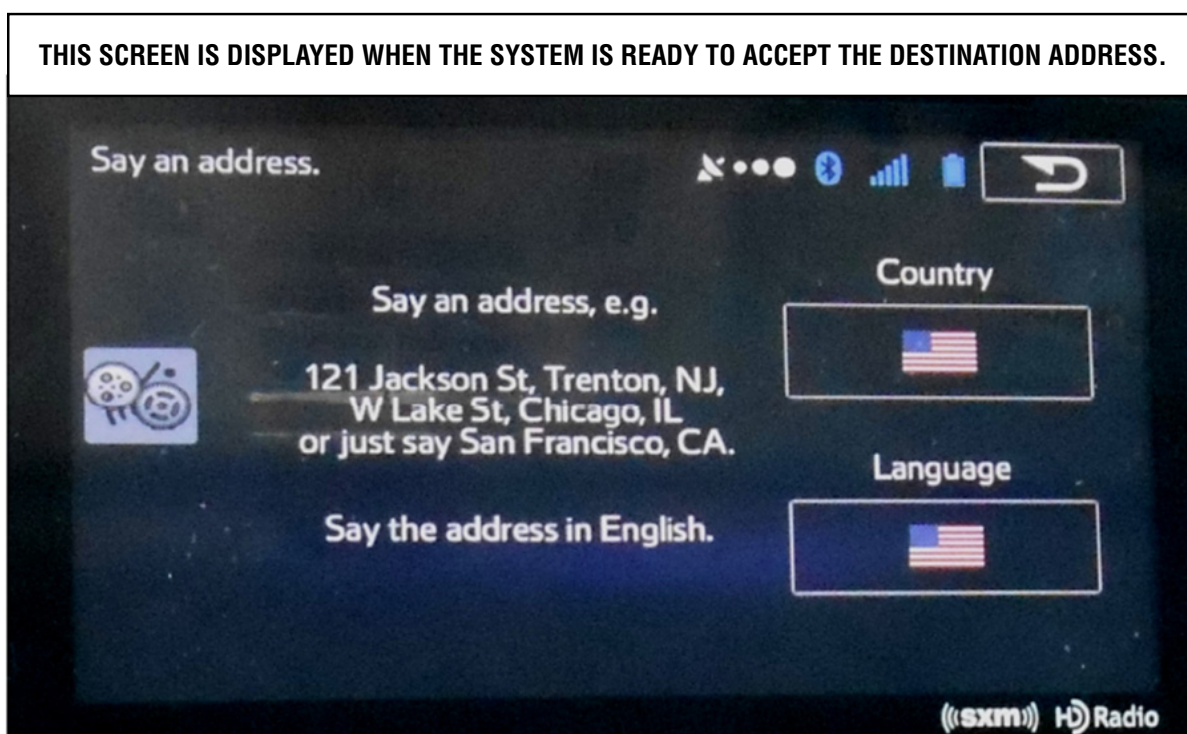
CONDITION #3: Unable to set up the “Destination Address” using voice command.

Incorrect command: 121[pause] Jackson [pause] Street [pause] Trenton [pause] NJ

Correct command: 121JacksonStreetTrentonNJ

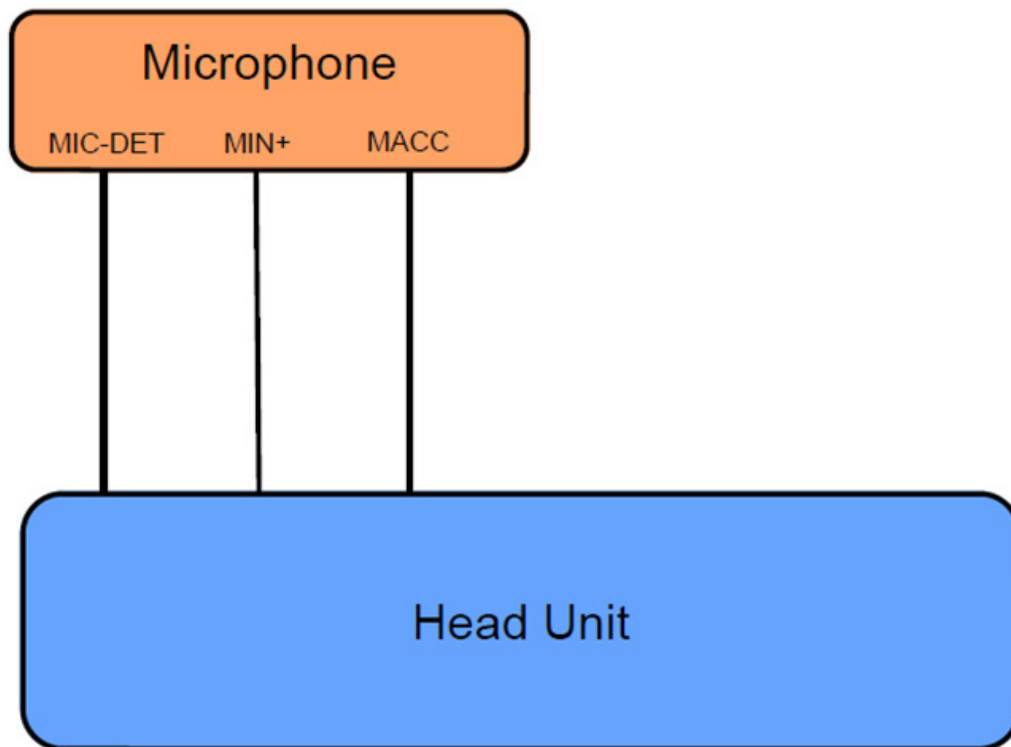
CONDITION: #5: A “Phone” button is not displayed on the HOME screen.

- Microphone is not properly connected to the head unit
- Microphone detection wiring (MIC DET) is open
- Microphone unit is defective

- Confirm the microphone wiring is securely connected to the head unit.
- Confirm there is not an open circuit or short in the Microphone detection (MIC DET) wiring.
- After the wiring has been confirmed to be OK, replace the microphone if necessary.

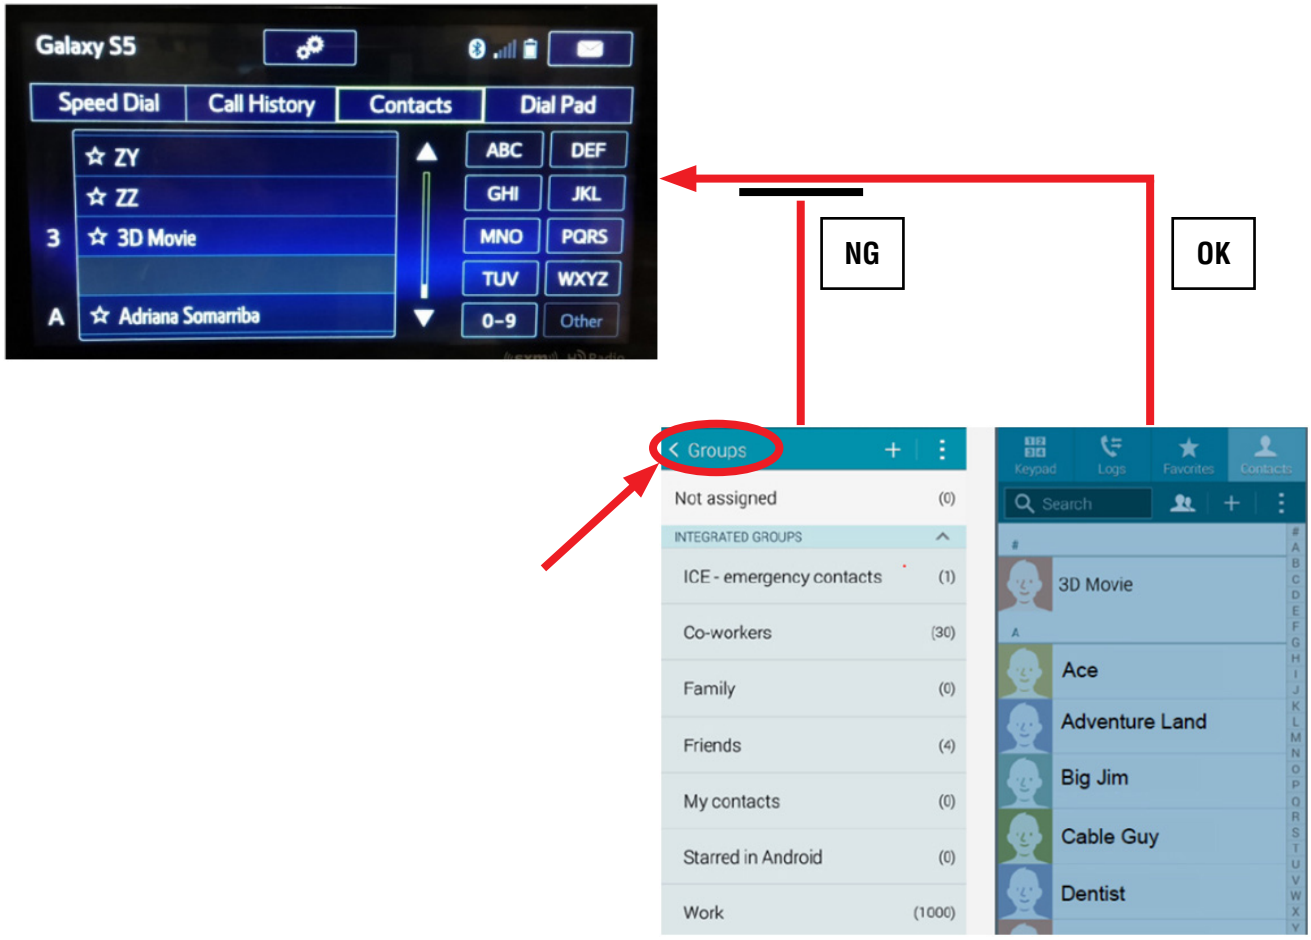
CONDITION #7: Individual contacts will transfer to the head unit from the smartphone, but group folders will not.

Although the head unit can retrieve individual contacts, it does not have the capability to retrieve group folders from the smartphone.

Explain to the customer, the head unit does not support the transfer of group folders from their smartphone.

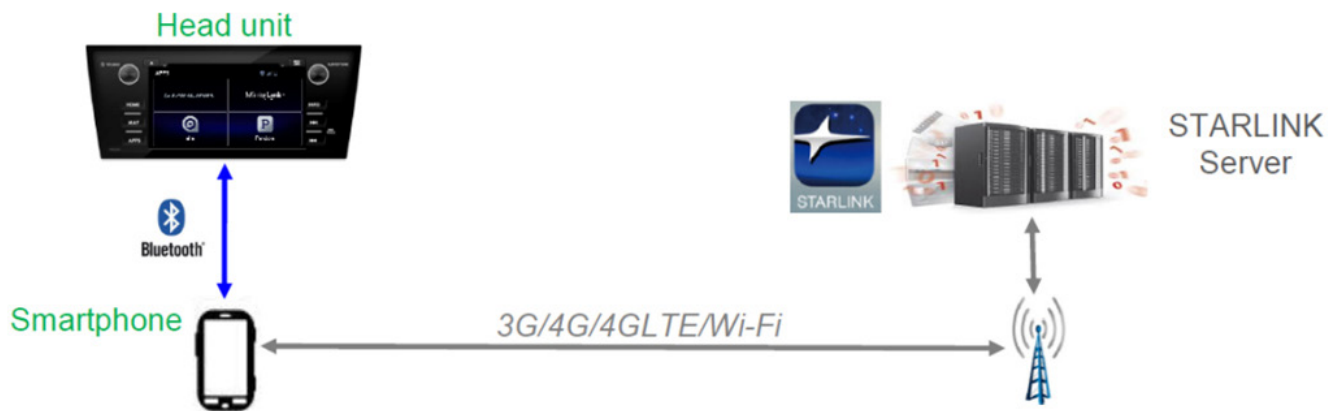
CONDITION #8: When selecting the STARLINK function on the head unit, an error message appears on the screen as shown below.

- STARLINK application on the Smartphone was not loaded and/or launched on the Smartphone prior to selecting the STARLINK function on the head unit. Therefore, Smartphone cannot communicate with STARLINK Server.
- Smartphone has not been paired with the head unit for Bluetooth connection

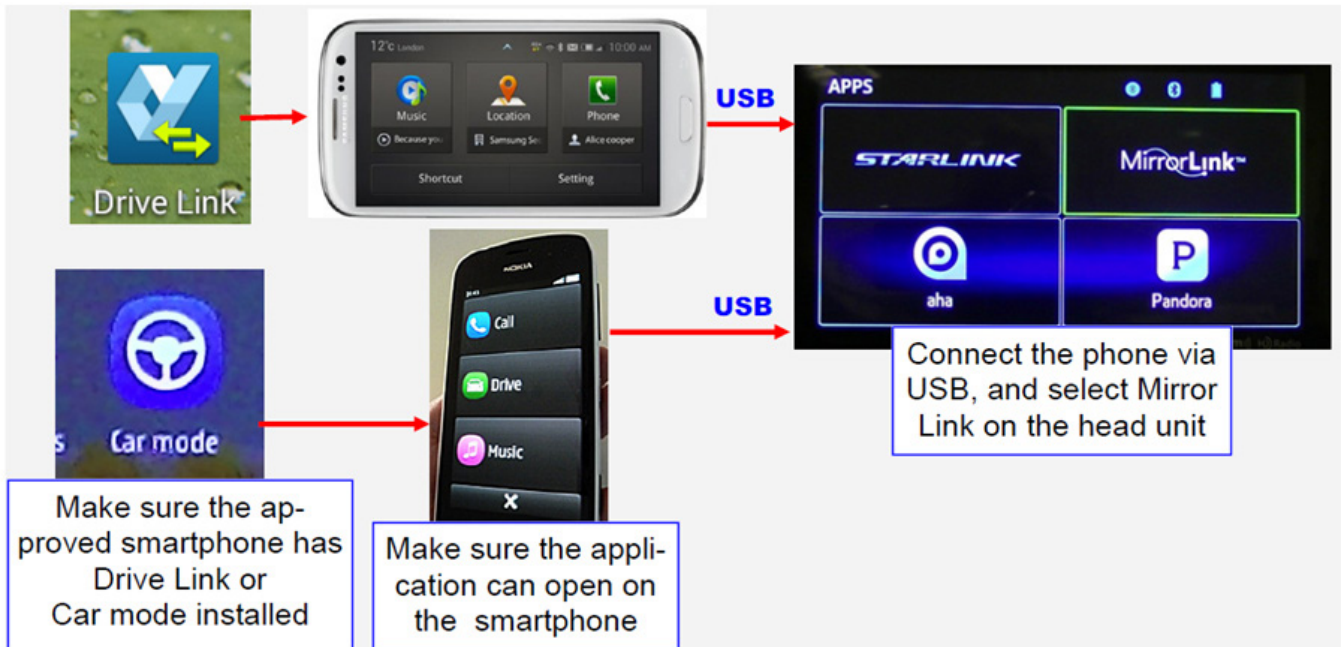
CONDITION #9: MirrorLink does not work with my Samsung or Nokia Smartphone.

- Make sure the Smartphone is compatible with MirrorLink (see Owner Manual Pg. 141.)
- Make sure the “Drive Link” application is installed on the approved Samsung Smartphone (See Owner Manual Pg. 141).
- Make sure the “Car mode” application is installed on the approved Nokia Smartphone (See Owner Manual Pg. 141).
- Once applicability has been confirmed and the application properly installed on the Smartphone, follow the steps below:
 1. Open/Launch the application on the Smartphone.
 2. Connect the Smartphone to the vehicle with a USB interconnect cable.
 3. Press the “APPS” button on the head unit.
 4. Select MirrorLink on the head unit.

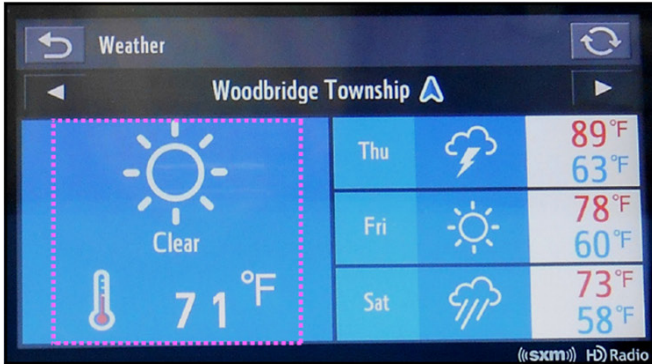
Weather information via STARLINK

CONDITION #11: Weather information from the “STARLINK” and “INFO” function appears to be different even when the time of day and location are exactly the same.

In the examples shown below, the temperature displayed is different even though the time of day and location are the same.

The source of the weather information is different between STARLINK and INFO. STARLINK utilizes weather information provided by Weather Underground while INFO utilizes Sirius XM.

Explain to the customer that the STARLINK and INFO functions utilize different sources to provide the displayed weather information as shown in the illustrations below.

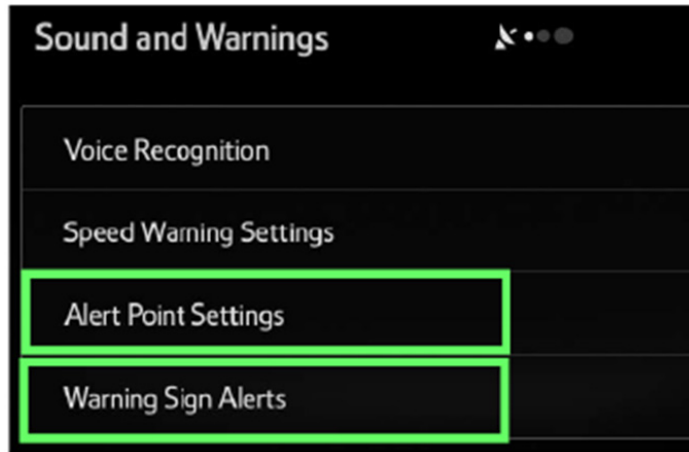
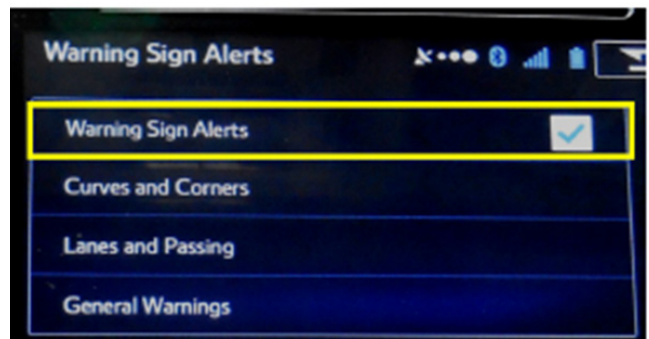
CONDITION #14: A chime is heard while driving.

- If the chime is unnecessary when approaching alert points, disable (uncheck) “Alert Point Warnings” or “Warning Sign Alerts” settings by following the steps below:
 1. Select “Menu” on Map screen.
 2. Select “More”.
 3. Select “Settings”.
 4. Select “Sound and Warnings”.

5. Select “Alert Point Settings” or “Warning Sign Alerts” (see picture below).
6. Disable (uncheck) the settings (press the check mark to “toggle” on / off).

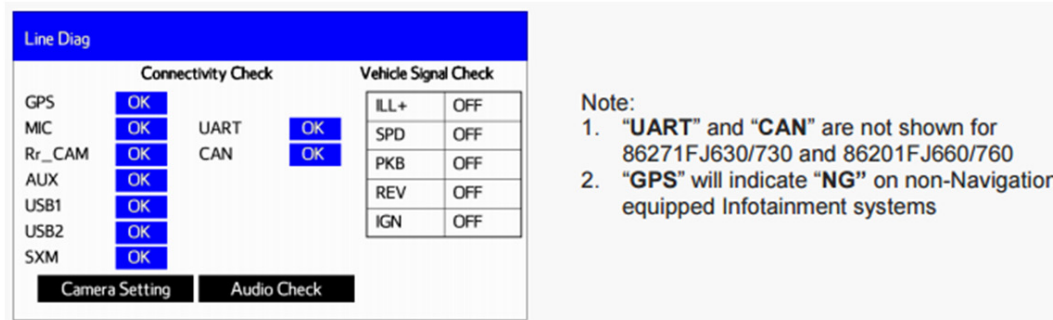
The “Line Diag” screen will be displayed where the connection status of each device is verified.

To exit Diagnostic Mode, press the “c” button for 3 seconds or cycle the ignition switch / button to OFF.

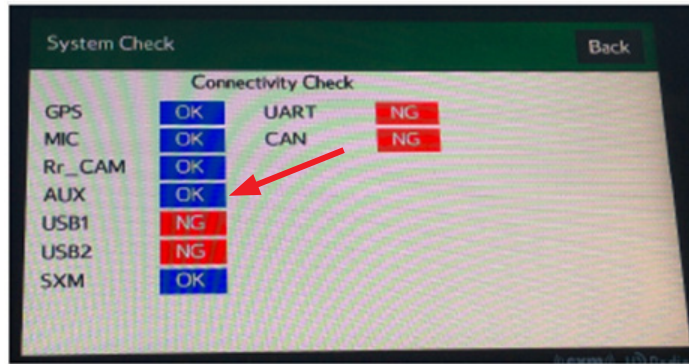
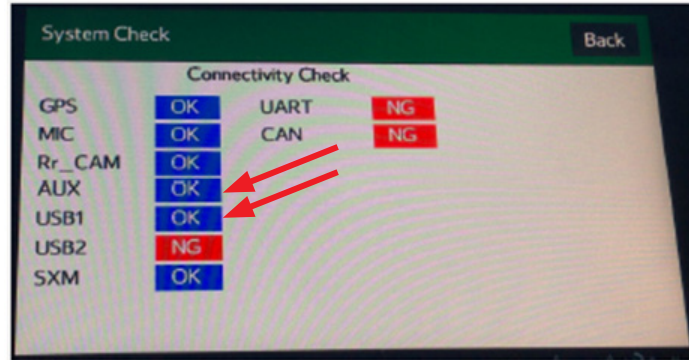
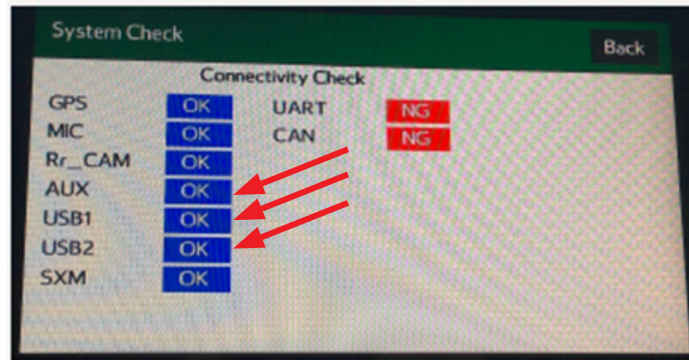
AUX cable & device connected

AUX cable, device & USB device connected

AUX cable, device & 2 USB devices connected

To change the display for AUX from “NG” to “OK” insert an AUX cable connected to a compatible device (e.g. MP3 player) into the AUX port.

To change the display for USB1 and/or USB2 from “NG” to “OK” insert a compatible USB device into the USB port. **NOTE:** you will need to insert 2 USB devices to test both USB ports at the same time.

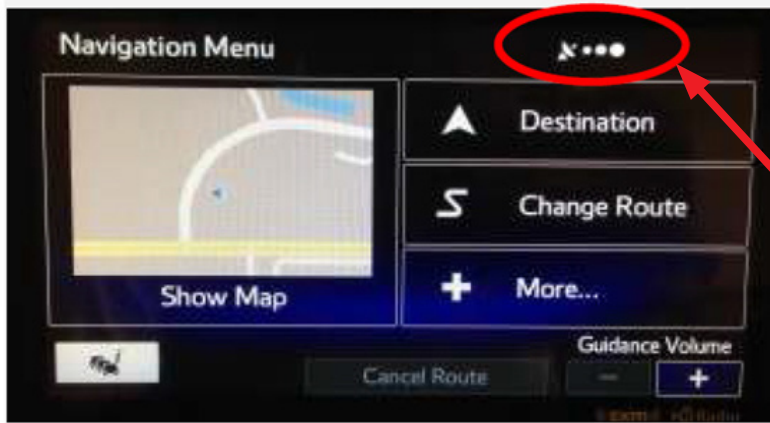
The GPS Signal strength indicator is always available for reference in the upper right of the “Navigation Menu” screen.

On the “Navigation Menu” screen, the GPS signal strength indicator is always available at the top right of the screen as shown below. In addition, if the GPS signal strength becomes weak, a Satellite icon will show when the MAP screen is displayed. If this Satellite icon (also a soft key) is pressed, the GPS information screen will be displayed which indicates how many satellites are currently being received along with the accuracy of the GPS signal.

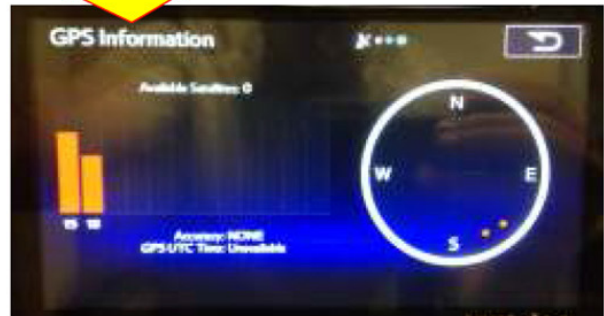
If the GPS signal becomes weak, a Satellite icon will appear in the upper right corner of the MAP screen. Touch the icon to show the GPS information.

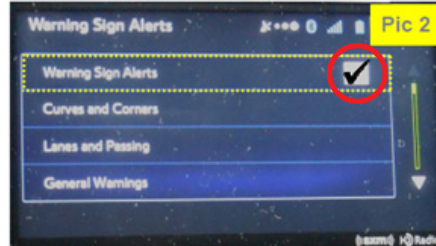
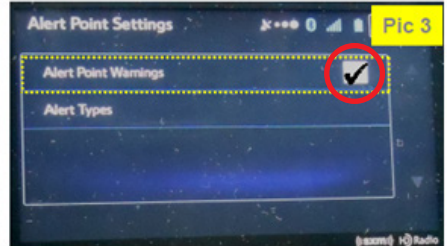
Warning Sign Alerts and Alert Point Warnings are enabled

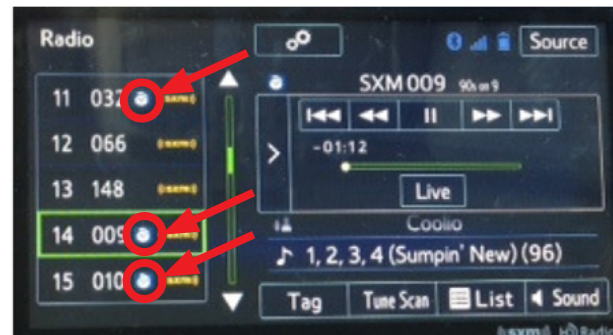
5. The Smart Favorites will now be displayed with the clock icon

as shown below.

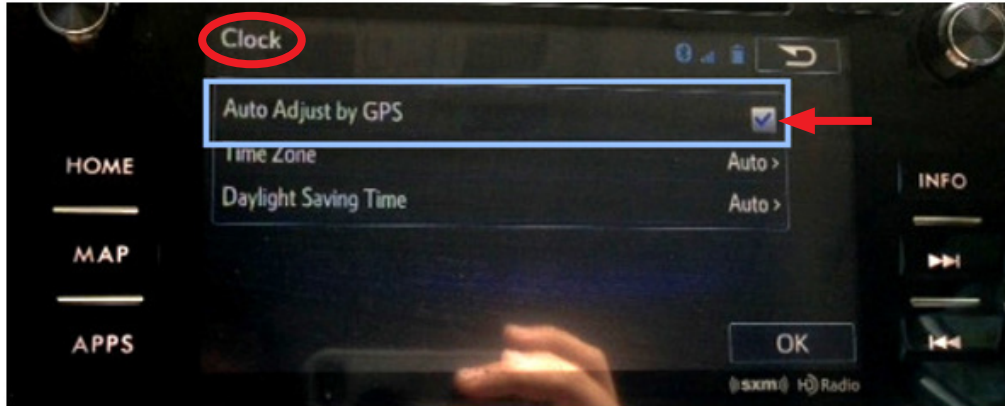
CONDITION #23: The clock display on HVAC panel is incorrect even when “Auto Adjust by GPS” is selected on the Clock settings menu.

The correct time is 4:59 pm but HVAC display shows 8:59 pm.

When a map SD card is removed from the AVN unit or the map SD card cannot be read properly by the AVN unit, the time displayed on the HVAC panel will automatically default to Greenwich Mean Time (GMT). In this case, the GMT is 4 hours “ahead” of local time.

2. If the map SD card is installed in the AVN unit, but the maps and / or time is not being displayed correctly, it may be due to a defective map SD card or possibly a faulty AVN unit.

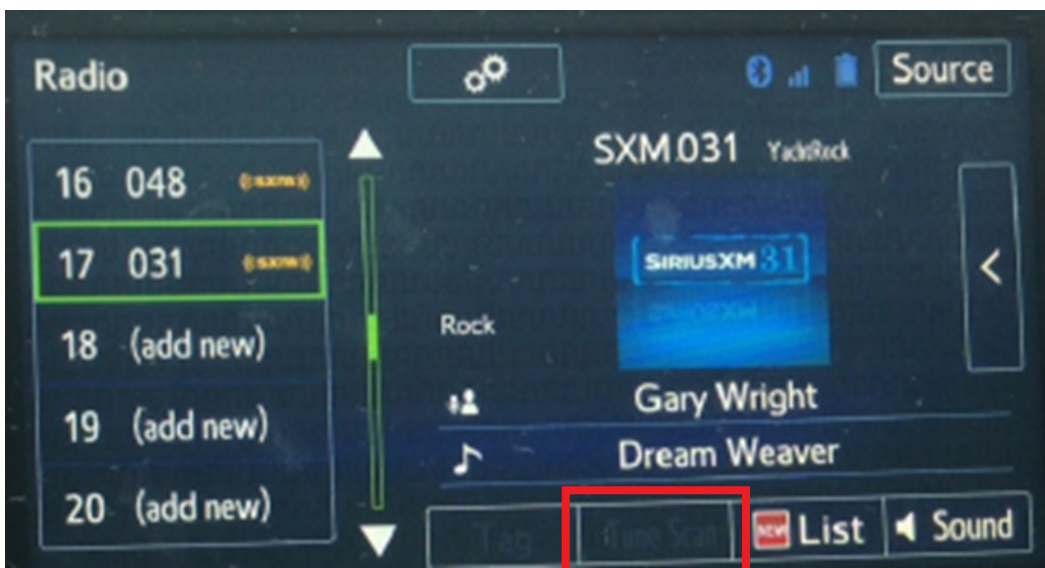
CONDITION #25: The “Tune Scan” feature is unavailable (2016 MY vehicles equipped with Gen 2.1 Navigation / Display Audio system).

YES: Pressing the button will activate “Tune Scan”

NO: Check to see if the user has any SXM presets setup as “Smart Favorites” (See Owner’s Manual pg. 75 for more about “Smart Favorites”)

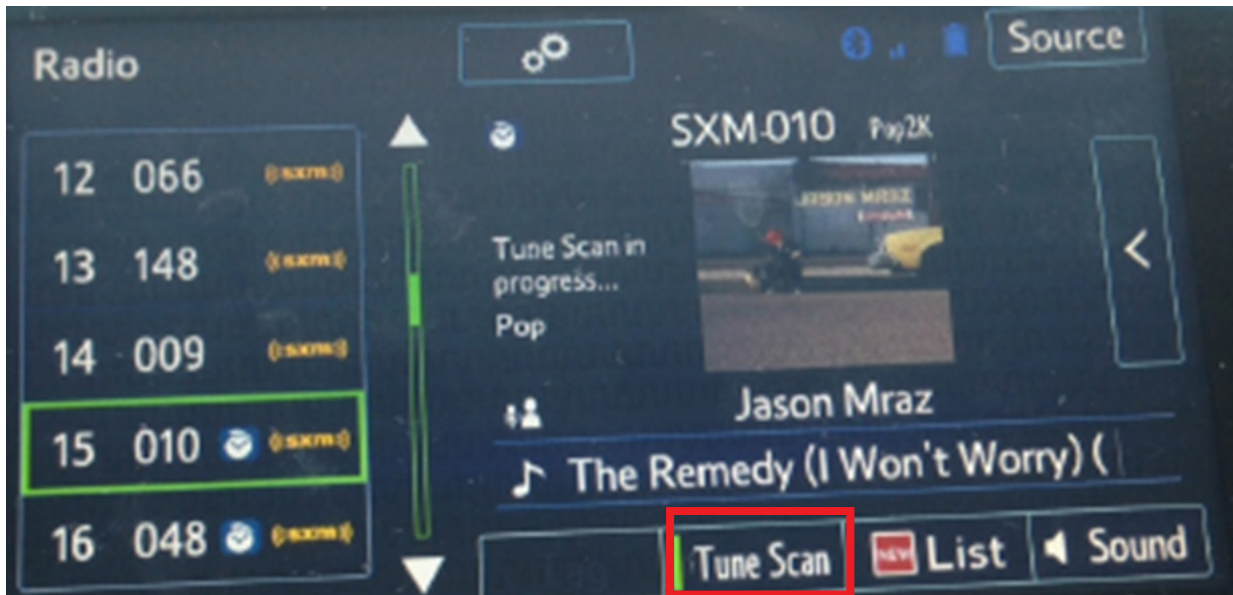
Are SXM preset channels stored as “Smart Favorites”?

YES: Wait for several minutes after the unit has received SXM signal for the “Tune Scan” button to become available.

NO: Store SXM preset channels as “Smart Favorites” then wait for several minutes after the unit has received SXM signal for the “Tune Scan” button to become available.

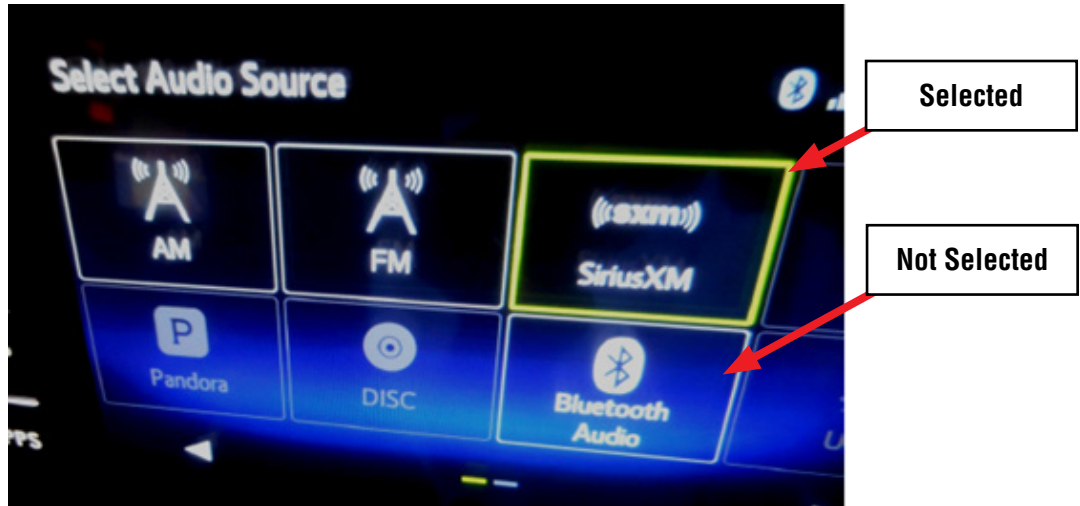
CONDITION #27: Navigation voice guidance cannot be heard from the vehicle speakers when the destination was requested by Siri (iPhone App) (2016 MY vehicles equipped with Gen 2.1 Navigation / Display Audio system)

Bluetooth Audio is not selected as an Audio Source.

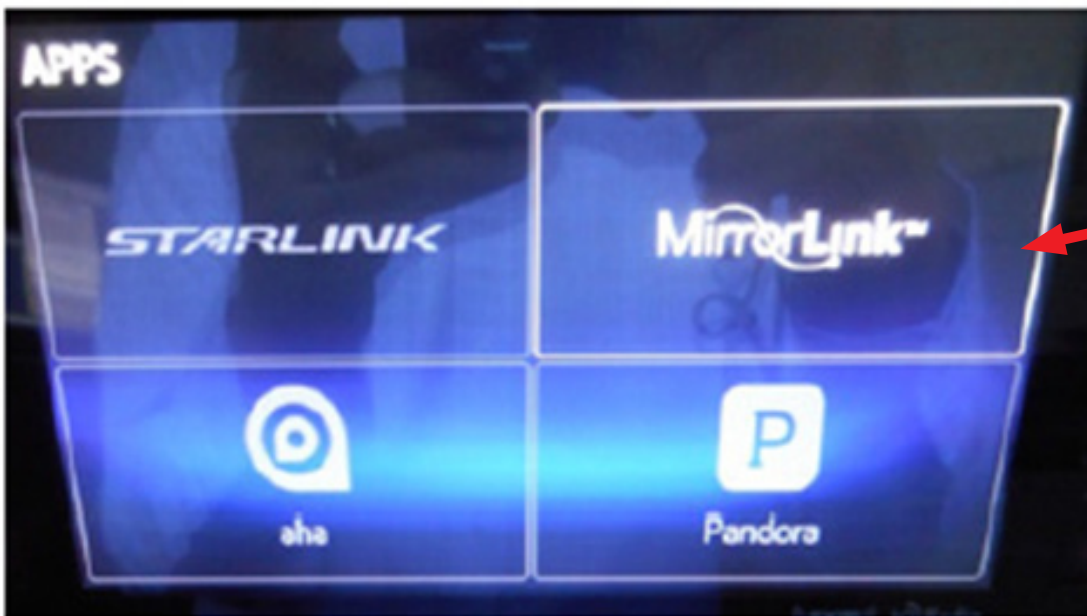
CONDITION #29: The “MirrorLink” button in the APPS screen is not active (grayed out).

- (1) Once MirrorLink compatibility with the phone has been confirmed, install MirrorLink-enabled app.
- (2) After installation is complete, connect the phone to the USB port.
- (3) Wait until the MirrorLink button becomes active on the APPS screen.

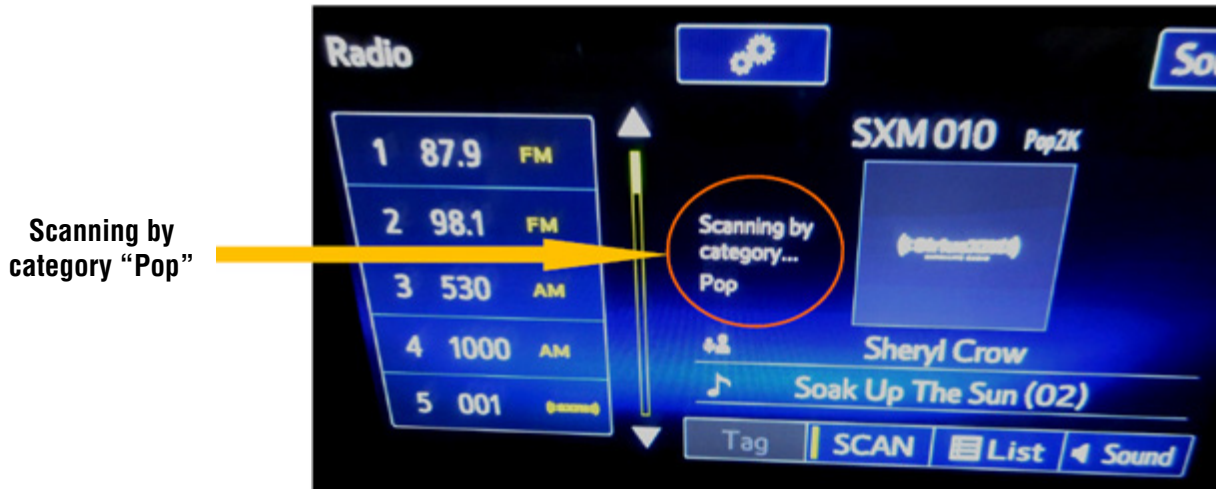
CONDITION #32: Cannot scan or seek through all SXM channels using the Seek, Scan and / or Steering Wheel buttons (2016 MY vehicles equipped with Gen 2.1 Navigation / Display Audio system)

The unit will only scan or seek through the category being listened to when it is in the SXM mode.

EXAMPLE: If you are listening to CH2, which is under a “Pop” category, and press the scan button, it will only scan channels (CH3, 4, 5, 6, 7, 8, 9, 10, 13, 14, 15, 16, 17, 18, 158, 300, 301, 302 and 2) which are under the Pop category, not all channels or categories.

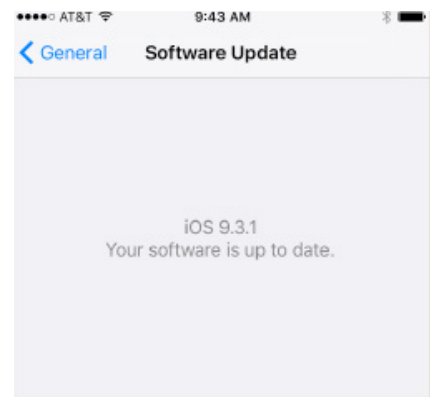
CONDITION #35: After using the Siri feature (2016 MY vehicles equipped with Gen 2.1 Navigation / Display Audio system), the head unit will automatically change from whatever audio source the user was listening to, over to the Bluetooth Audio Source. Why does that condition occur?

It is caused by iOS software versions 9.2 and 9.21.

Suggest the customer update their iPhone’s software to iOS version 9.3.

NOTE: The user may need to delete their iPhone’s Bluetooth connection then re-pair the phone after the software update is complete to verify the condition has been addressed.

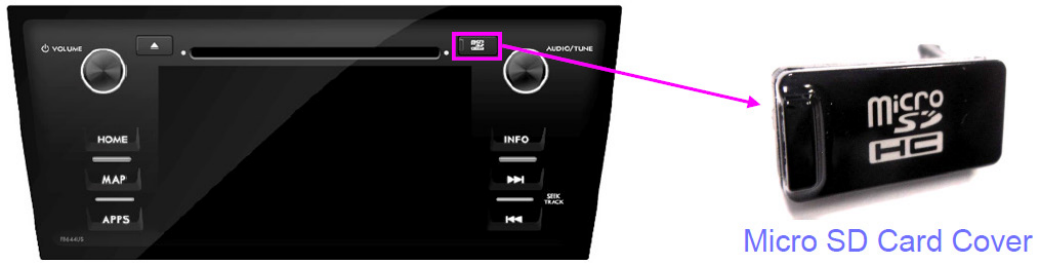
CONDITION #36: Replacement procedure for lost or damaged Micro SD Card covers

If the Micro SD card slot cover is lost or damaged, a replacement is available directly from F10

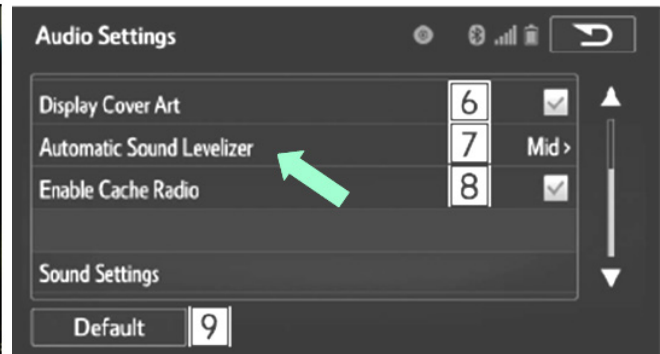
CONDITION #38: ASL (Automatic Sound Levelizer) function does not appear in Audio Settings as indicated in the Owner’s Manual.

ASL function as described in Owner’s Manual.

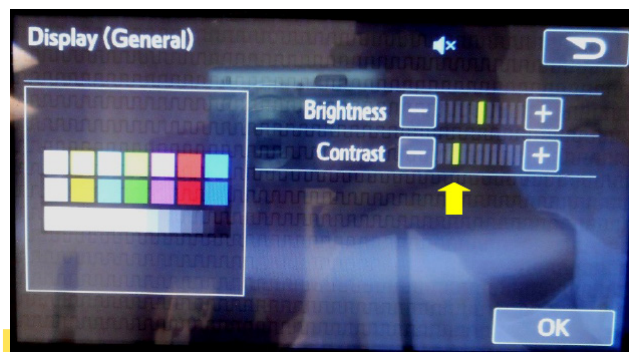
CONDITION #40: Display background color uneven, a “smile” -type image appears.
(Applicable to 2015-16MY Impreza, 2015-17MY Crosstrek, 2016-18MY Forester and 2015-17MY Legacy / Outback)

This condition is NOT a defect. It is actually a background image of Subaru STARLINK which becomes visible when the contrast is set to the highest setting as shown in the screen shot below.
