SERVICE BULLETIN

APPLICABILITY: 2017-18MY Impreza
 2018MY Crosstrek
 2018MY Legacy and Outback
 2018MY BRZ*

NUMBER: 15-211-17R

SUBJECT: Reprogramming File Availability for Additional Optimization of Harman Gen 3 Audio and Navigation Head Units

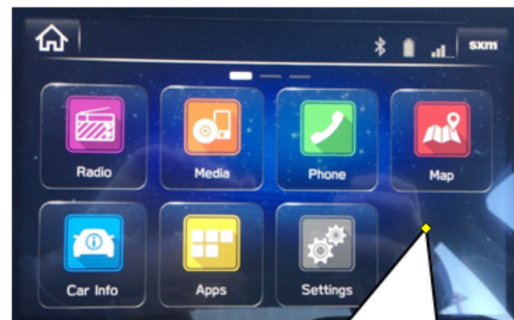
- Update for condition where only the star field background is displayed (without icons) after the HOME button is pressed.

Background shown, but no icons

Normal HOME screen with icons

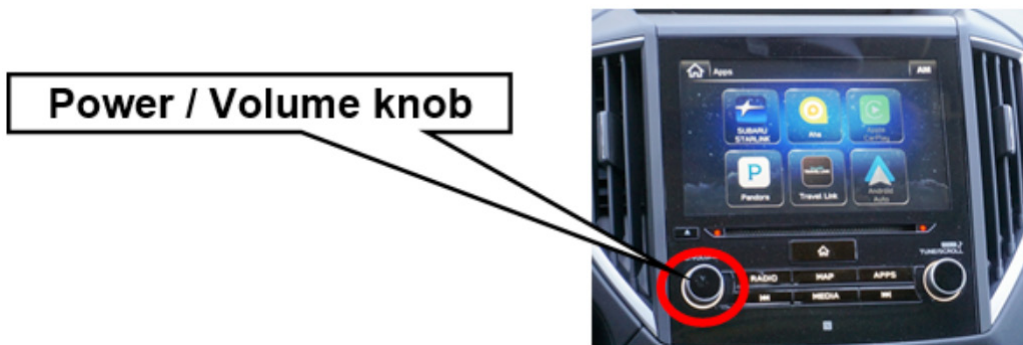
- The Mute function of the Power / Volume knob (a brief press and release of the Power / Volume knob to mute audio output) is unchanged.
- A “system reboot” function is initiated by pressing and holding the Power / Volume button for 10 seconds. This feature was included as part of the previous (11/2017) software update.
