Engine Crankshaft Inspection

Reference: PC704

Date: July 17, 2019

PC704 - 2019 – FRONTIER/NV ENGINE CRANKSHAFT INSPECTION

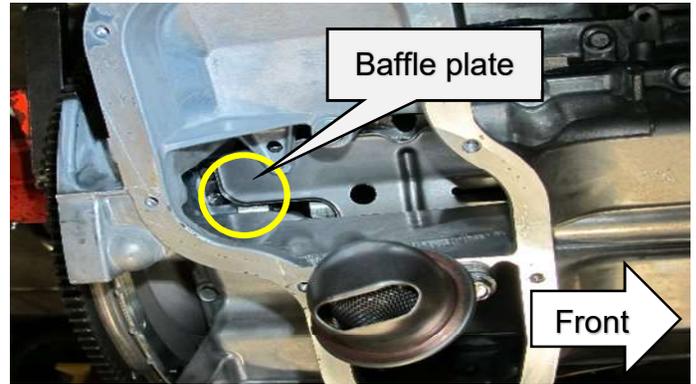
Figure 10

9. Locate baffle plate and crankshaft #6 counterweight.

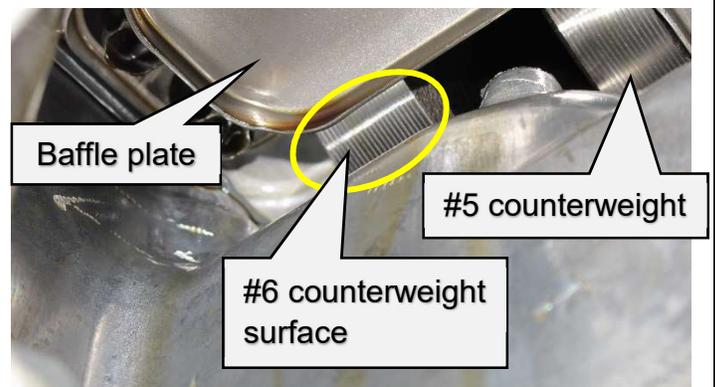
Figure 11

- Locate baffle plate (Figure 10)
- Locate round edge of baffle plate; the crankshaft counterweight surface will be located behind the baffle plate (Figure 11)
- Continue to step 10 for inspection of crankshaft counterweight surface

10. Rotate crankshaft pulley clockwise to inspect counterweight machined surface
- Verify the crankshaft pulley is at the 5 o' clock position and rotating to the 7 o' clock position (moving clockwise only) while inspecting the counterweight machined surface
 - **OK condition**-smooth machined surface with no impact marks (Figure 12) reassemble vehicle per the ESM and claim inspection operation code
 - **NG condition**- impact mark(s) located on machined surface area of counterweight when crankshaft pulley notches are between the 5 o' clock and 7 o' clock positions (Figure 13) **continue to step 11**
