CAMPAIGN BULLETIN

VCR Engine Inspection

Reference: PC707

PC707 - 2019 ALTIMA VCR ENGINE INSPECTION

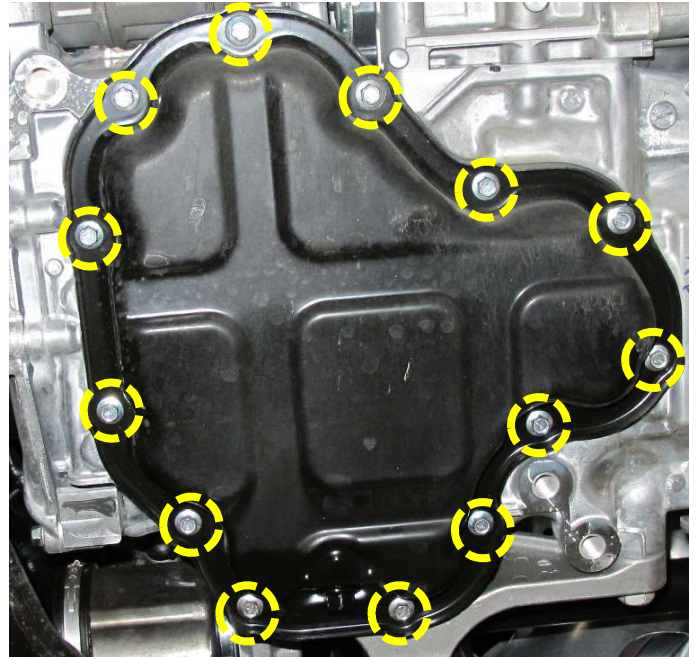
Figure 2

- Remove the (13) bolts from the oil pan (Figure 2)
- Separate lower engine oil pan from the upper engine oil pan using (J-37228) (Figure 3)

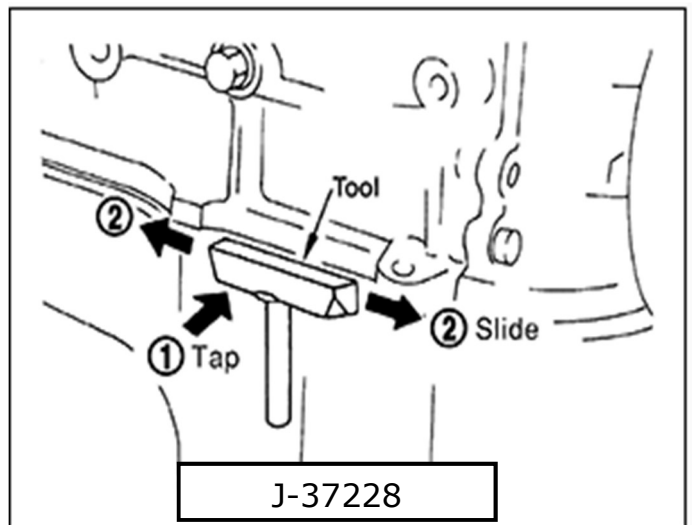
Figure 3

NOTE: Tap (1) Tool to insert it and then slide (2) it by tapping on the side of the Tool as shown.
