GLOBAL SAFETY FIELD INVESTIGATIONS
DCS5038
URGENT - DISTRIBUTE IMMEDIATELY

Subject: N192210460-01 – Service Update
eBoost Control Module Software False Detection with DTC Associated
Revised Labor Times and Service Procedure

Models: 2019 Cadillac CT6 w/ LSY or LTA motors
2019 Chevrolet Silverado 1500 (New Model)
2019 GMC Sierra 1500 (New Model)

N192210460 eBoost Control Module Software False Detection with DTC Associated

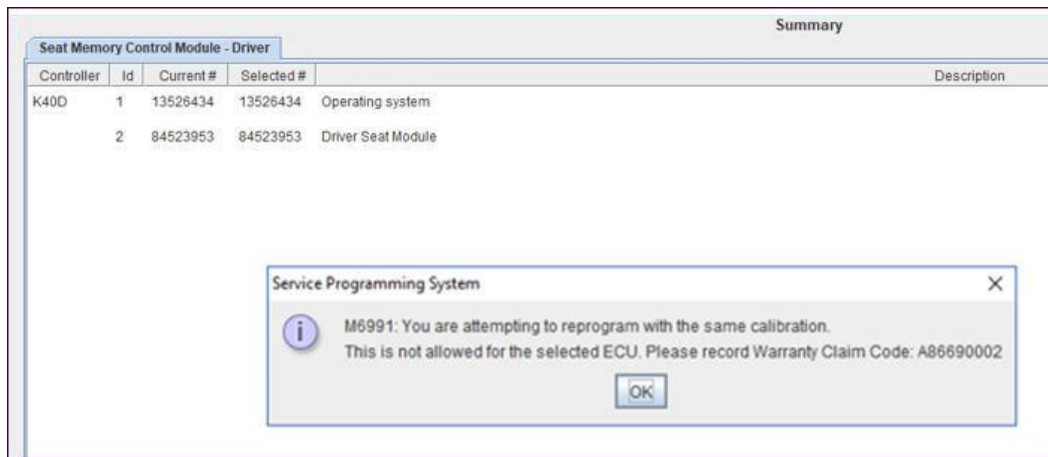
5164840

Note: If the Same Calibration/Software Warning is noted on the SPS Summary screen, record the warranty claim code (WCC) and select OK and follow screen instructions. After a successful programming event, the WCC is located in the Service Programming System dialogue box of the SPS Summary screen. No further action is required. Refer to the Warranty section of the bulletin.
