**SERVICE BULLETIN**

**APPLICABILITY:** 2019MY Impreza  
 2019MY Crosstrek (Including Hybrid Model)  
 2019MY Forester  
 2019MY Legacy/ Outback  
 2019MY WRX  
 2019MY BRZ- Navigation -equipped ONLY  
 2019MY Ascent

**NUMBER:** 15-236-18R  
**DATE:** 12/04/18  
**REVISED:** 08/21/19

**SUBJECT:** Reprogramming File Availability for Optimization of Harman Gen 3.1 Audio and Navigation Head Units

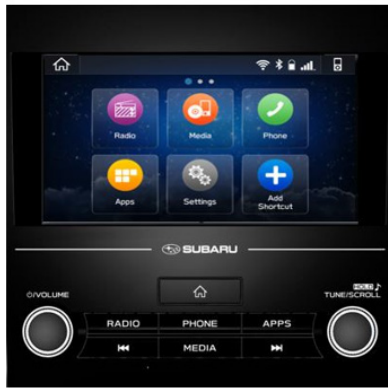
BASE

Multimedia System Type	Descriptive Features
6.5 Inch Display Audio System (Base)	No CD slot / Eject Button
6.5 Inch Display Audio System (Base +)	Equipped with CD Player and Eject Button
8.0 Inch Display Audio System (Mid)	Phone Button
8.0 Inch Audio / Navigation System (High)	Map Button but no Phone Button

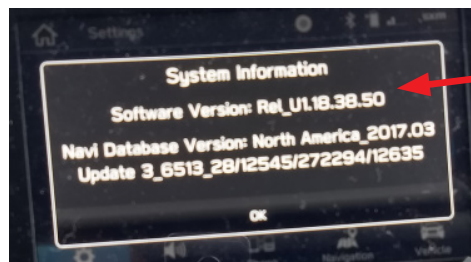
- The currently installed software version will be displayed. If the Software Version is **Rel\_U1.18.38.50** (or before) proceed to **Step 2**. This version number is the same for all 4 levels of head unit.

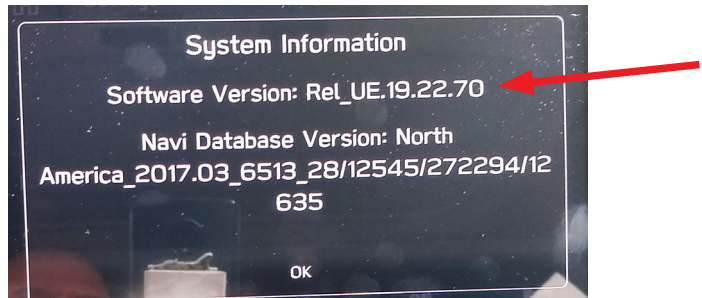
**VERY IMPORTANT:** If the current version is **Rel\_UE 19.22.70** or **Rel\_UE.19.25.70**, **STOP** as the latest version has already been installed and no update is required at this time.

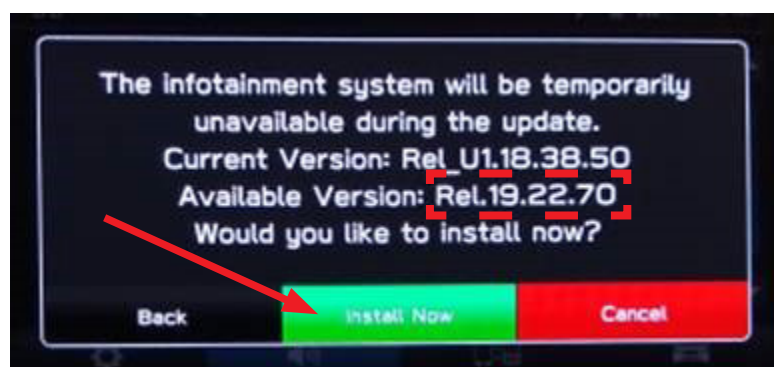
- The current and available software version information will be displayed. The Available Version I.D should be **Rel.19.22.70**.

- After confirming the Available Version, press “Install Now” to start the reprogramming process. The screen will go blank (black) for a brief period after installation begins.
- Each of the updates (Base, Mid and High) should take less than 10 minutes to install.

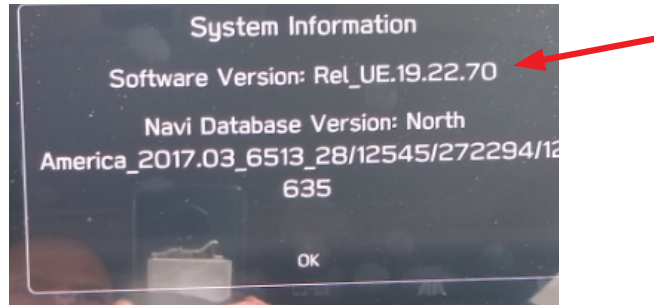
- Confirm Software Version is now “**Rel\_UE.19.22.70**”.
