SERVICE BULLETIN

APPLICABILITY: 2010-**19MY** Legacy and Outback
 2014-**19MY** Forester
2012-19MY Impreza
2013-19MY Crosstrek
 2015-**19MY** WRX
2019-20MY Ascent

NUMBER: **16-103-16R**

SUBJECT: Transmission Fluid Seepage

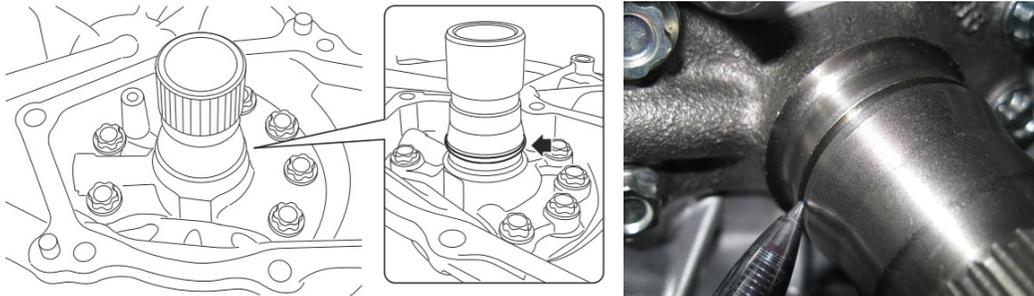
- The re-designed input shaft oil seal has a new side lip added to supplement the existing main seal lip. The purpose of the additional side lip is to direct the flow of dust and water around the seal and away from the sealing surfaces.
- Apply CVT fluid to the main seal lip **only** before installation.
- When installing this new seal, it is **STRONGLY** recommended to use the proper installer tool ****OPTIONAL Special Tool 927890000** as shown in the illustration below. Otherwise, If the seal were to be installed too deep into the bore of the chain cover (beyond flush with the chain cover edge as shown below), the oil passage may become restricted or blocked.
