Fraying Headliner Cords

Topic number	LI77.30-P-070145
Version	1
Function group	77.30 Vario roof, soft top - complete
Date	08-15-2019
Validity	205 and 238 cabrios produced before June 2019
Reason for change	
Reason for block

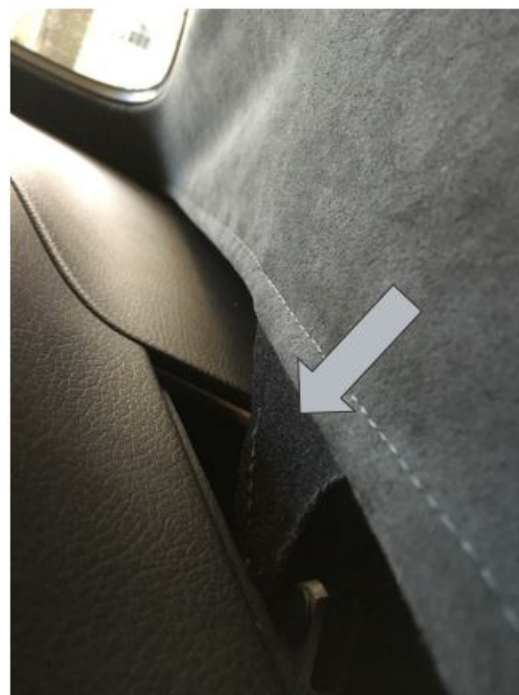
Abb.26.JPG:

In vehicles produced prior to the change, which require a new soft top interior trim in repair cases, the tensioning strap is fastened

See Fig. 26.
