SIB 64 06 13

A/C COOLING: INTERMITTENT REDUCTION OF AIR FLOW

This Service Information Bulletin (Revision 9) supersedes SI B64 06 13 dated June 2017.

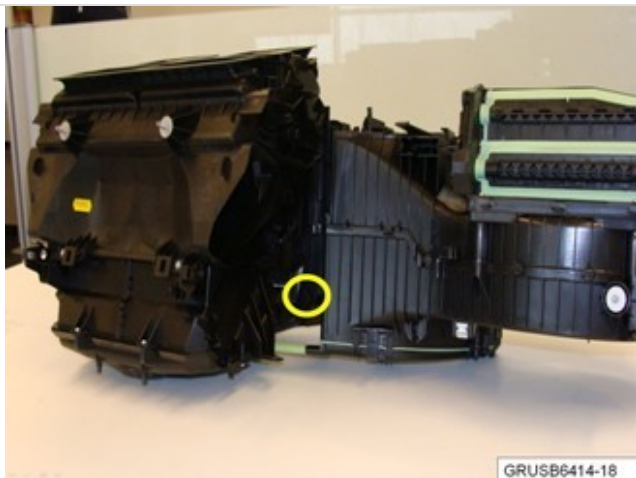
4. The IHKA housing (removed for clarity) shown is viewed from the passenger's side.

The circle shows the approximate location of the evaporator temperature sensor.
