SIB 01 21 18

N63 ENGINE: OIL CONSUMPTION CLASS ACTION SETTLEMENT DIAGNOSIS AND REPAIR PROCEDURES

This Service Information bulletin (Revision 11) supersedes SI B01 21 18 dated **June 2019**.

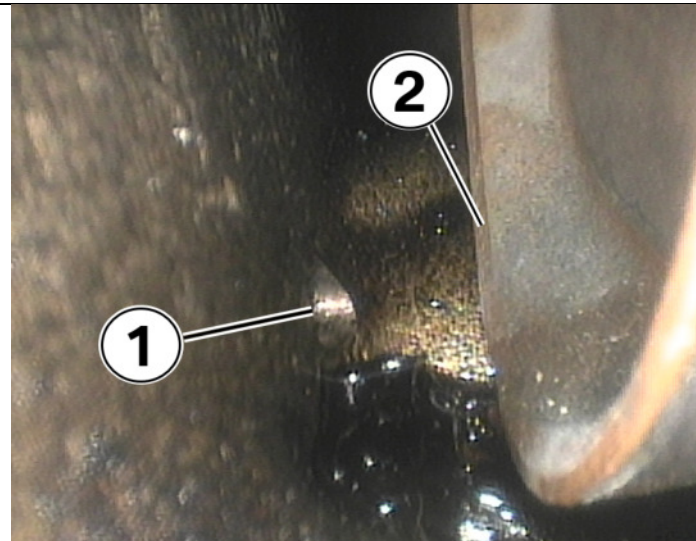
<p>Inspect the surrounding area of the engine valley drain hole (1).</p> <p>Engine valley drain hole (1)</p> <p>Metal vacuum reservoir (2) shown.</p> <p>This is a clean picture. No oil can be seen in the oil drain hole (1).</p> <p>The dark material at the bottom of the photo is dust and dirt. This material appears to be reflective but it is dry</p>

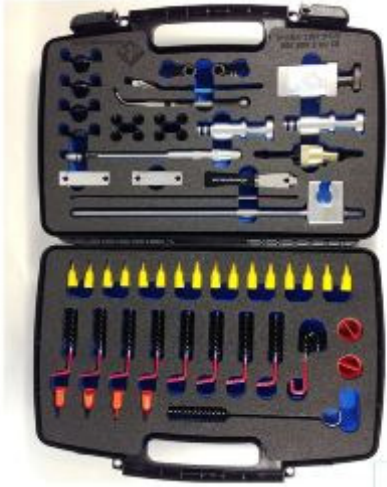
GRUSB1115-11

If the turbocharger inspection is "NOT OK", then replace the turbochargers in conjunction with the recommendations in step 11. Go to step 11.

11. Replace the intake and exhaust valve seals using the N63 Valve Seal Replacement Tool Kit P/N 83 30 2 408 268 as per SI B11 08 15 or Repair Instruction 11 34 570 "Replace all valve stem seals using special tool 83 30 2 408 268 (N63)".
