SIB 32 08 18

SERVICE ACTION: REWORK THE STEERING GEAR

This Service Action involves F22, F23, F30, F32 and F36 Series vehicles produced from October 19, 2011 to May 19, 2015.

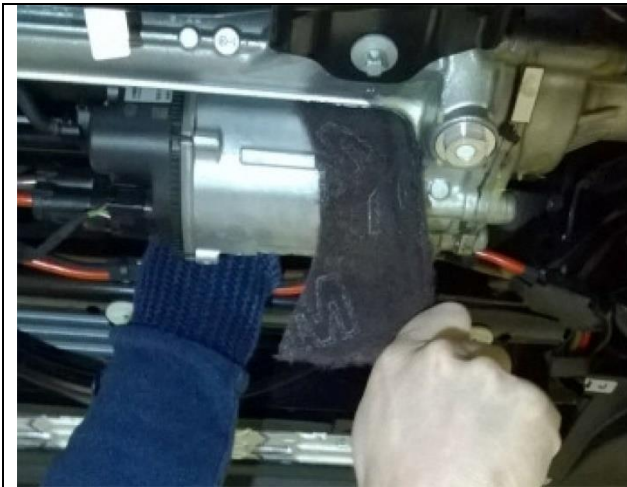
Screws attaching the power pack to the steering gear may be broken. Broken screws result in noises during steering motions and variable steering assistance.

1. Clean the outside of the steering gear, especially in the vicinity of seals, using non-woven abrasive cloth.
 - Approved non-woven abrasive is Scotch-Brite Hand Pad.

- Carefully clean around the five screws (callout #4 in illustration).
- Using compressed air, blow off any loose dirt.

Warning: Do not loosen more than one screw at a time or damage to the steering system may occur!</p> <p>4. Replace the five indicated screws, one at a time, using the following procedure.</p> <p>
