SIB 51 24 19 CRACKING NOISE FROM DASHBOARD TRIM

| E-Series | Model Description |
|---|---|
| F90 | M5 Sedan |
| G30 | 5 Series Sedan |
| G32 | 640i xDrive Gran Turismo |

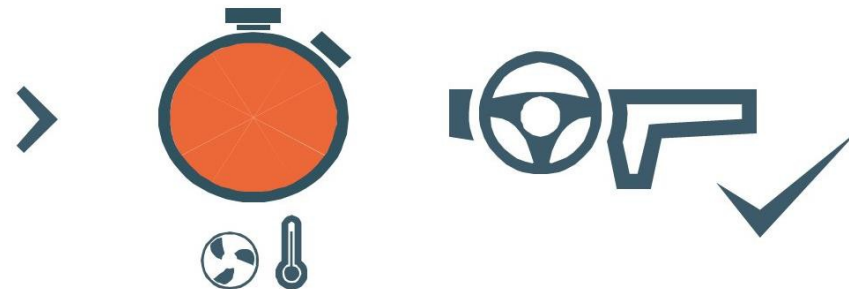
Validation test:

- Cool down for approx. 10 minutes with the air conditioning system switched on (temperature setting of air conditioning control unit at lowest level, AC - ON).
- Heat the interior to the highest setting and evaluate the vehicle during the heating process about 5 minutes.
- After heating up, carry out a test drive about 15 minutes. Temperature setting via the air conditioning control unit to the lowest level, AC – ON.
