Technical product information

Topic	Unable to run basic settings within the Adaptive suspension control unit (J775)
Market area	Bentley: worldwide (2WBE),Hongkong-Macau (5HK)
Brand	Bentley
Transaction No.	2055693/1
Level	EH
Status	Approval
Release date

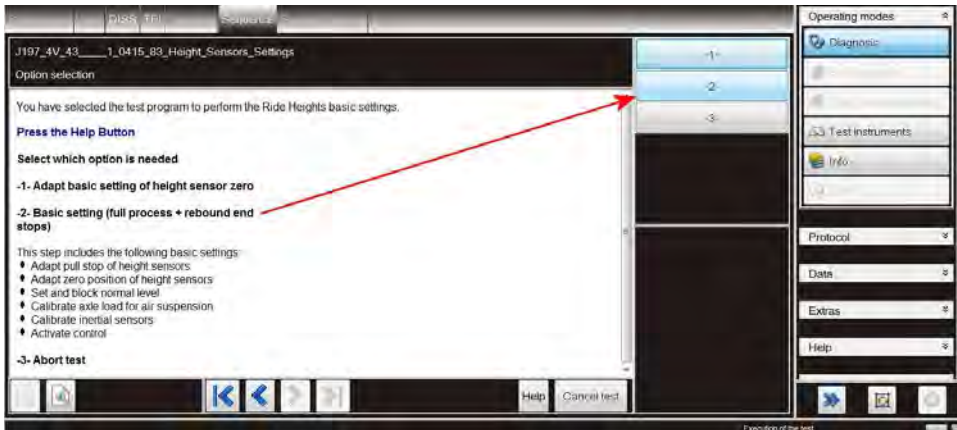
Figure 1

Referring to Figure 1, During the Basic setting (full process + rebound end stops) the routine can stop during the initial part of the procedure, in particular at the stage shown in Figure 2, which is when the vehicle is raised to allow all four wheels to hang down to their full rebound position

Should this issue be evident and the Basic settings routine does not continue - Refer to the Measure section of this TPI
