SERVICE BULLETIN

APPLICABILITY: 2013-19MY BRZ

NUMBER: 02-136-12R

SUBJECT: Oil Seepage Diagnosis and Repair Procedures

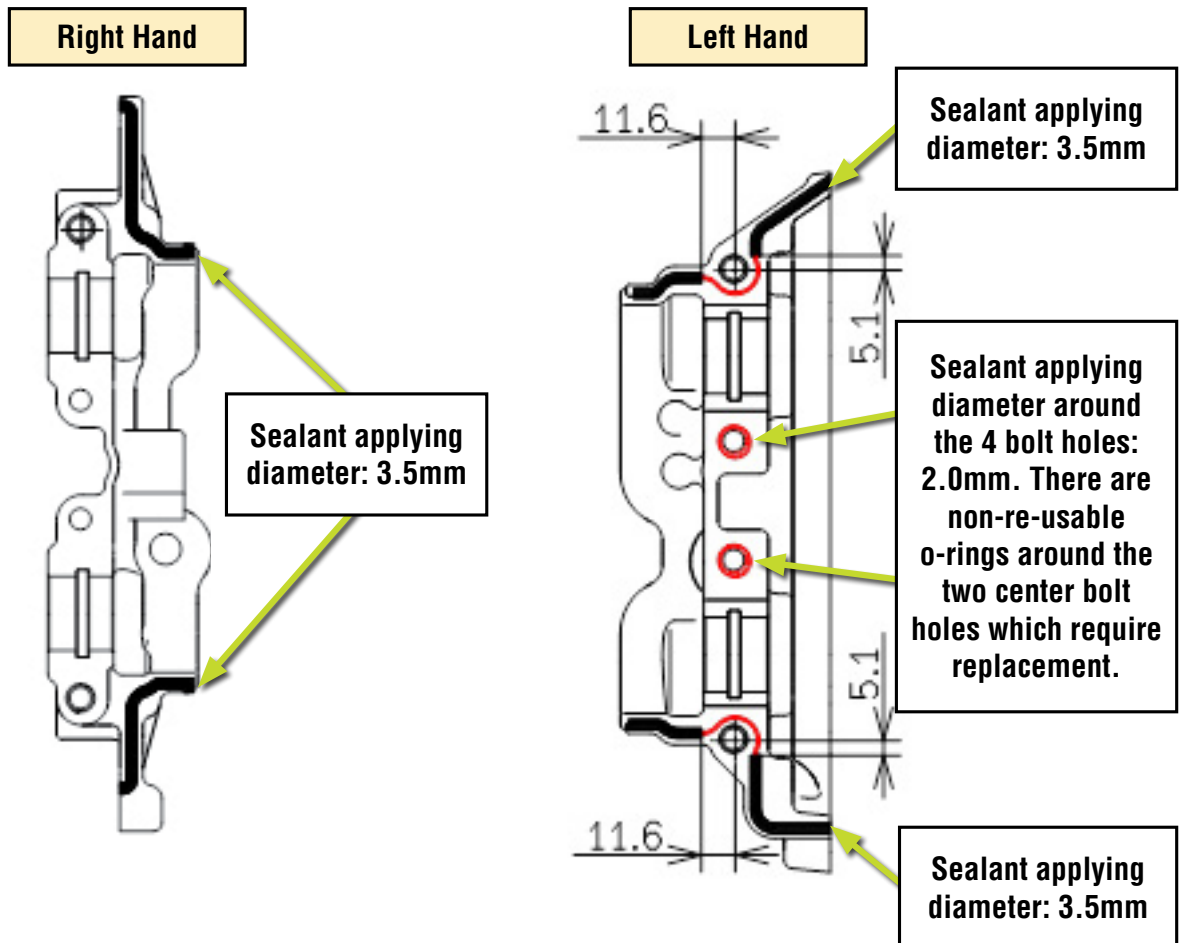
If oil seepage is verified coming from the front camshaft cap and/or camshaft carrier as shown in the photos below, remove the cam cap and clean both surfaces thoroughly before applying sealer. **Note:** The 2 o-rings between the camshaft cap and the cam carrier will need to be replaced as they are not re-usable.

Apply Liquid Gasket, ThreeBond 1280B, (Part No. SOA5499100) or equivalent* as shown below:

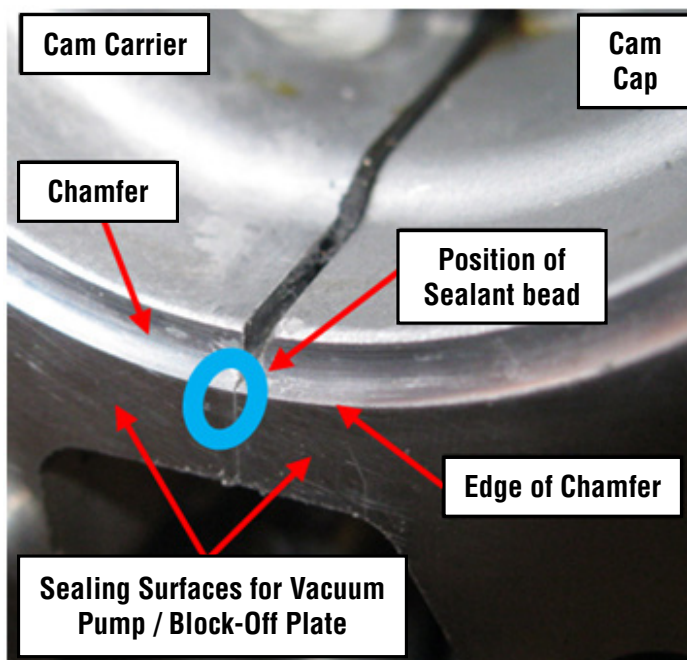
If oil seepage is verified at the bottom of the cylinder head block-off plate (on M/T models) or bottom of the vacuum pump assembly (on A/T models), the source may be the area between the cam carrier and the intake cam cap. The seeped oil then collects at the bottom of the block-off plate or vacuum pump as shown in the photo and illustration below.

Remove the cylinder head block-off plate (or vacuum pump) following the procedure outlined in the applicable Service Manual and thoroughly clean all the machined sealing surfaces. Be sure to trim away any sealant which may have squeezed out during installation of the intake cam cap onto the cam carrier. Apply ThreeBond 1280B sealant as shown in the reference illustrations below.

*a	Selant Bead Diameter: 2.0 - 4.0mm
*b	Location of bead: Within 1.0mm of Chamfer Edge
*c	Edge of Chamfer
