MODEL
**2020MY
Telluride (ON)**

NUMBER
PS627

SUBJECT: INOPERATIVE LICENSE PLATE LAMP AND/OR
LIFTGATE HANDLE SWITCH

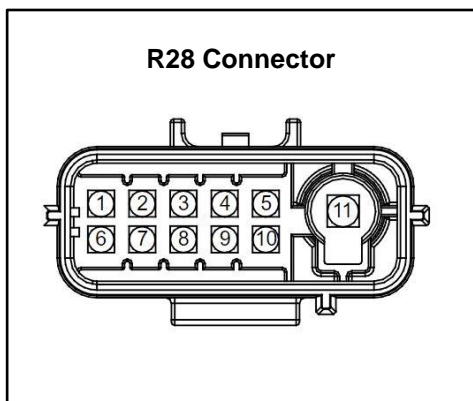
Pin	Color	Function
1	G/B	Rear View Camera (shield)
2	G/O	Rear View Camera (ground)
3	B	Tailgate Handle Switch (ground)
4	-	-
5	B	License Lamp (ground)
6	-	-
7	Y	Rear View Camera (power)
8	Gr/B	Tailgate Handle Switch
9	R	License Lamp (LH)
10	Y/B	License Lamp (RH)
11	W	Rear View Camera (coaxial)

Inspect the connector R28 for bent or backed out pin(s). If the connector pin(s) are found to be damaged, repair as needed. Once repaired, check for correct operation of the license plate tail lamps and liftgate handle switch. If no damage is found on the connector, proceed with normal diagnosis.
