RS19-005

ITB19-024

September 12, 2019

## DTC B00A0-00 STORED

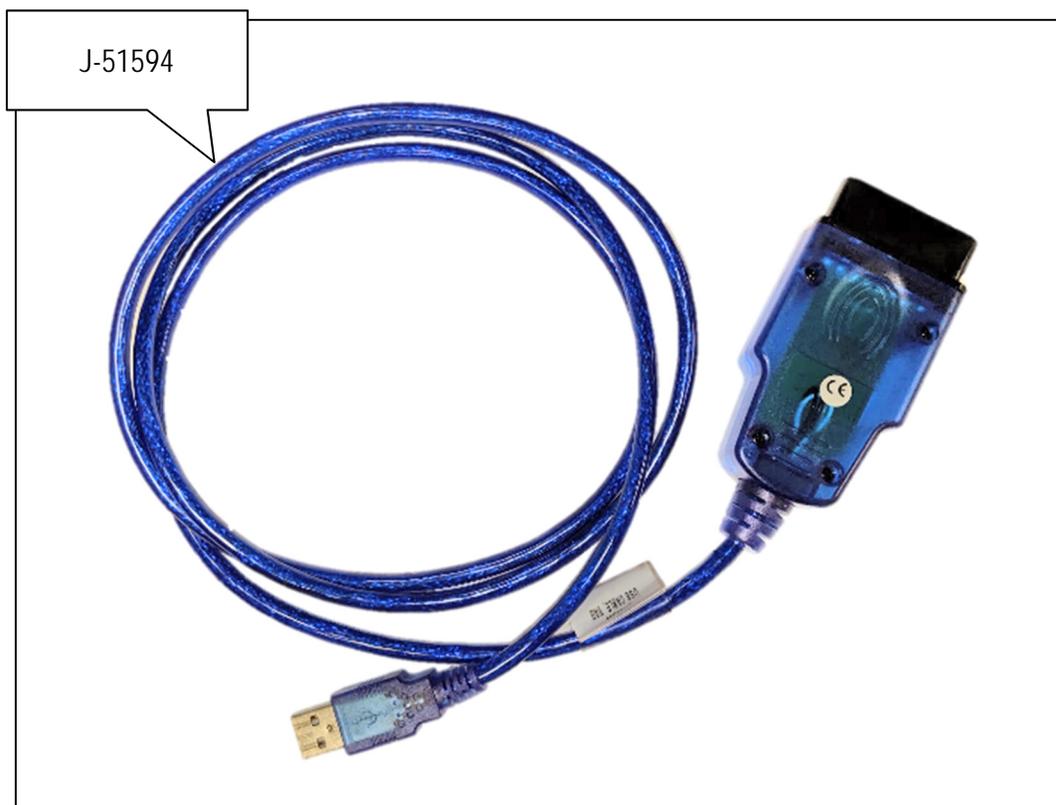
Figure 2

## REQUIRED SPECIAL TOOL: OCS Reprogramming Cable J-51594

Special (essential) tool J-51594 has been previously sent to each dealer.
