**SIB 51 27 19**  
**SIDE TRIM IS LOOSE OR COMES OFF**

E-Series	Model Description	Production Date	Affected Option Code / Engine
G29	Z4 Roadster	From November 1, 2018- March 31, 2019.	337 M Sport Package, or 760 High gloss shadowline, or 7M9 individual high gloss shadowline

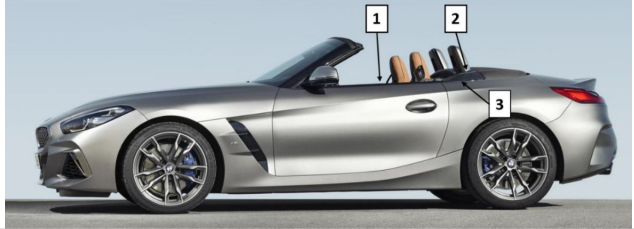
3. Numbers correspond to those in the operation below.

Firmly press the side trim onto the vehicle body, ensuring all 3 clips of the side trim are completely installed.

Note: When correctly positioned, a 4mm gap is present between the front (1) and rear side trim (3) as shown to the left.

Ensure that any additional window adhesive that spills over is immediately cleaned from the vehicle body.
