October 11, 2019

Version 1

2017-18 NSX Wind Noise

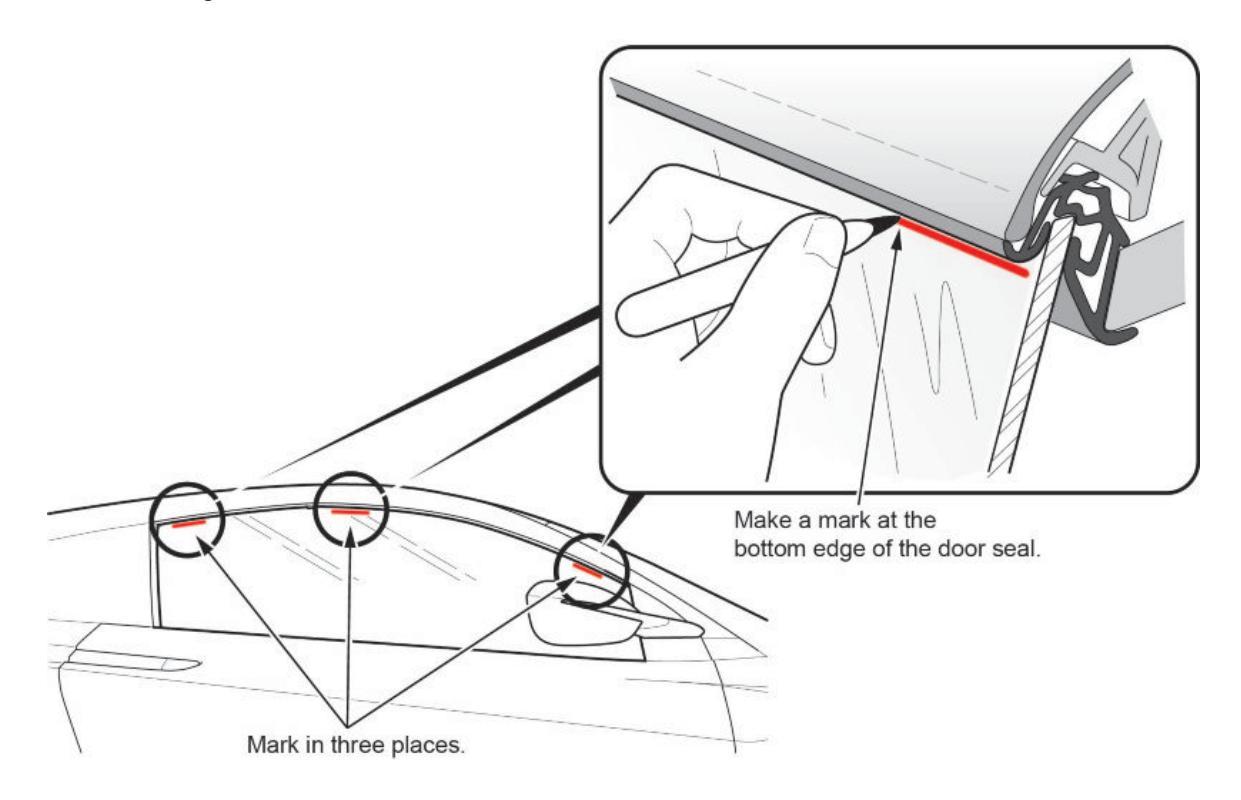
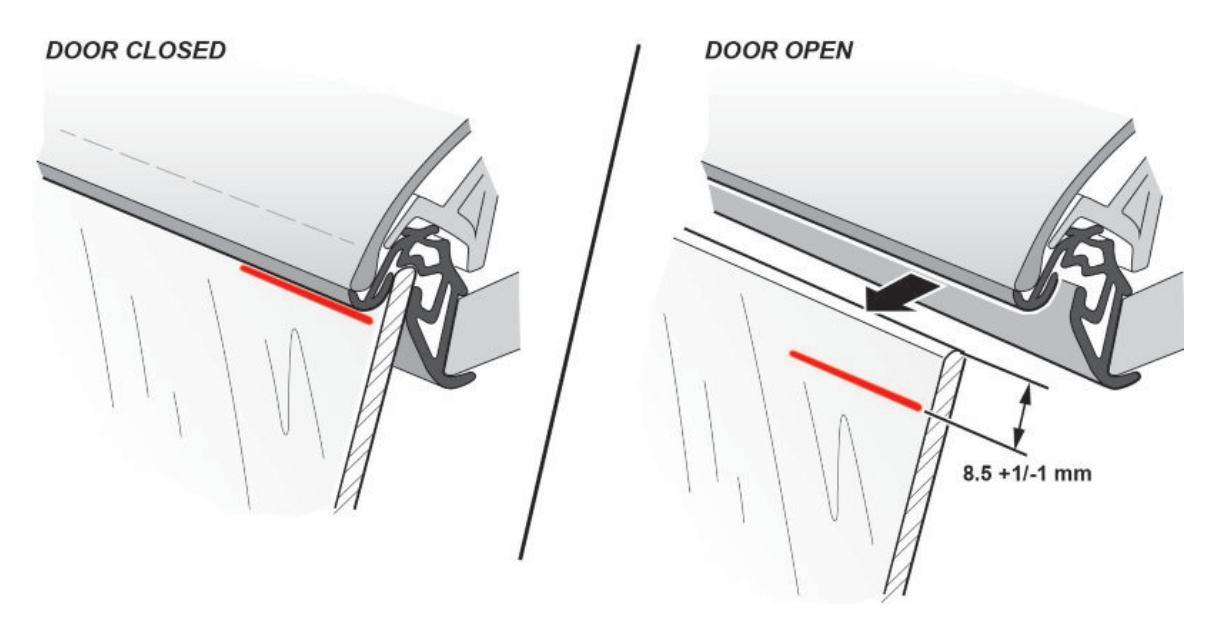
1. With the window fully closed, use a dry erase marker to mark the window as shown. Be sure to mark the glass where the edge of the seal ends.

Open the door, and let the window index down. Measure the distance from the mark to the very top edge of the window glass. Check that this measurement is within **8.5 +1 / -1 mm**.

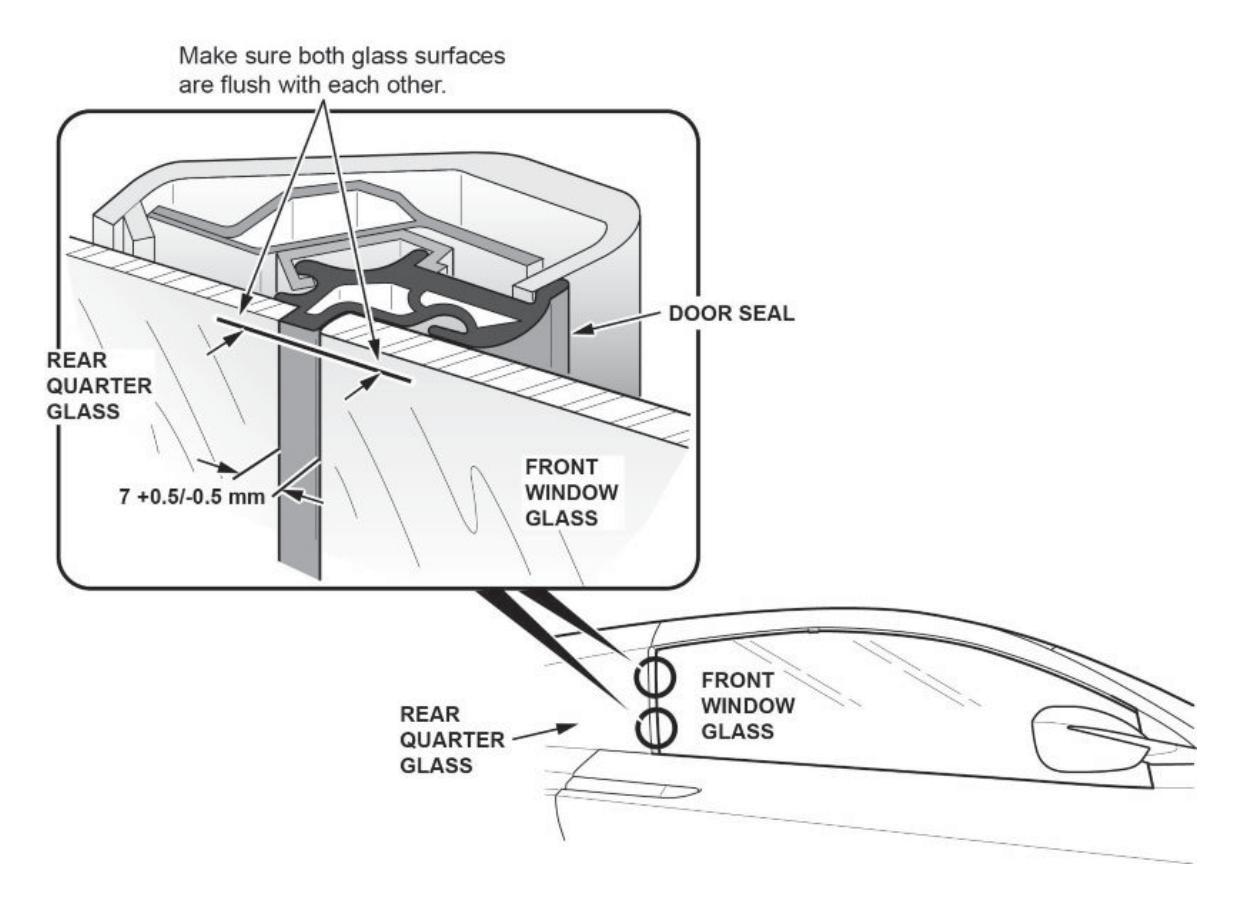
2. With the door closed, measure the distance between the front window glass and the rear quarter glass. Check that this measurement is within **7 +0.5 / -0.5 mm**.

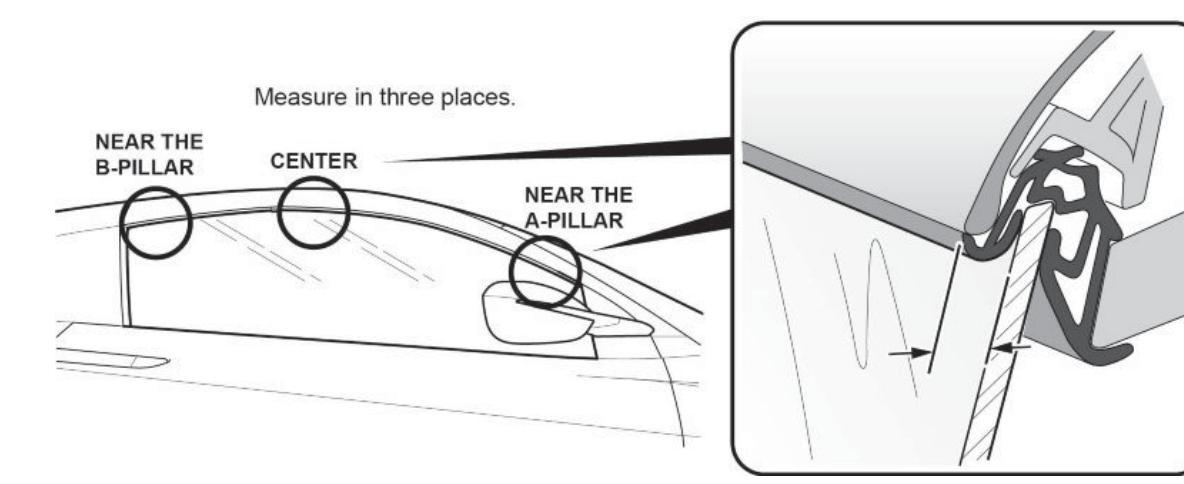
3. Measure from the surface of the glass to the edge of the roofline. Check that these measurement are within ranges shown below.

Measuring Point	Acceptable Limit	
Near the A-Pillar	10.5 - 12 mm	
Center	11.3 - 12.8 mm	
Near the B-Pillar	18.4 - 19.9 mm

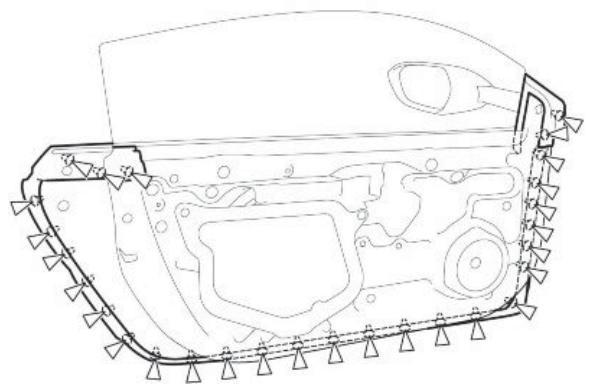
When installing the door outer seal, press the seal against the edge of flange B. Make sure the lip of the door outer seal rests on the top edge of flange A. Do not stretch the opening of the outer door seal greater than 10 mm. This will cause permanent damage to the seal and result in a wind noise.

10. Remove and replace the door outer seal. Refer to the service information.

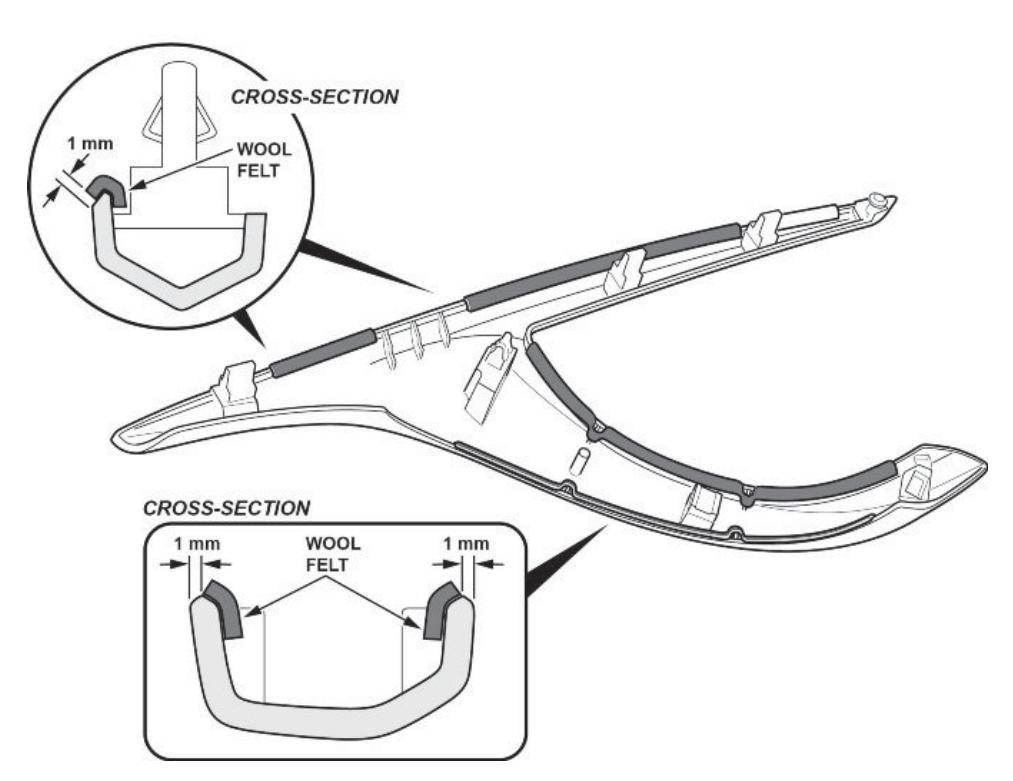
Before installing the door grip cover, make sure the wool felt on the back of the cover is attached evenly and has not been damaged during removal. The felt should be positioned **1 mm** as shown. If it is not applied evenly, or it is damaged or missing, noise could result. Remove any uneven, damaged, or missing felt, and apply new felt as needed.

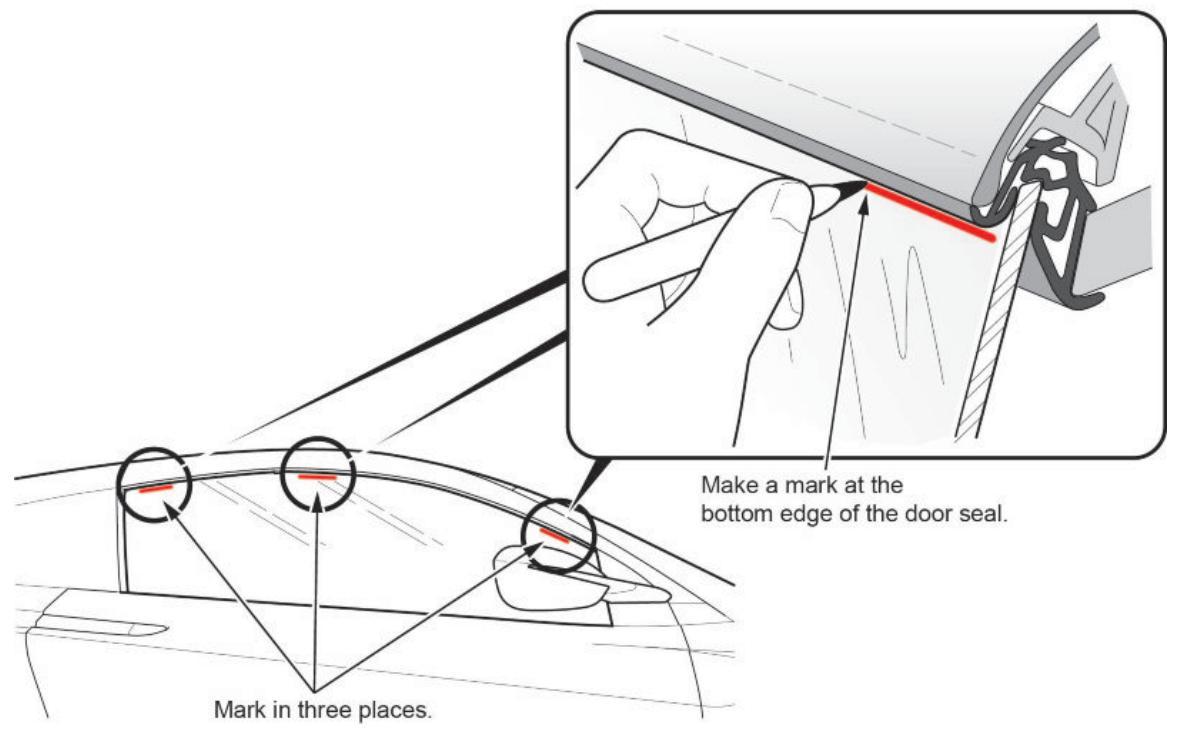
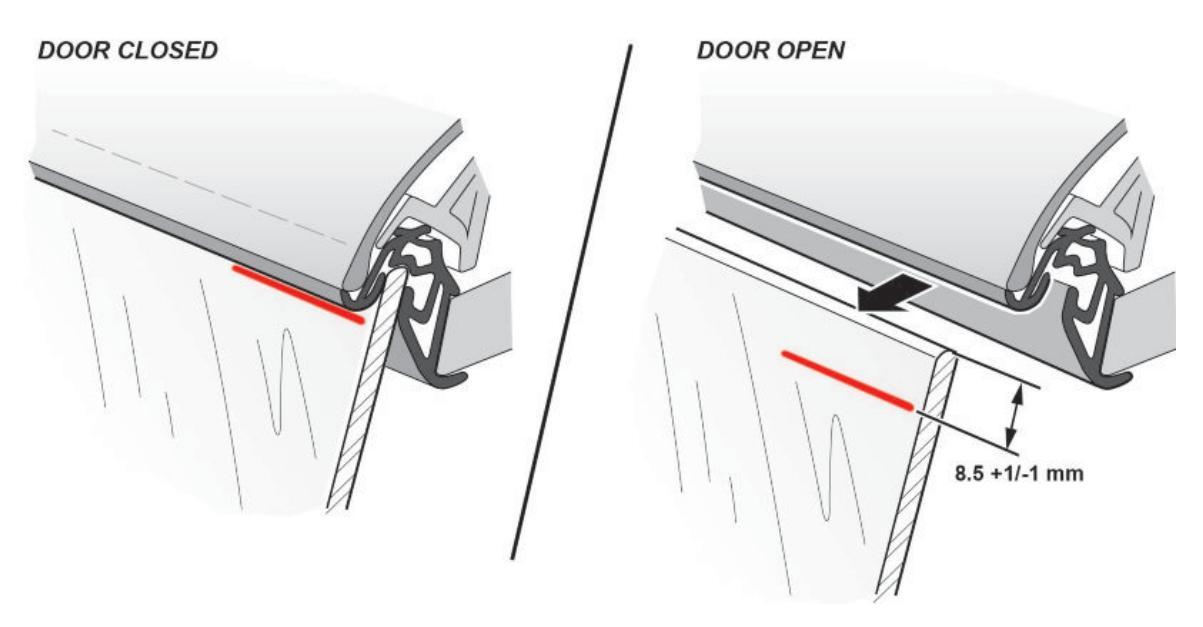
1. With the window fully closed, use a dry erase marker to mark the window as shown. Be sure to mark the glass where the edge of the seal ends.

Open the door, and let the window index down. Measure the distance from the mark to the very top edge of the window glass. Check that this measurement is within **8.5 +1 / -1 mm**.

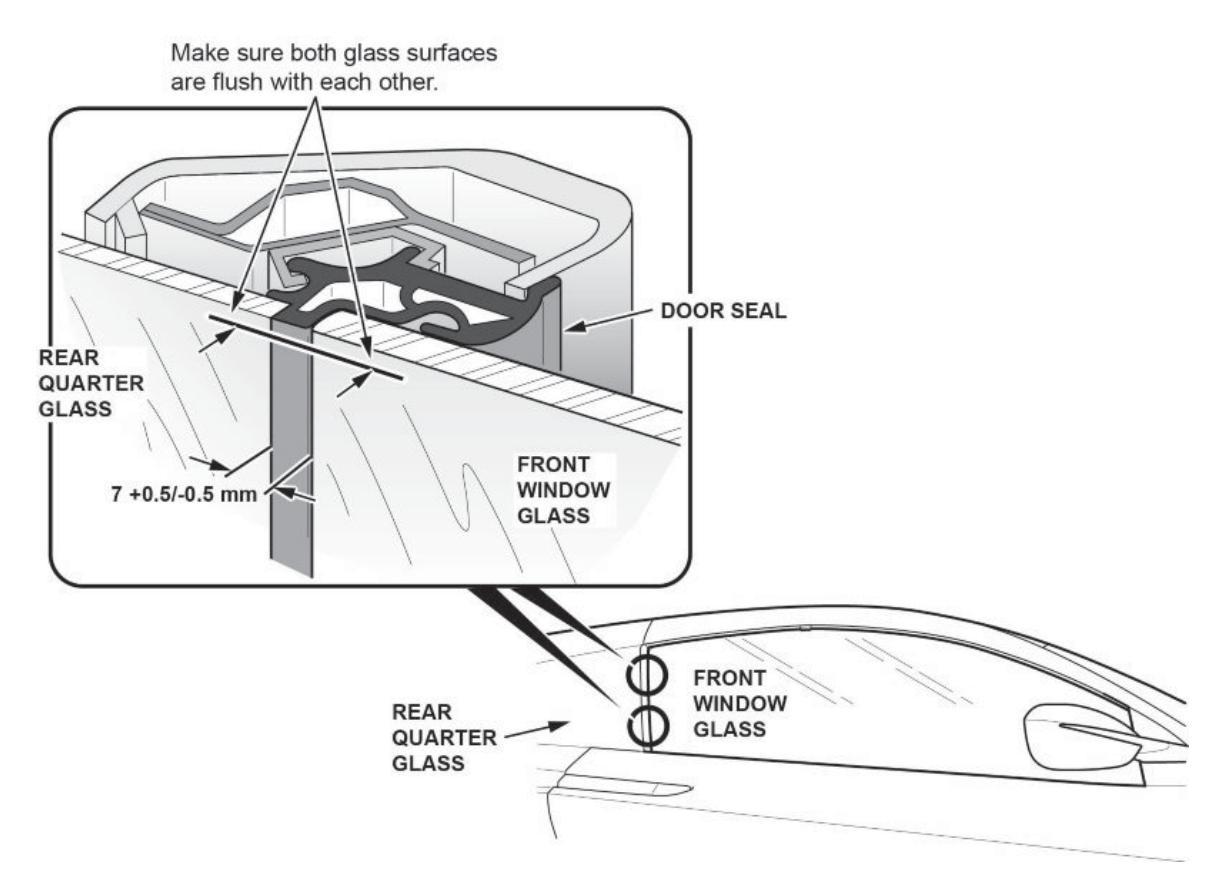
2. With the door closed, measure the distance between the front window glass and the rear quarter glass. Check that this measurement is within **7 +0.5 / -0.5 mm**.

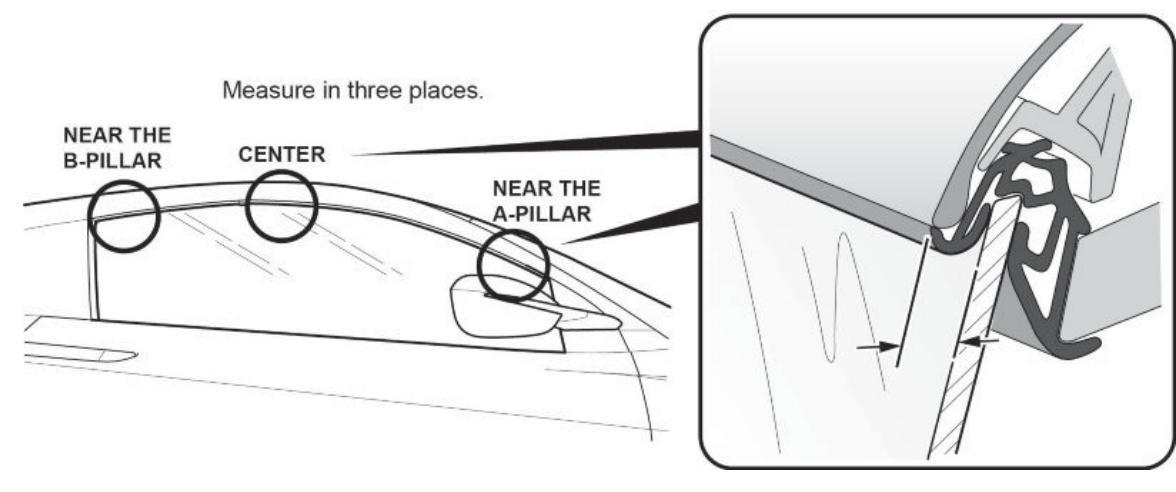
3. Measure from the surface of the glass to the edge of the roofline. Check that these measurement are within ranges shown below.

Measuring Point	Acceptable Limit	
Near the A-Pillar	10.5 - 12 mm	
Center	11.3 - 12.8 mm	
Near the B-Pillar	18.4 - 19.9 mm

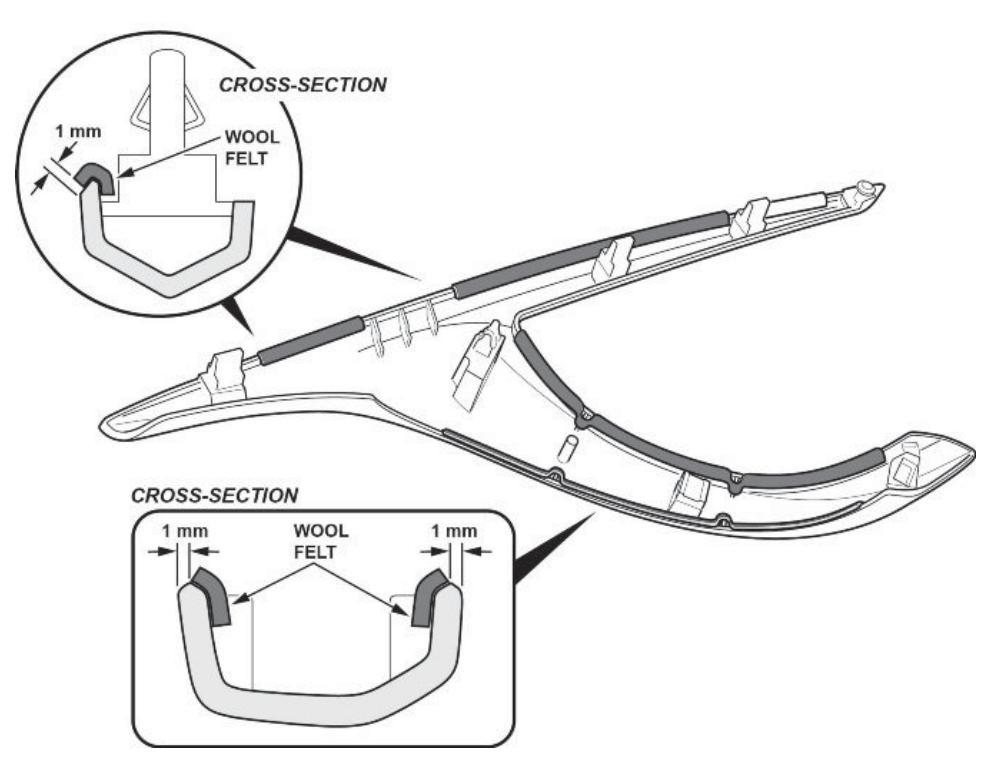
Before installing the door grip cover, make sure the wool felt on the back of the cover is attached evenly and has not been damaged during removal. The felt should be positioned **1 mm** as shown. If it is not applied evenly, or it is damaged or missing, noise could result. Remove any uneven, damaged, or missing felt, and apply new felt as needed.

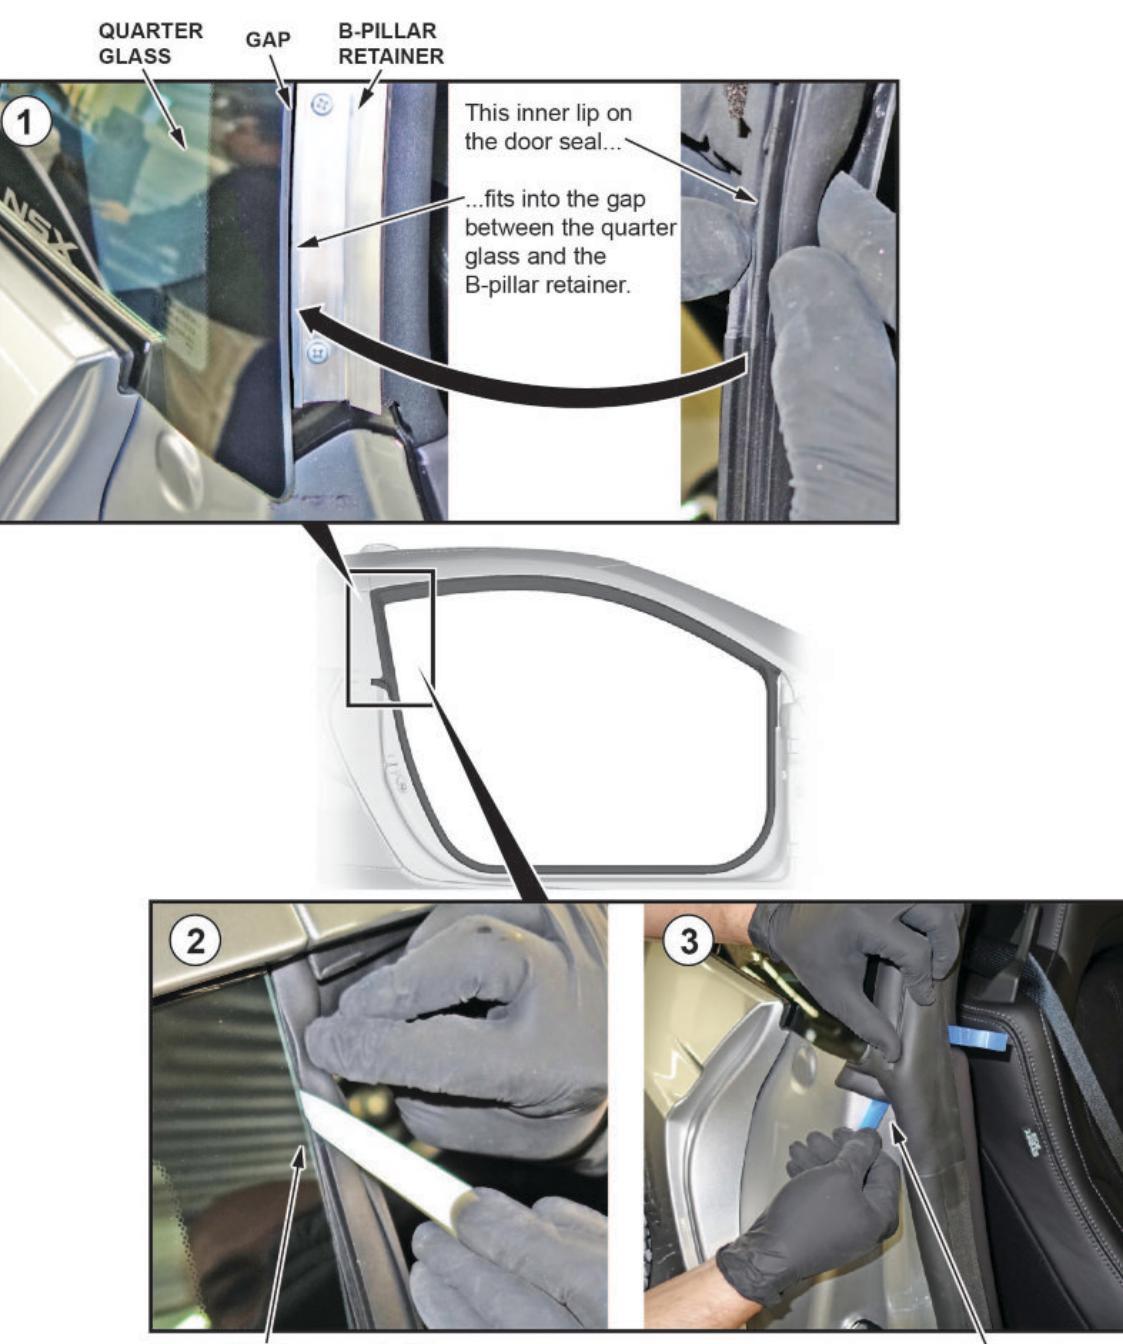
Make sure the inner lip of the seal is properly installed in the gap between the quarter glass and the B-Pillar retainer. A plastic stick may help set this seal lip.

14. Position the inner door seal to the front lower corner area of the quarter glass. Make sure the inner door seal tightly wraps around the lower corner of the quarter glass. Pull the adhesive backing on the inner door seal, and attach the adhesive tape to the body.

Ensure the door seal lip fits into the gap using a plastic stick.
