**NUMBER:** 08-082-19

UAV and UCV Radio Enhancements

This bulletin involves inspecting and if required, updating the radio software level to 28.3

2019 (WK) Jeep Grand Cherokee

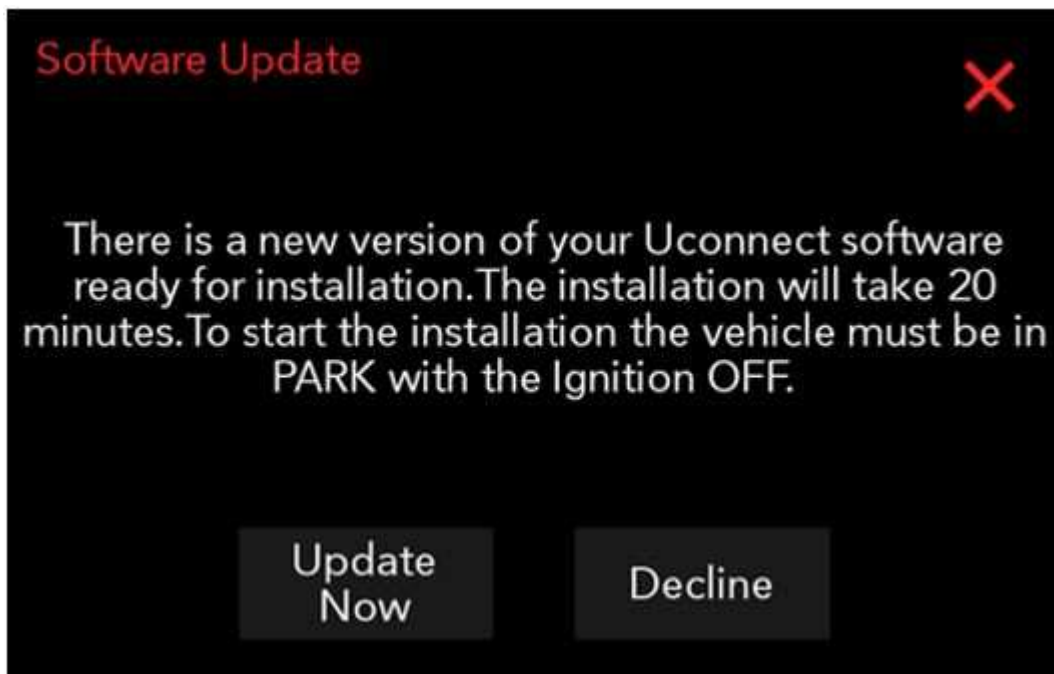
Fig. 8

Software Update Is Available

13. Once the system has verified there is an available update, touch the "Update Now" button. Make sure the vehicle is in park. **Do NOT turn off the ignition at this point,** (Fig. 8) .

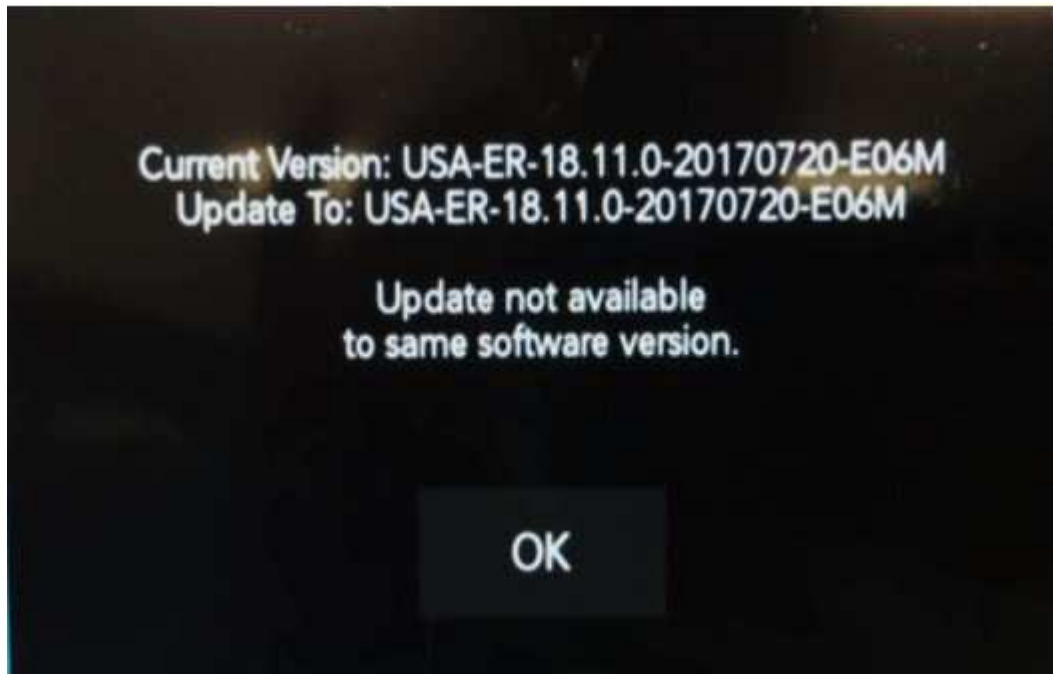
Fig. 11

Software Levels (The Figure Is For Reference Only).

16. Once the update has completed, the radio will reboot. With the USB flash drive still inserted in the USB port and the ignition in the "RUN" position, the screen in (Fig. 11) will be displayed. Press "OK" and remove the USB flash drive.
