NUMBER: 08-083-19

Flash: Hands Free Module (HFM) Software Enhancements

2012 - 2019	(JC)	Dodge Journey
2012 - 2014	(LD)	Dodge Charger
2012 - 2014	(LX)	Chrysler 300

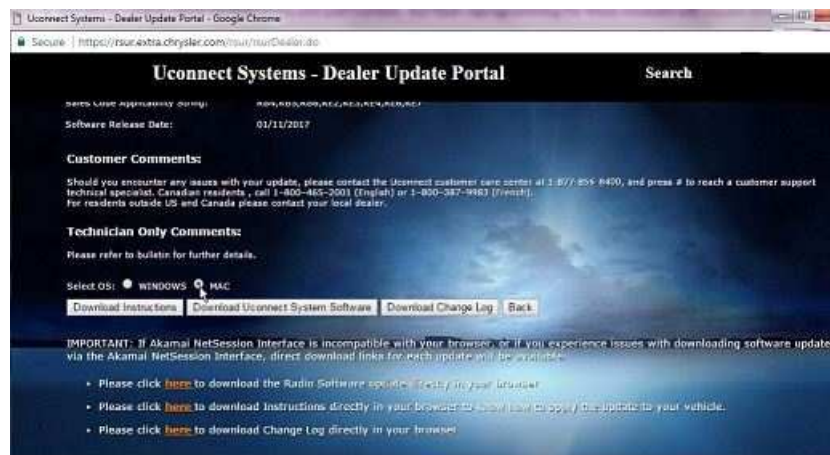
Fig. 2

Download Software - Push Windows or MAC Radial-Button

2. The HFM USB Flash application only runs on Windows PCs, however for “OS” selection, you can choose either “WINDOWS” or “MAC” to download files. If you select “WINDOWS” you will download a self-extracting “.exe” file. If you select “MAC”, you will download a “.zip” file. In either case, after clicking on the downloaded file, you will be able to extract the bundled files (flash file and flash PC application). For this flash, regardless of “OS” selection, you’ll end up with the same files after extraction and you must use a PC running either Windows 7 or Windows 10 (Fig. 2) .

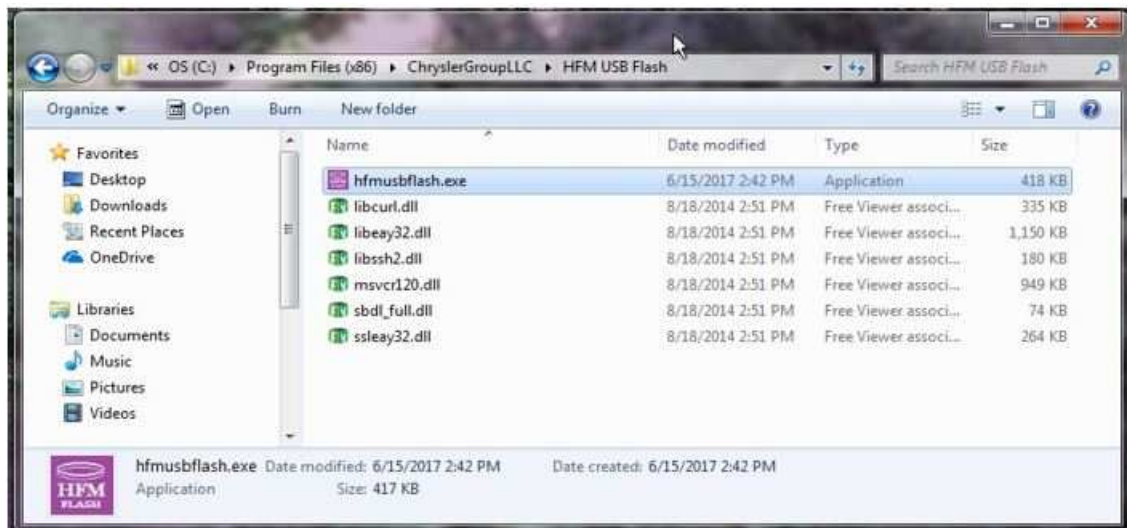
Fig. 3

Create Shortcut

NOTE: After installation, you will find the application in “C:\Program Files x86)\ChryslerGroupLLC\HFM USB Flash”, where you can create a shortcut to it. Right click on “hfmusbflash.exe” to create a shortcut to your desktop.
