# Service Action Code: 1903

**Coolant Bottle**

October 16, 2019

The coolant bottle may leak coolant into the electrical connector for the coolant level sensor.

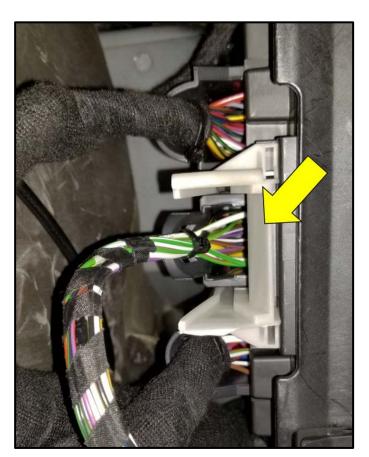
### Access -J519-:

- Connector T46b connector will be inspected.
- If NO liquid coolant or corrosion is found:
  - Reassemble vehicle in reverse order of removal.
  - o Proceed to Section E.
- If corrosion is found on the -J519- pins:
  - o -J519- must be replaced.
  - Corroded connector pins must be replaced.
- If only liquid coolant is found at the -J519-, but there is NO corrosion:
  - -J519- should be cleaned with a dry, lint free cloth.
  - The -J519- pins must be cleaned with compressed air.

- See ELSA Repair Manual: Repair manual > Electrical System > Electrical Equipment > 97 Wiring > Control Modules > Vehicle Electrical System Control Module -J519-, Removing and Installing
- Remove the T46b connector <arrow>.
