October 15, 2019

Version 2

Engine Stalls In Reverse Shortly After Cold Start (On-Board Snapshot Required)

Supersedes 18-072, dated July 3, 2018. See Revision Summary.

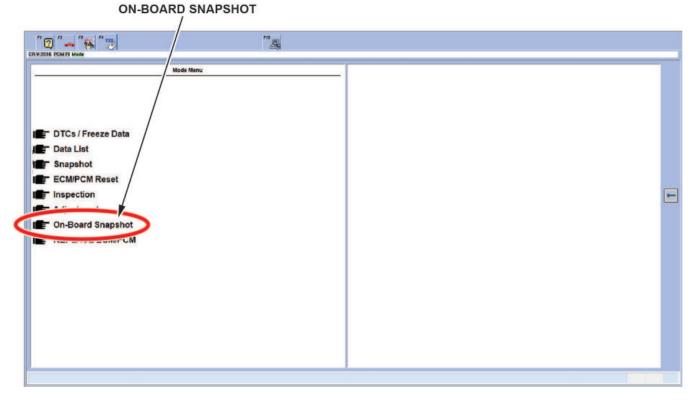
1. Connect to the vehicle using the i-HDS, and navigate to **System Selection Menu**, **PGM-FI**, then **On-Board Snapshot**.

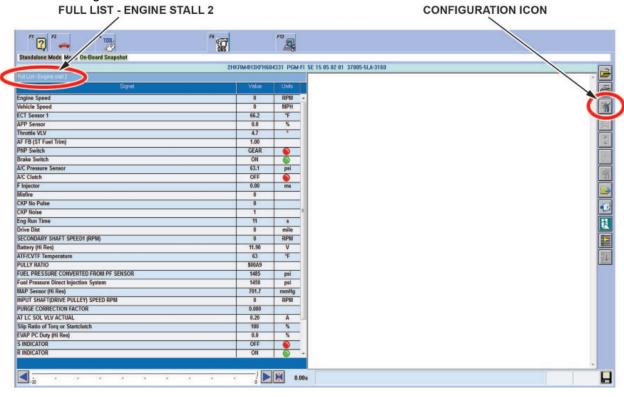
3. Select the Configuration icon.

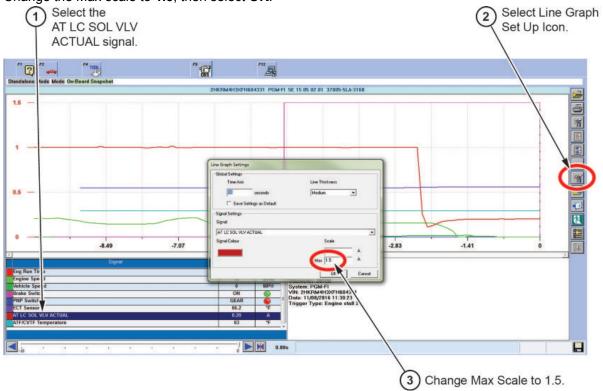
- 5. Select the AT LC SOL VLV ACTUAL signal, then the Line Graph Set Up icon.
- 6. Change the Max scale to **1.5**, then select **OK**.
