Applicable Vehicles					
Model(s)	Year	Eng. Code	Trans. Code	VIN Range From	VIN Range To
Tiguan LWB	2018	All	All	AX_JM000001	AX_JM158351

B-Pillar noise due to part production process.

## 51-19-01 - B-Pillar Noise while Driving

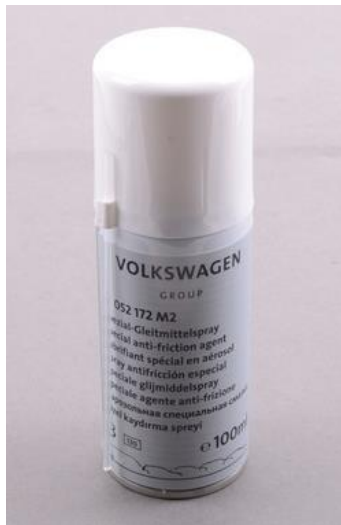
Krytox™ aerosol 100ml can.

- 3.1 Apply approximately 5 ml of Teflon (Krytox™) between the lower part of the bracket and cover sheet metal, apply in a uniform application on the entire contact zone of the bracket. See Figures 7 and 8.

Figures 7 - 8 show use with Krytox™ syringe, however, use Part #G 052 172 M2 and apply with the supplied nozzle.
