MODEL
2014MY
Soul (PS)

NUMBER
152 (Rev 1, 10/28/2019)

TECHNICAL SERVICE BULLETIN

SUBJECT: MULTI-FUNCTION SWITCH REPLACEMENT
FOR HEADLAMP FLICKERING

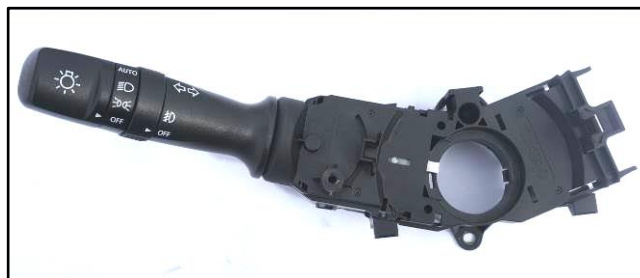
This bulletin provides the procedure to replace the multi-function switch on some 2014MY Soul (PS) vehicles, produced from July 21, 2013 through June 20, 2014, which may exhibit intermittent flickering of the low/high beams. To duplicate the concern, repeatedly operate the multi-function switch by activating the following:

If customer complains of an intermittent flickering of the low/high beams, replace the multi-function switch by following the procedure outlined in this bulletin. **Duplication of this concern is NOT required to replace the multi-function switch.**

1. Replace the multi-function switch (A) by referring to the “Body Electrical Switch → Multifunction Switch → Repair procedures” chapter in the applicable Shop Manual on KGIS.

Be sure to replace the two (2) multi-function switch retaining screws (part no.: 12290 05121) (B) when installing the new switch (A).
