Service Update

N192266751 Incorrect Driver Display Message for Diesel Exhaust Fluid

Release Date: October 2019

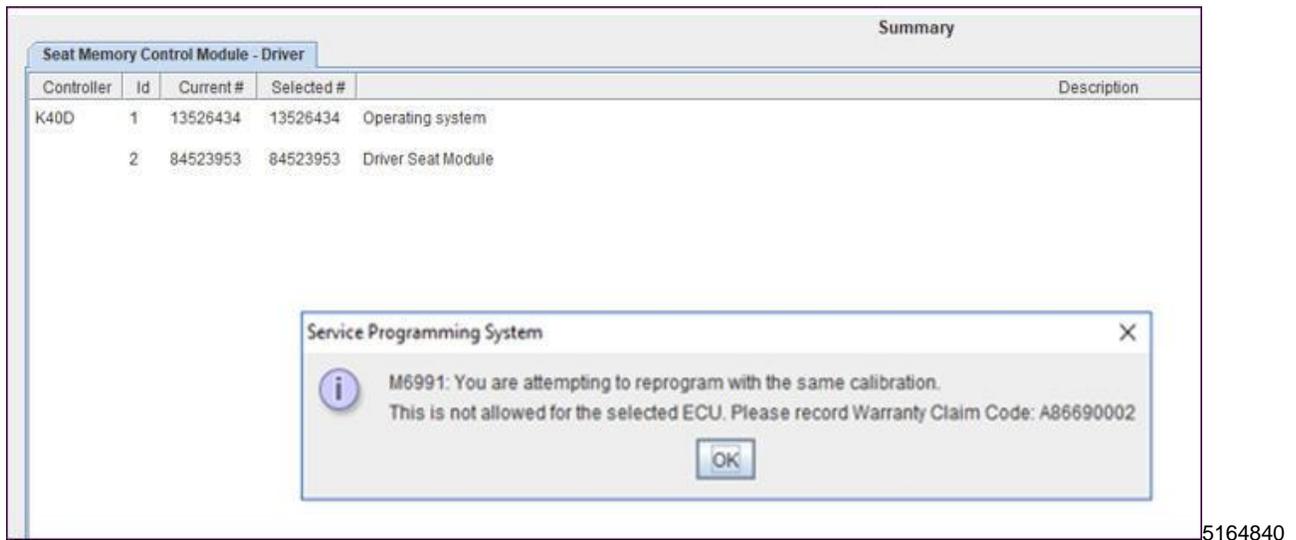
Note: If the Same Calibration/Software Warning is noted on the SPS Summary screen, record the warranty claim code (WCC) and select OK and follow screen instructions. After a successful programming event, the WCC is located in the Service Programming System dialogue box of the SPS Summary screen. No further action is required. Refer to the Warranty section of the bulletin.
