SIB 01 21 18

2019-10-22

## N63: OIL CONSUMPTION CLASS ACTION SETTLEMENT DIAGNOSIS/REPAIRS (VERSION 12.0)

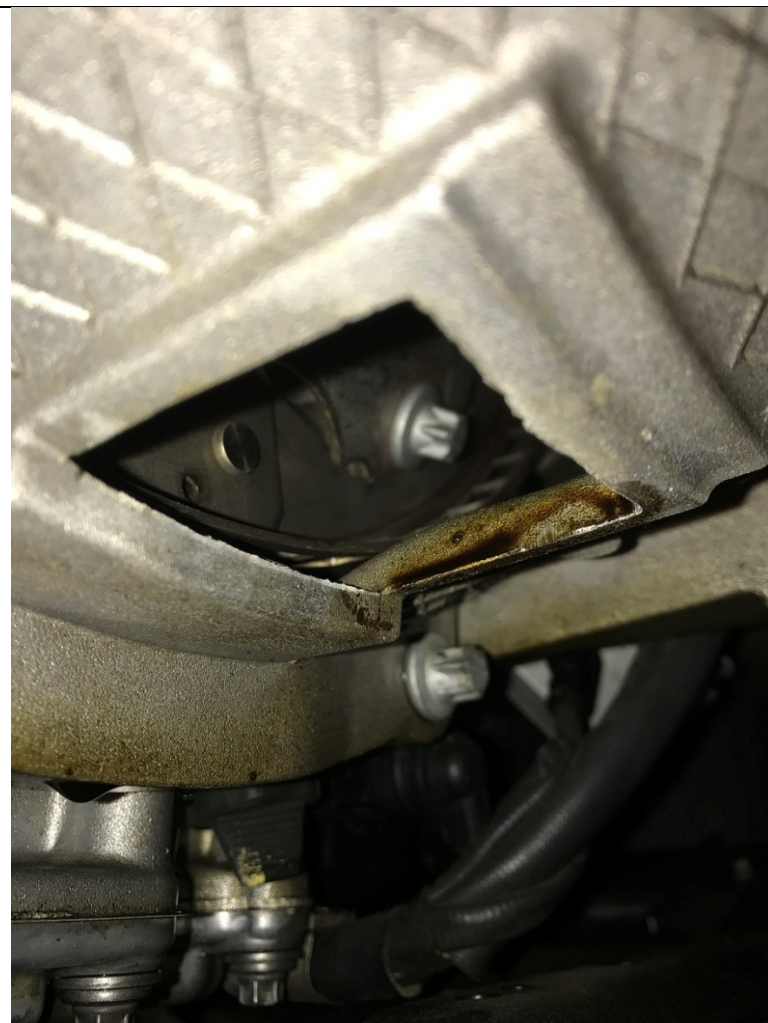
6. Inspect the lower bell housing for engine oil leakage

The lower bell housing is **not** leaking. Go to step 8.

The lower bell housing is leaking. Go to step 7.

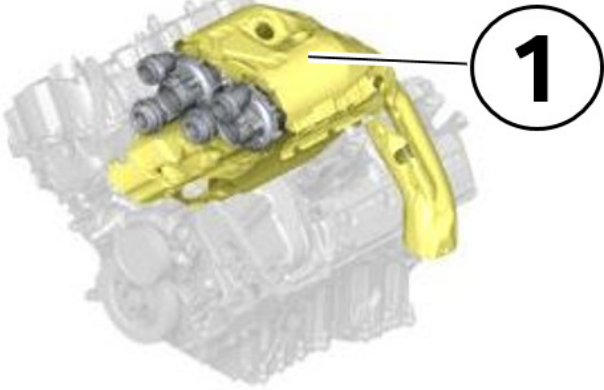
<p>Remove the heat shield (1) to diagnose the engine oil leak.</p> <p>Refer to Repair Instruction 11 65 180 Removing and installing/replacing heat shield at top.</p>

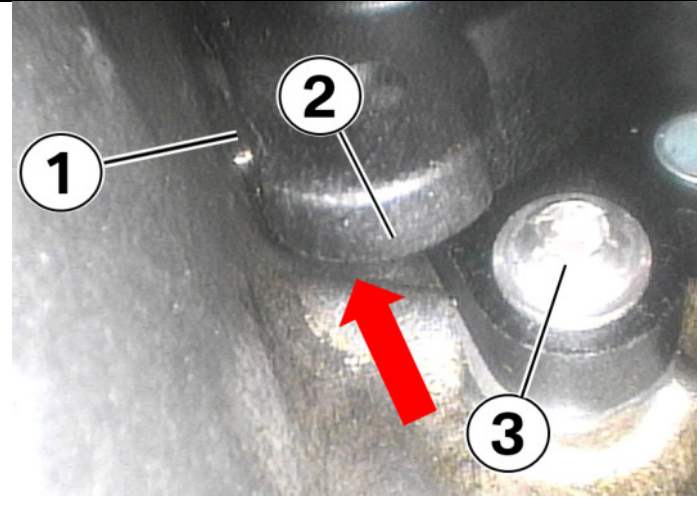
<p>Continue to push bore scope down ward towards the plastic vacuum reservoir tab (2).</p> <p>The bore scope needs to be moved towards the direction of the red arrow and under the tab (2) to have the best viewing angle of the engine valley drain hole (1).</p> <p>Engine valley drain hole (1)</p> <p>Plastic vacuum reservoir tab (2)</p> <p>Reservoir mounting screw (3)</p>

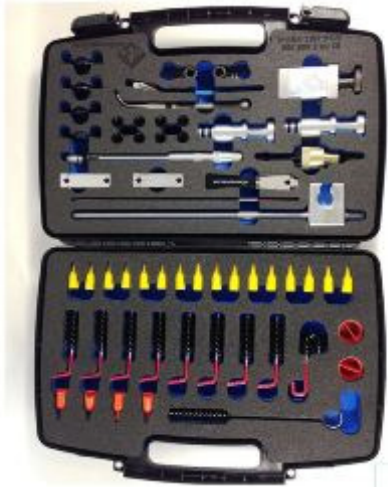
GRUSB1115-11

If the turbocharger inspection is "NOT OK", then replace the turbochargers in conjunction with the recommendations in step 11. Go to step 11.

11. Replace the intake and exhaust valve seals using the N63 Valve Seal Replacement Tool Kit P/N 83 30 2 408 268 as per SI B11 08 15 or Repair Instruction 11 34 570 "Replace all valve stem seals using special tool 83 30 2 408 268 (N63)".
