SIB 51 33 19

2019-10-30

SERVICE ACTION: INSPECT REAR WINDOW

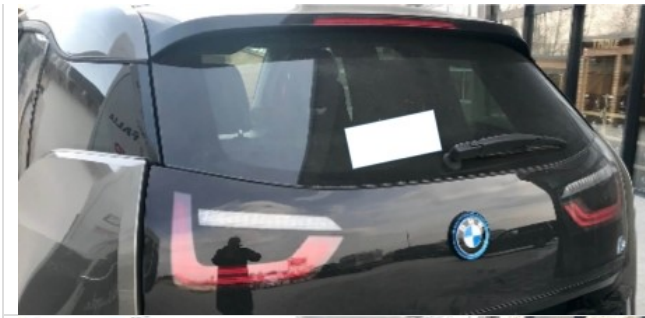
1. Tape a piece of standard paper to the inner surface of the rear window as shown.

4. Remove, reseal, and reinstall the rear window following repair instructions **REP 51 31 200 “Removing and installing rear window”**.

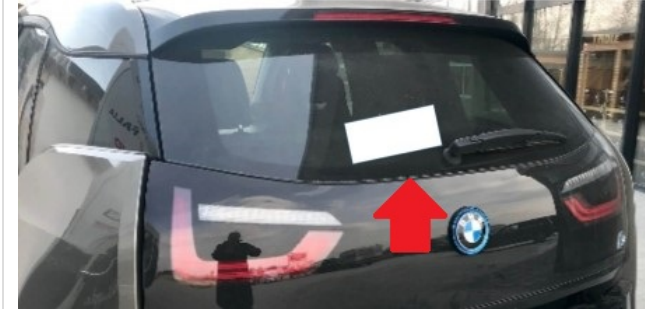
- Tape the paper at the top edge, to allow the bottom of the paper to move freely

2. From the outside of the vehicle, use a compressed air blow gun to blow air along the outside edge of the rear window (at the bottom gap) in the area shown.

Watch the paper closely for signs of movement caused by air entering into the vehicle.
