# Service Bulletin

Bulletin No.: 19-NA-087

**Subject:** Radio Software Version V805 Over-the-Air Update

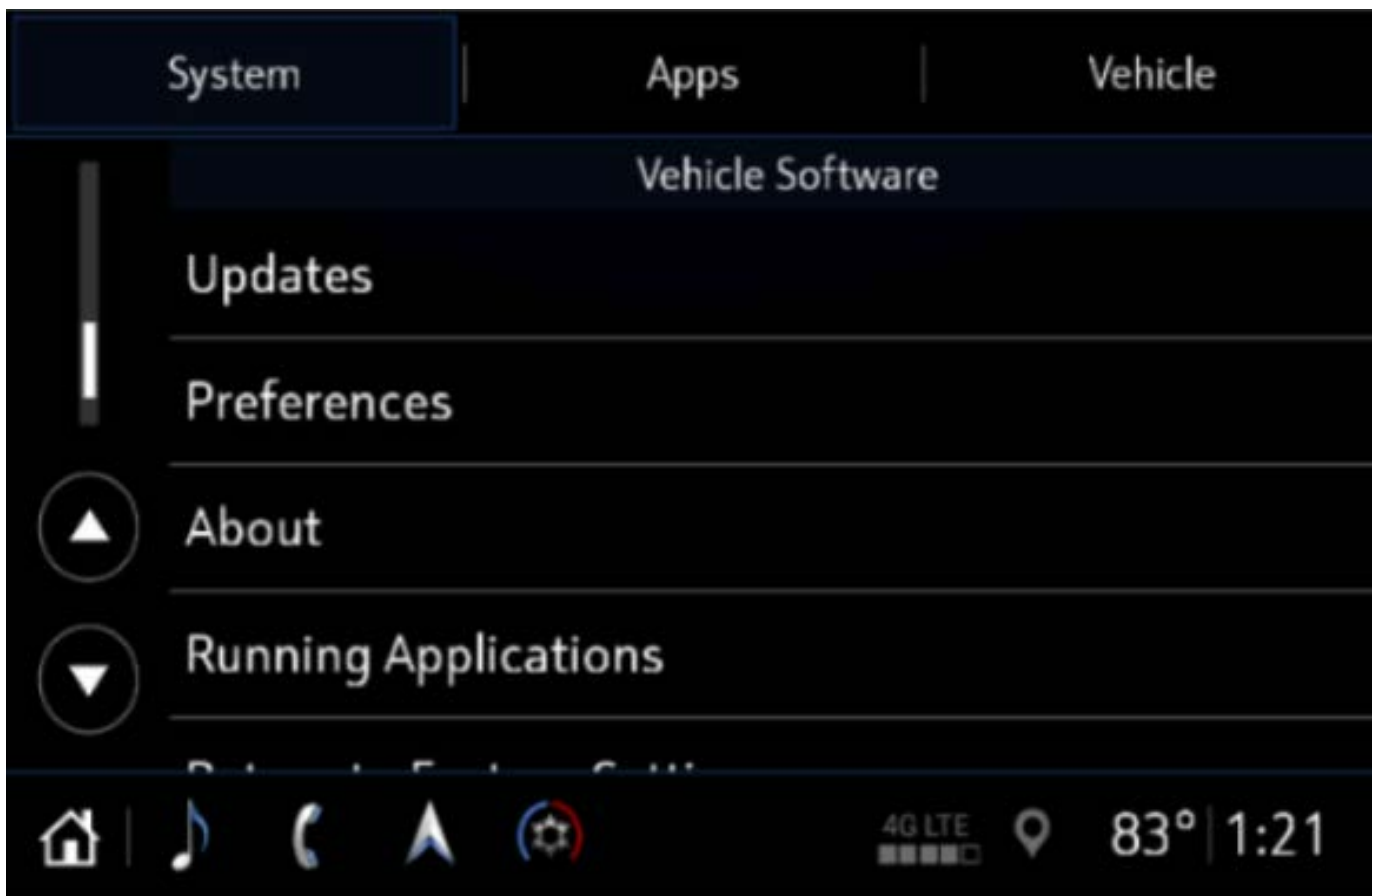
5313331

The process used for this update is dependent on the status of the software on the module and if the module already has a remote install package downloaded. To verify if an update package is already on the vehicle, open “Settings” and then scroll to “Updates” on the radio screen. If an update is shown under the “Updates” screen, proceed to the **Update Procedure Using Remote Vehicle Update** section of this document.

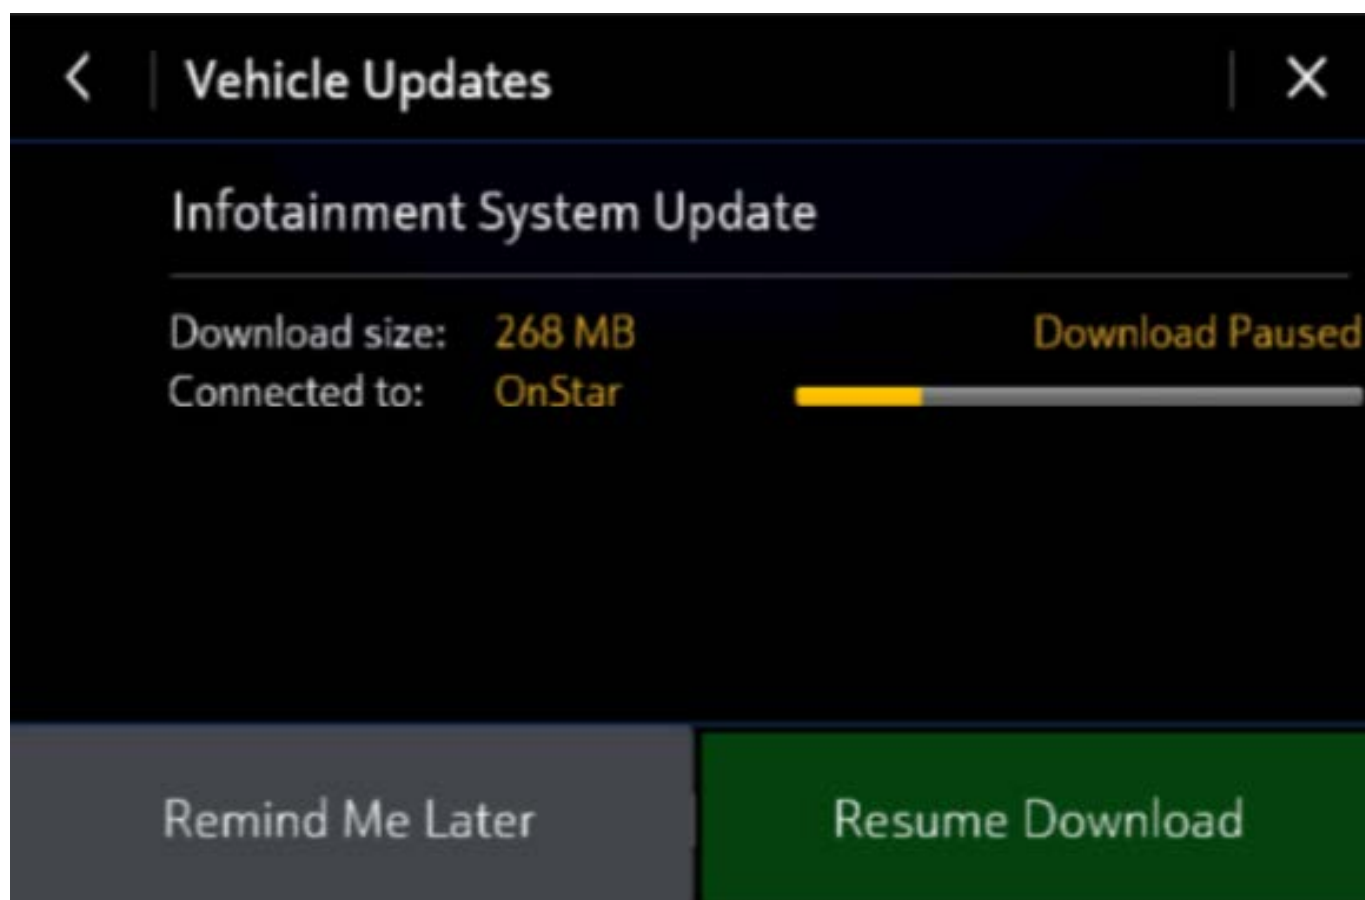
5313332

If no update is shown (see “No Updates Available” image in next section), go to the “About” screen and verify the build number (i.e., L206, V507, V509, V803 etc.). If the build number is less than V805, proceed with the software update following the **Update Procedure Using TIS2WEB (USB Download)** section of this document.

**Caution:** If Vehicle Update screen shows “Infotainment System Update” (such as the screen above) do not use TIS2WEB or insert a USB stick. Use of the USB stick when the Remote Update has already been downloaded, installed, or paused during installation could result in program failures or module lockup condition. The update should be completed using the Remote Vehicle Update procedure, following prompts on the infotainment screen. Refer to Update Procedure Using Remote Vehicle Update after reading the remaining information in this section if the Remote Update has already been downloaded to the radio.

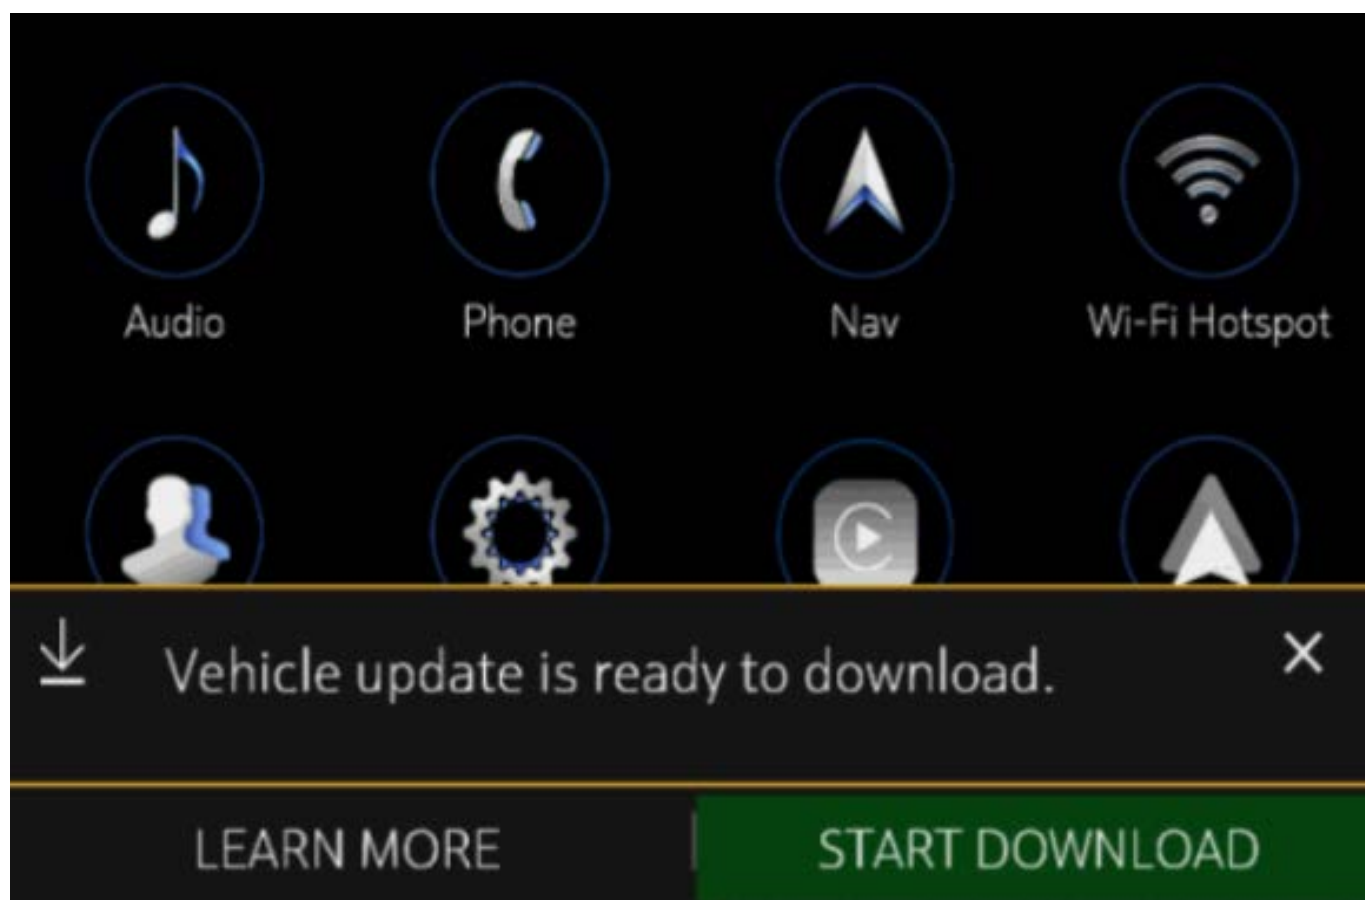
5313328

1. If a remote package is on the system, you may see the below pop up.
  - If the remote vehicle update has not been downloaded, select “Start Download,” wait for the download to complete and then follow the prompts to complete installation.

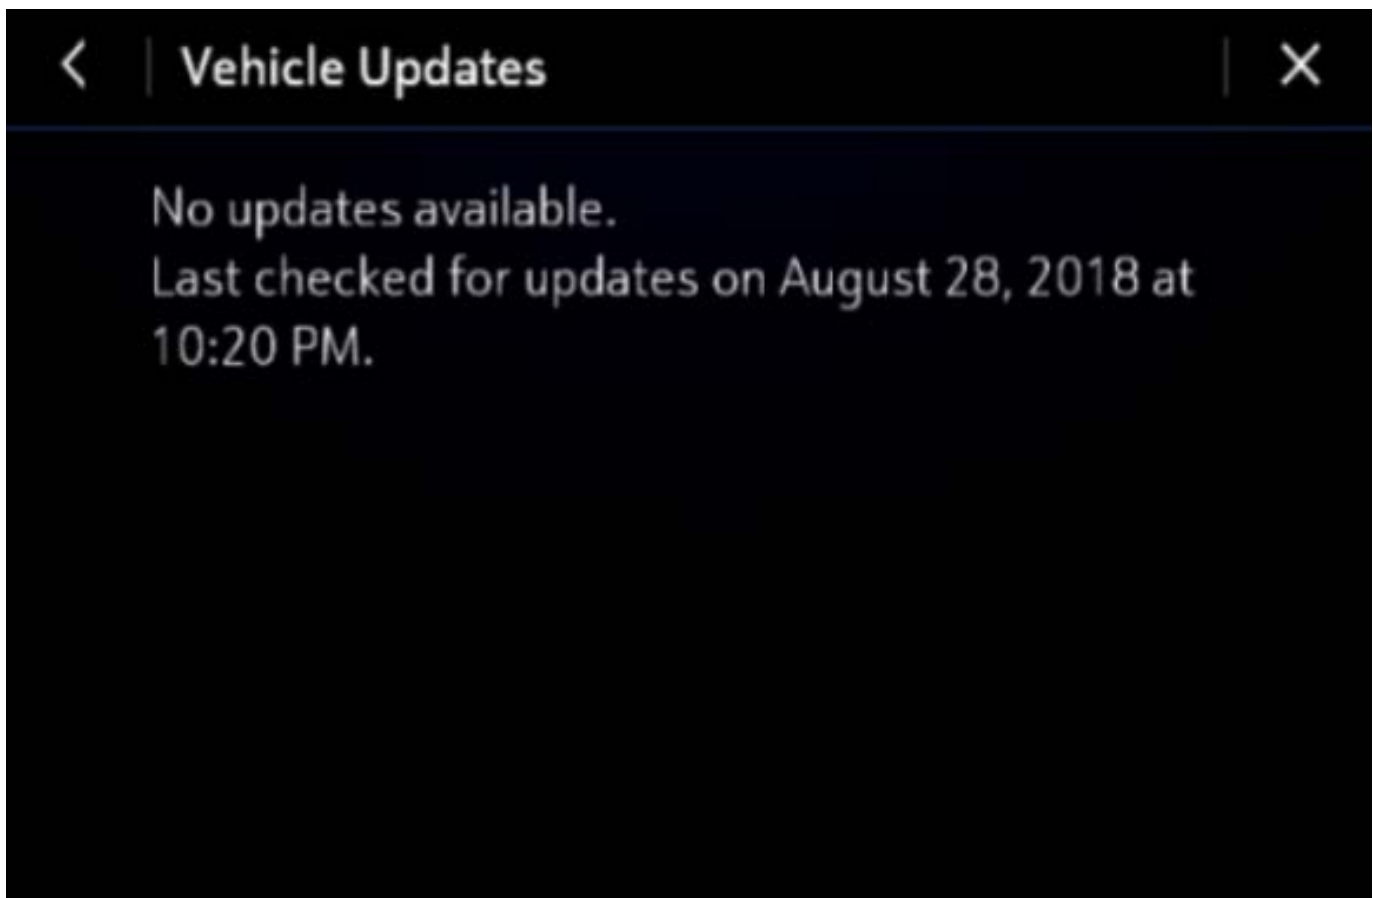
5313324

2. If no "Start Download" or "Install Now" pop up is displayed, navigate to "Settings" -> "Updates." If there is a remote package on the system, it will display "Install Now" Or "Start Download." If the screen below is shown, then there is no remote update package on the system. Navigate to Settings -> About to verify the software version. If the build number is not V805 or greater, update via USB.

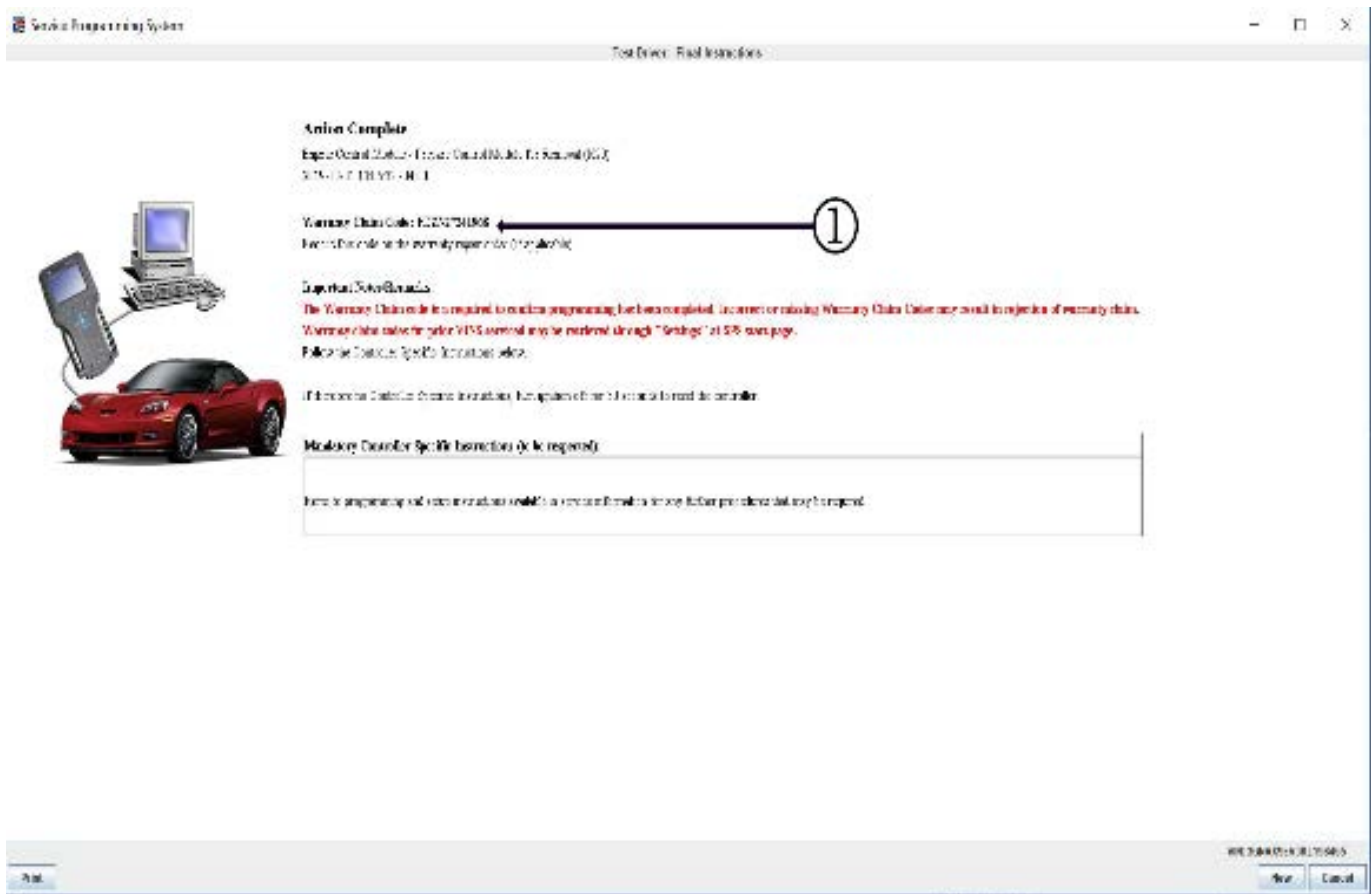
5418111

1. Start SPS, select Radio – USB File Transfer and follow the on-screen instructions.

**Note:** To avoid warranty transaction rejections, you **MUST** record the warranty claim code provided on the SPS Warranty Claim Code (WCC) screen on the job card. Refer to callout 1 for the location of the WCC on the SPS screen.

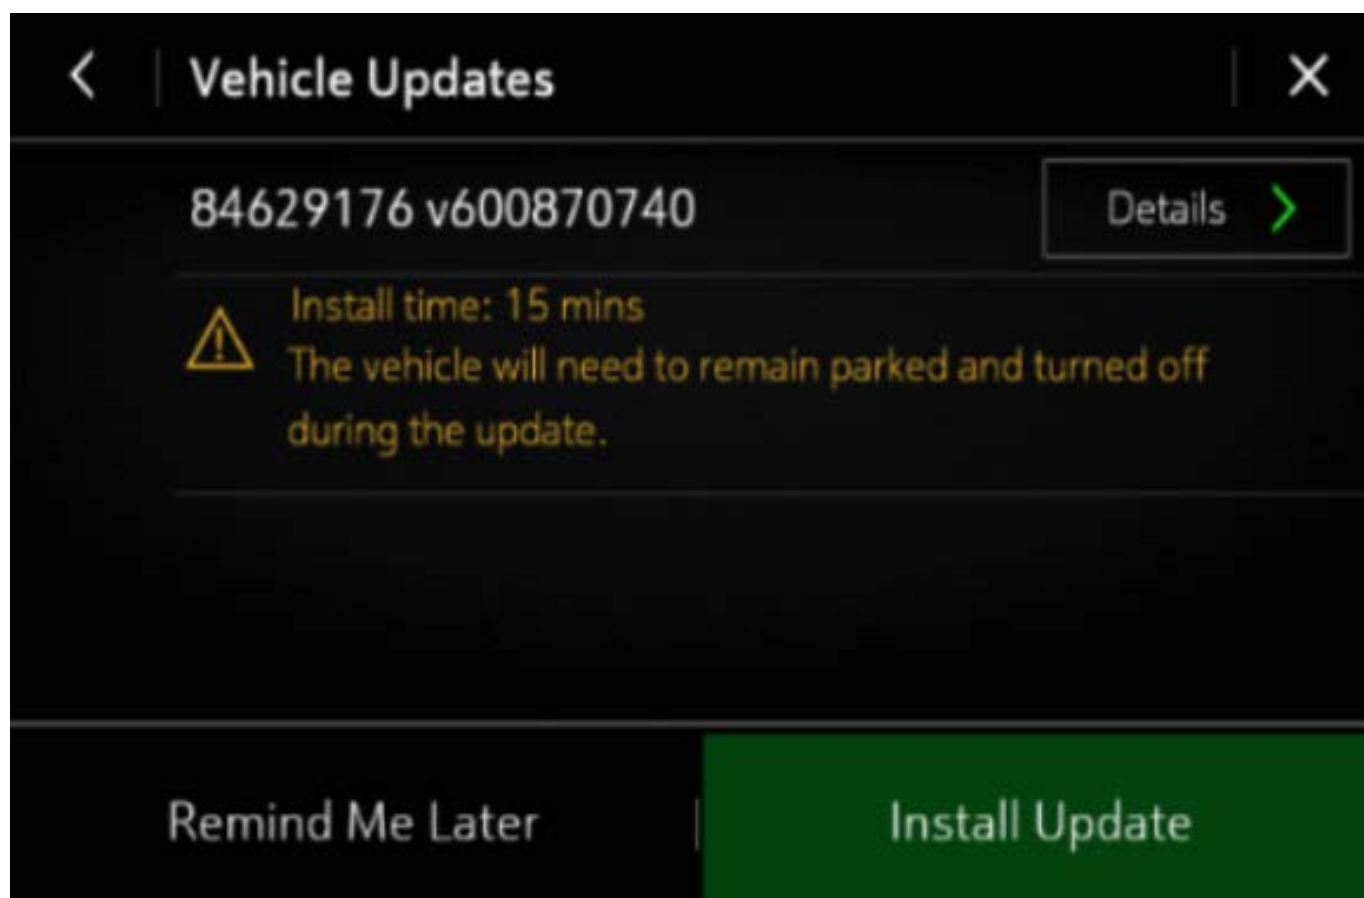
5313321

2. Record SPS Warranty Claim Code on job card for warranty transaction submission.
3. Insert the USB into the vehicle while in Park. On the radio screen, select "Settings" —> "Updates" or select "Learn More" on pop up after USB insertion.
4. Select Install Update.
5. Follow on screen prompts to complete the update.
