Service Bulletin

Bulletin No.: 19-NA-103

Subject: Intermittent Click Noise at Front of Vehicle, ABS, Traction Control System (TCS)/ Stabilitrak Lamps May Illuminate Intermittently and/or Deactivate for Ignition Cycle, DTC P0721, P215B, C0500-C0504 and/or C0506-C050A Set

Brand:	Model:	Model Year:		VIN:		Engine:	Transmission:
		from	to	from	to		
Chevrolet	Volt	2016	2019

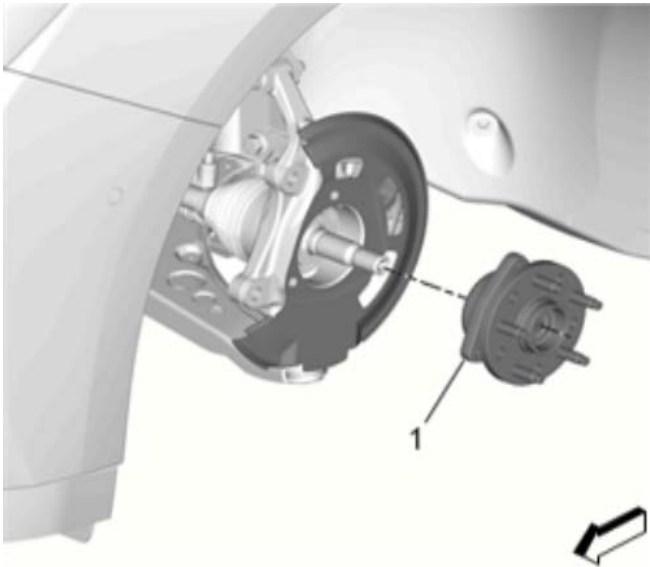
5317526

Note: In cases where the condition is verified on both sides of the vehicle, remove the anti-click washer from BOTH sides.

1. Remove the front wheel bearing and hub assembly (1) from the vehicle, on the affected side. Refer to *Front Wheel Bearing and Hub Replacement* in SI.
