# Service Action Code: 1903

**Subject** Coolant Bottle

**Release Date** November 8, 2019

**Problem Description** The coolant bottle may leak coolant into the electrical connector for the coolant level sensor.

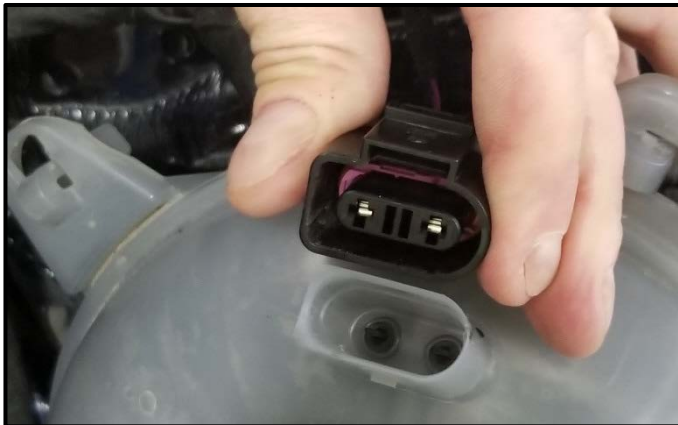
### Repair Overview

- Check coolant bottle for coolant migration.
