WKG7 - Reworking Filler Flap/Charge Port Door Module (Workshop Campaign)

Vehicle Type: **Panamera Sport Turismo (971)**

Model Year: **As of 2018 up to 2019**

Subject: **Filler flap/charge port door module**

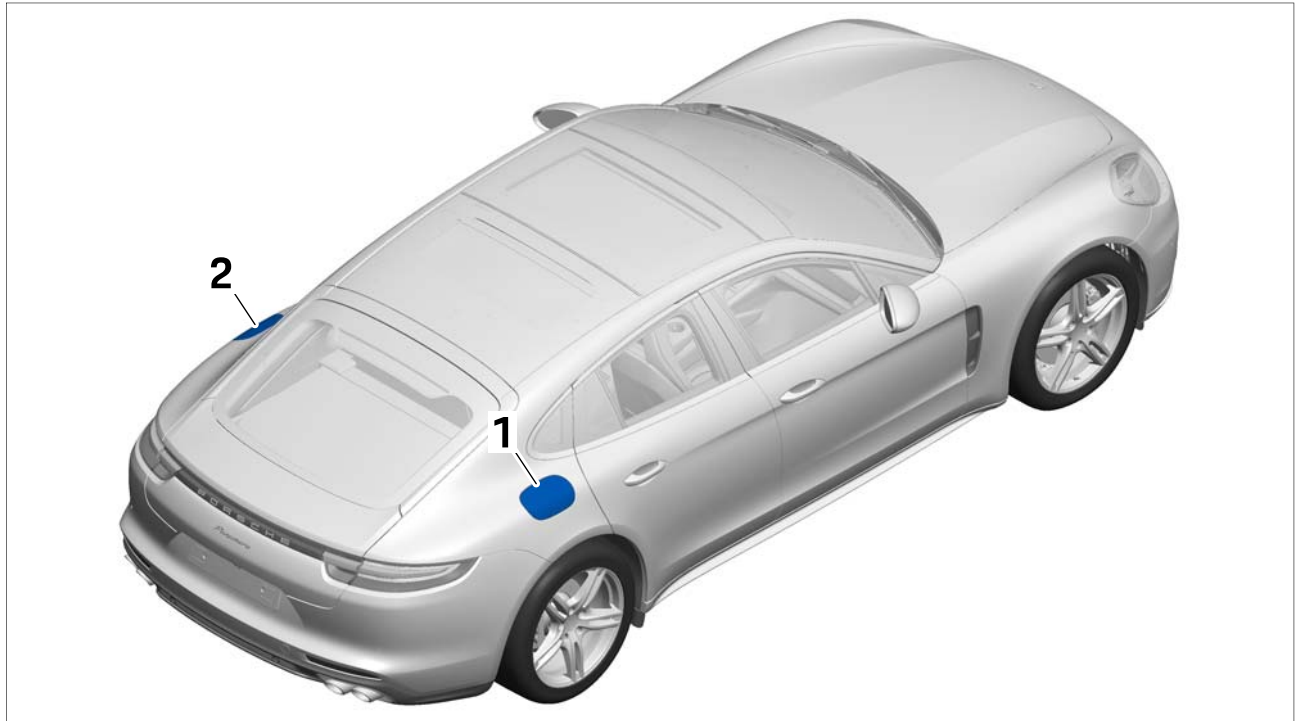
Installation position of filler flap and charge port door

- 1 – Filler flap module
- 2 – Charge port door module (**only for Hybrid vehicles**)
