GROUP	MODEL
BOD	2020MY Sorento (UMa)
NUMBER	DATE
198	November 2019

TECHNICAL SERVICE BULLETIN

SUBJECT: SERVICE ACTION: DRIVER DOOR CHECKER ROD

INSPECTION AND REPLACEMENT (SA407)

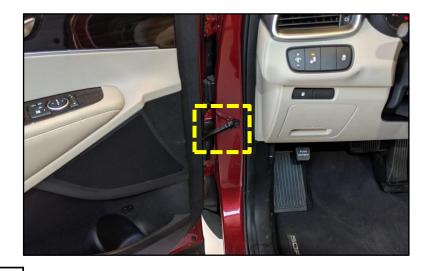
This bulletin provides the procedure to inspect and if necessary replace the front left driver door checker rod assembly on some 2020MY Sorento (UMa) vehicles produced from September 23, 2019 through September 30, 2019, which may have an incorrect checker rod assembly installed during production. When operating the driver door, it may be very hard to open and/or close due to increase resistance from the door checker rod assembly. Before conducting the procedure, verify that the vehicle is included in the list of affected VINs.
