GROUP TRA	MODEL 2011-2020MY Sportage (SL, QL) 2013-2020MY Sorento (XMa, UMa)
	NUMBER 086	DATE November 2019
SUBJECT: TECHNICAL SERVICE BULLETIN		
PARTIAL REPAIR OF 4WD COUPLING

SUBJECT: **FOUR WHEEL DRIVE (4WD) COUPLING REPAIR**

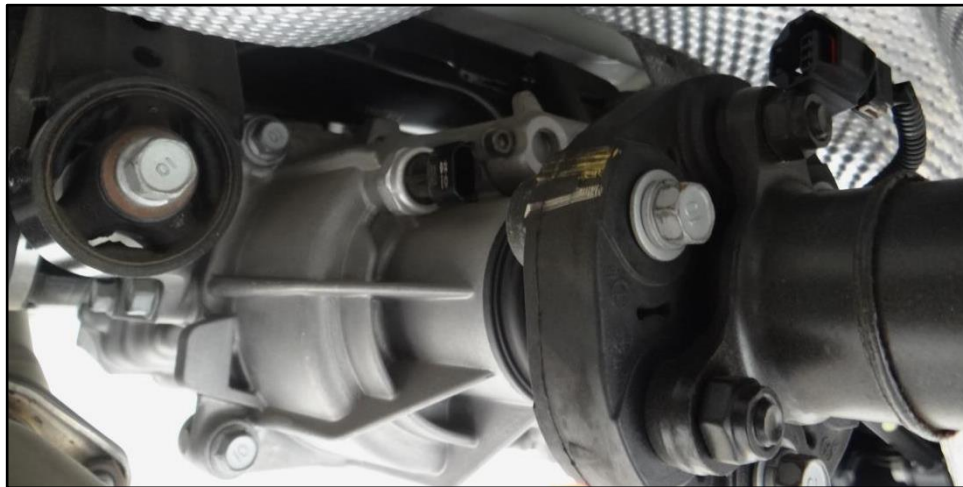
This bulletin provides the procedure information regarding the partial repair of the Four Wheel Drive (4WD) Coupling Assembly, Pressure Sensor, Actuator Motor or 4WD harness on some 2011-2016 Sportage (SL, QL) and Sorento (XMa, UMa) 4WD vehicles for a concern regarding:

- Oil leakage from the 4WD coupling assembly
- 4WD Malfunction and MIL lamp ON with DTCs
- Abnormal noise or vibration while driving

To correct any one of these concerns, refer to the repair table on page 2 and follow the recommended repair procedure outlined for each concern.
