In This Issue

Vehicle Technical Info

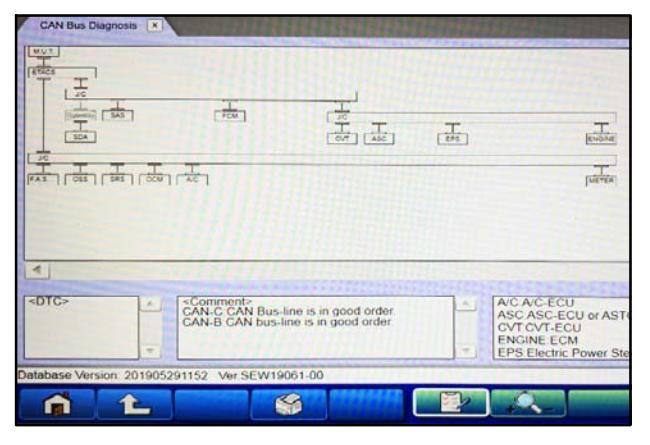
1) Check CAN-Bus line operation.

NOTE: The CAN Bus line check is essential. It is the first step when diagnosing all electrical concerns.

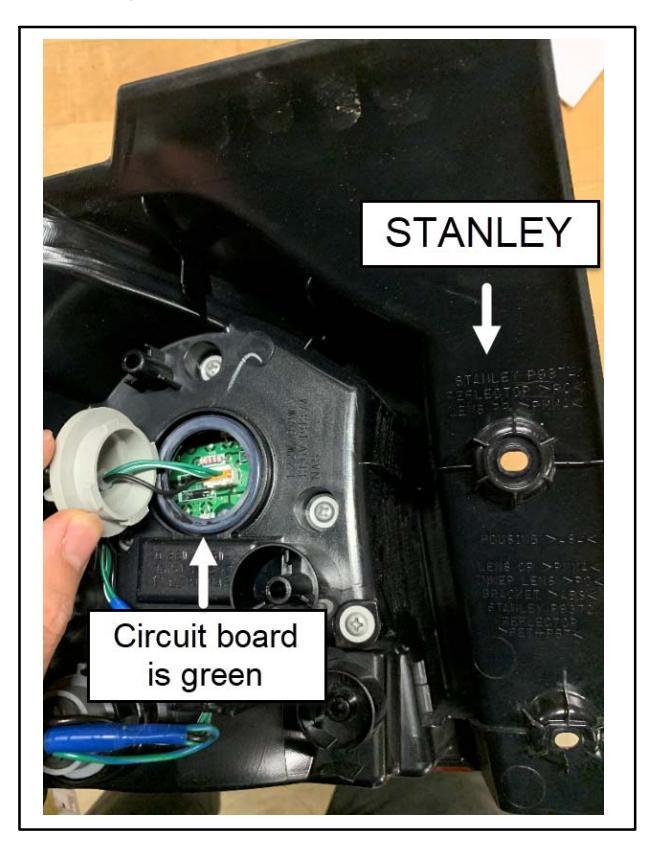
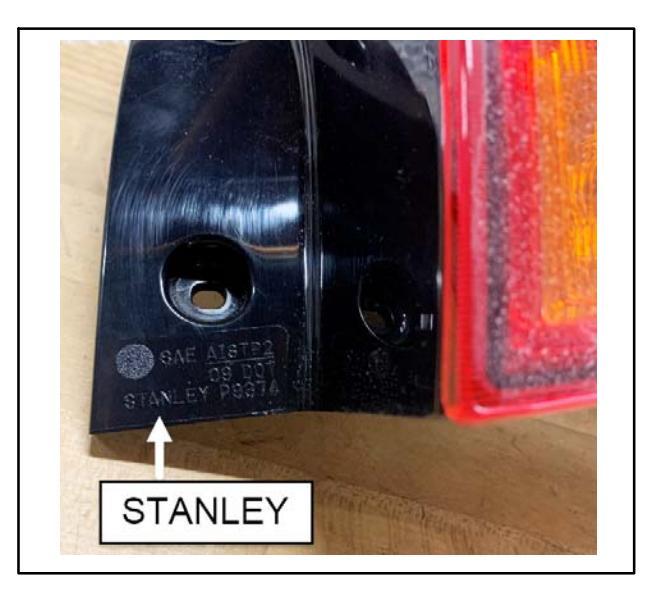
For stoplight switch Continuity No continuity $3.6 \pm 0.4 \text{ mm}$ $(0.14 \pm 0.01 \text{ in})$ For cruise control No continuity Continuity $4.5 \pm 0.5 \text{ mm}$ $(0.18 \pm 0.01 \text{ in})$ 3) Make sure the LH and RH rear combination lamp assemblies are genuine parts and not aftermarket. (Only Genuine Mitsubishi parts guarantee that the LED circuitry has the correct specifications and electrical parameters. In addition, aftermarket parts are not covered under warranty)

The original parts are made by "Stanley" (see following examples).

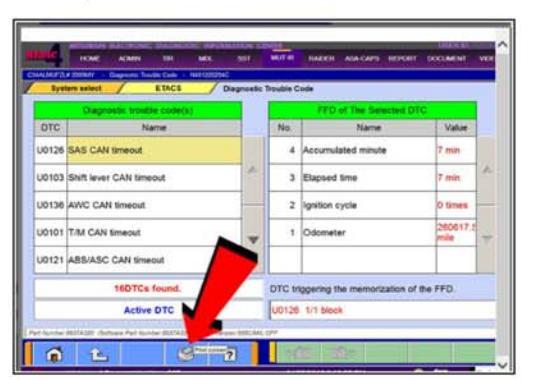
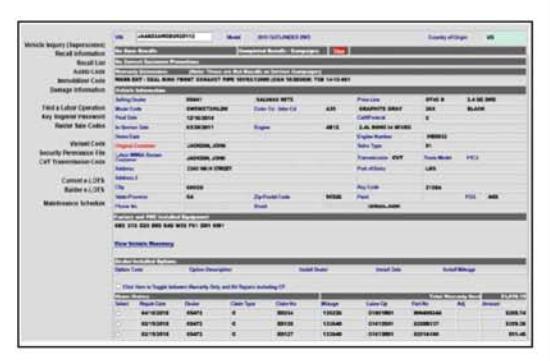
A printout of the Vehicle Information Screen must also be attached to the Repair Order.

From Service > Systems, select Vehicle Information, and enter the VIN to inquire and print the Superscreen information.
