Norco Gearbox Drip Tray Installation

This process describes the repair where under certain temperature conditions the Norco slide cable system gearbox may leak oil/grease on the slide roof membrane. The following procedure describes how to install a drip pan to prevent damage to the roof membrane, and make repairs if necessary.

Affected Production Dates: Keystone, Dutchmen, and CrossRoads units with Norco slides produced in 1/1/2017 through 3/31/2018 and 8/1/2018 through 9/30/2018.

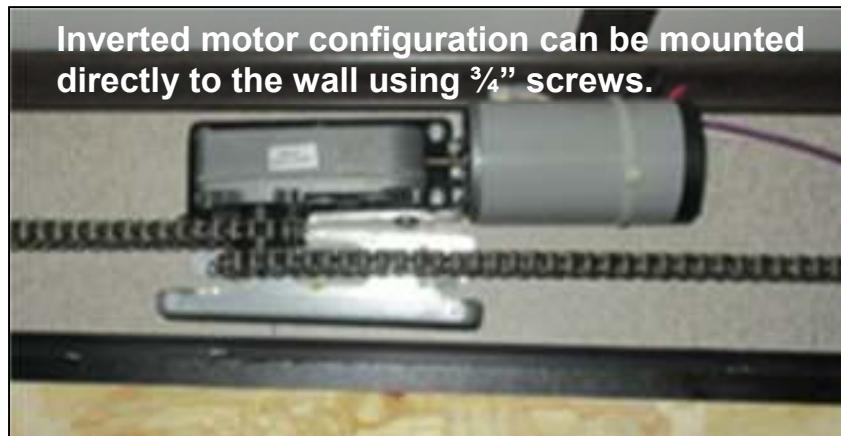
*~ Note: In some cases, a section of fascia board
may need to be removed to gain access to the
motor/gearbox bracket.*

Attached drip tray with the 2 screws that
you removed in the previous step.
