NUMBER: 08-112-19

UGQ Radio Enhancements

This bulletin involves inspecting and if required, updating the radio software level to 28.31.

2019 (MP) Jeep Compass

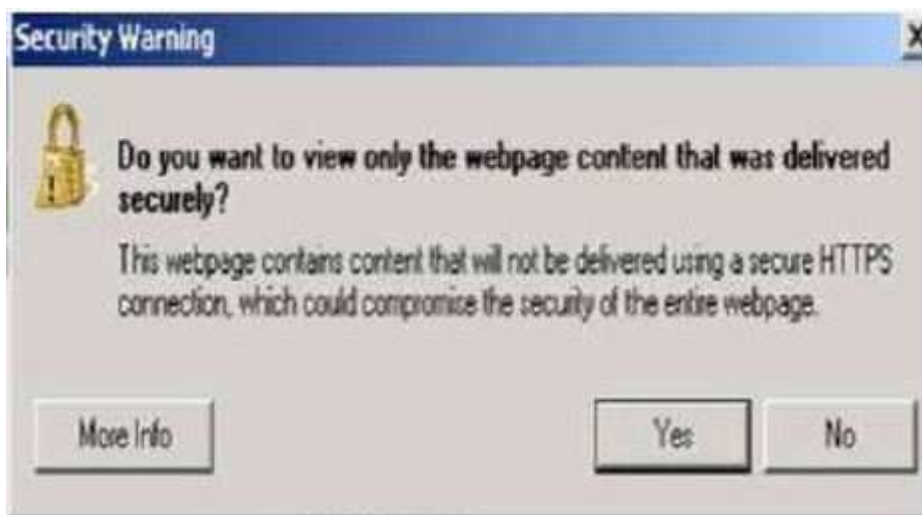
Fig. 2
Pop-Up Security Message

2. Go to DealerCONNECT>Service>Uconnect Command Center>Uconnect>More Information >Dealer software downloads to download the files.
3. If a security message appears “Do you want to view only the webpage content that was delivered securely?” ([Fig. 2](#)) . Press “No” to continue.

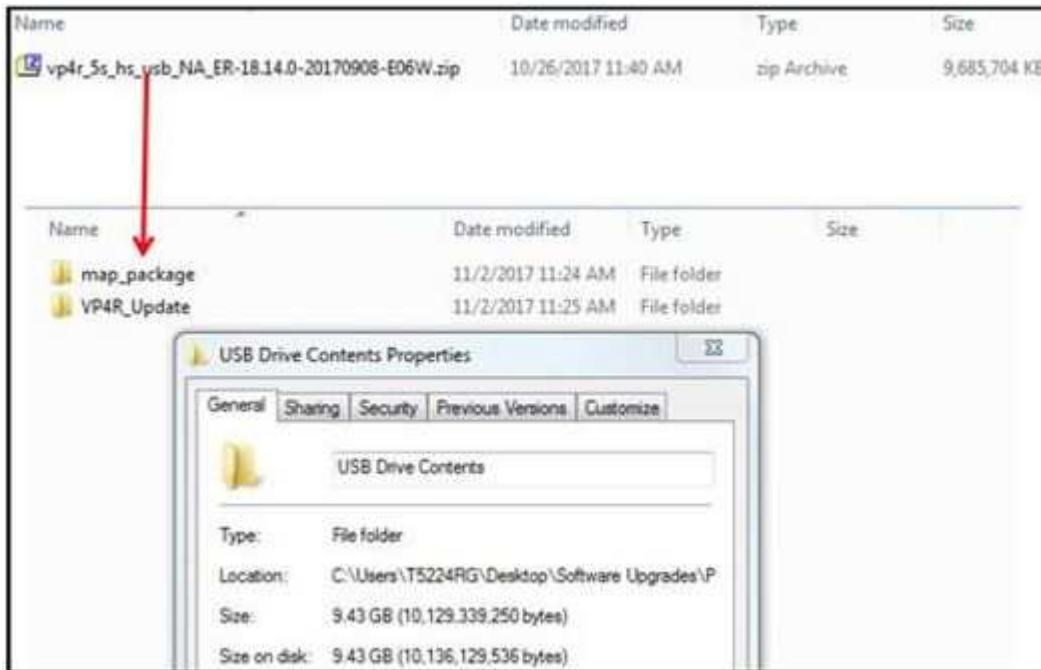
Fig. 4
Files/Folders In The USB Flash Drive

- Unzip all the files to the root folder of USB flash drive. Files should not be within a zip folder. Your USB files should look like (Fig. 4) when you open it, displaying multiple files/folders.
