Service Bulletin

Bulletin No.: 19-NA-100

Date: November, 2019

Subject: Radio Software Version 22.8 Over-the-Air Update

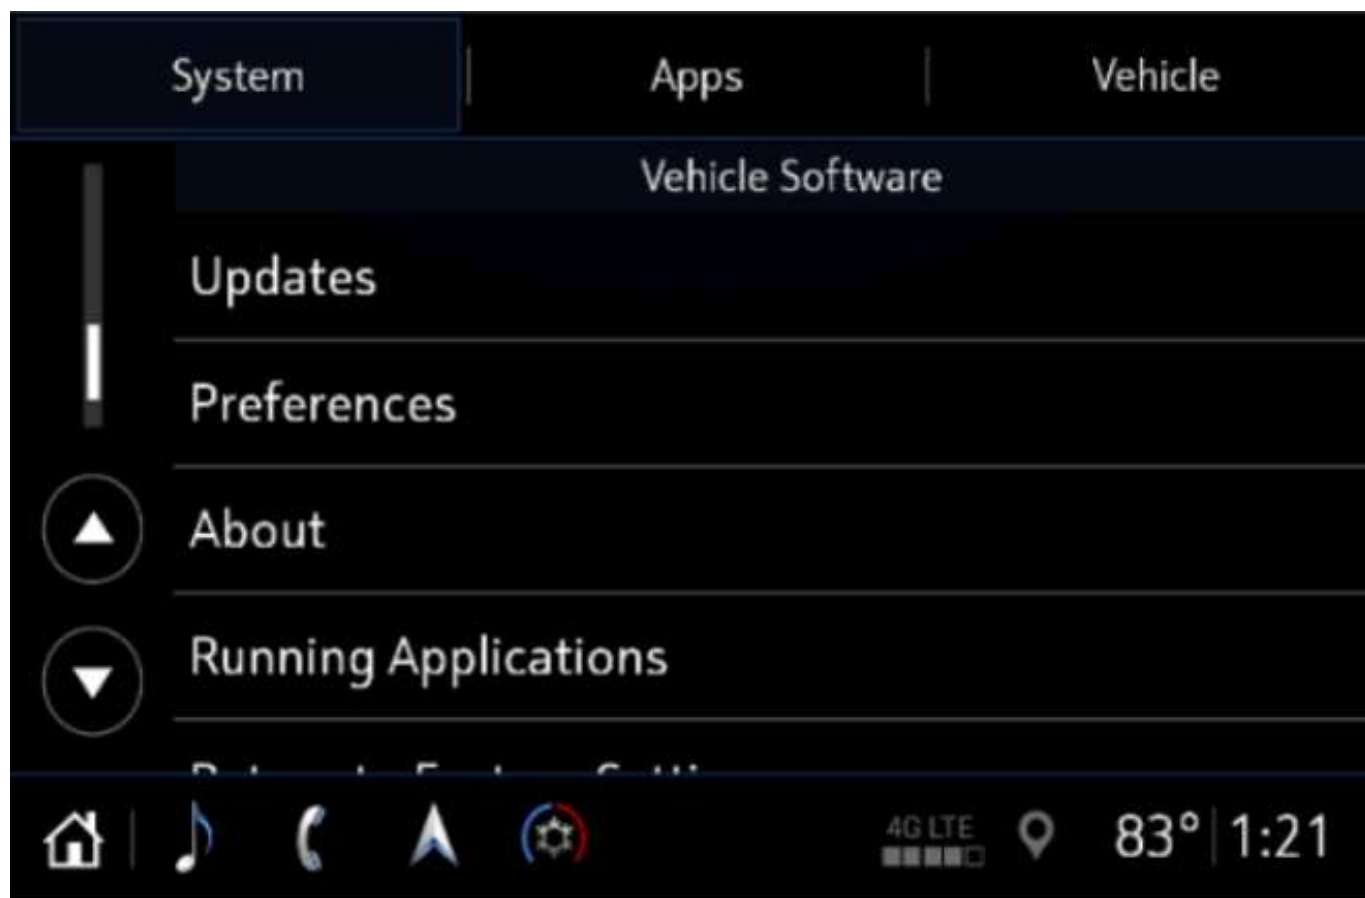
5313331

The process used for this update is dependent on the status of the software on the module and if the module already has a remote install package downloaded. To verify if an update package is already on the vehicle, open “Settings” and then scroll to “Updates” on the radio screen. If an update is shown under the “Updates” screen, proceed to the Update Procedure Using Remote Vehicle Update section of this document.

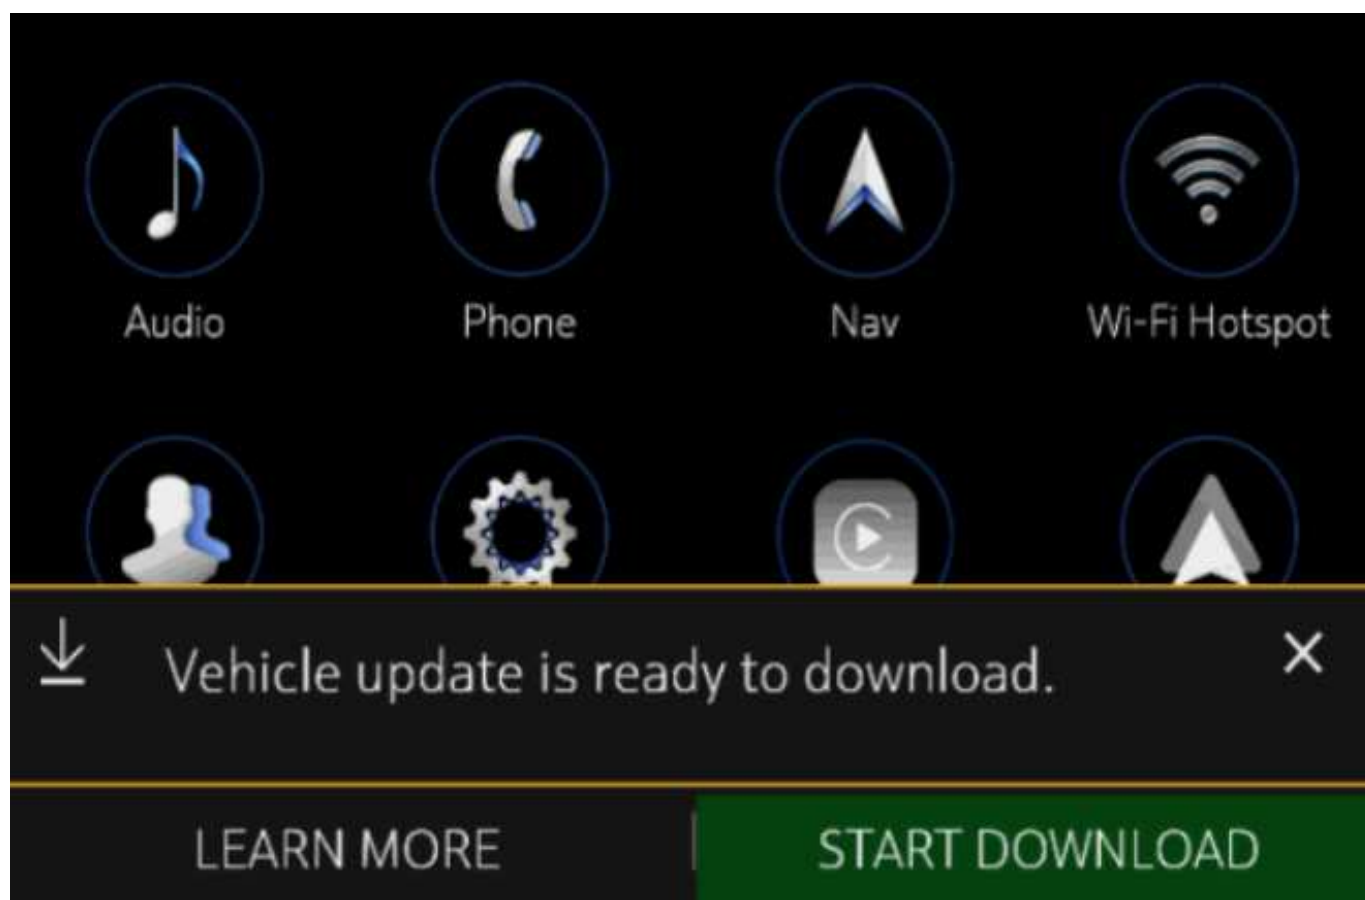
5313328

1. If a remote package is on the system, you may see the below pop up.
 - If the remote vehicle update has not been downloaded, select “Start Download”, wait for the download to complete and then follow the prompts to complete installation.

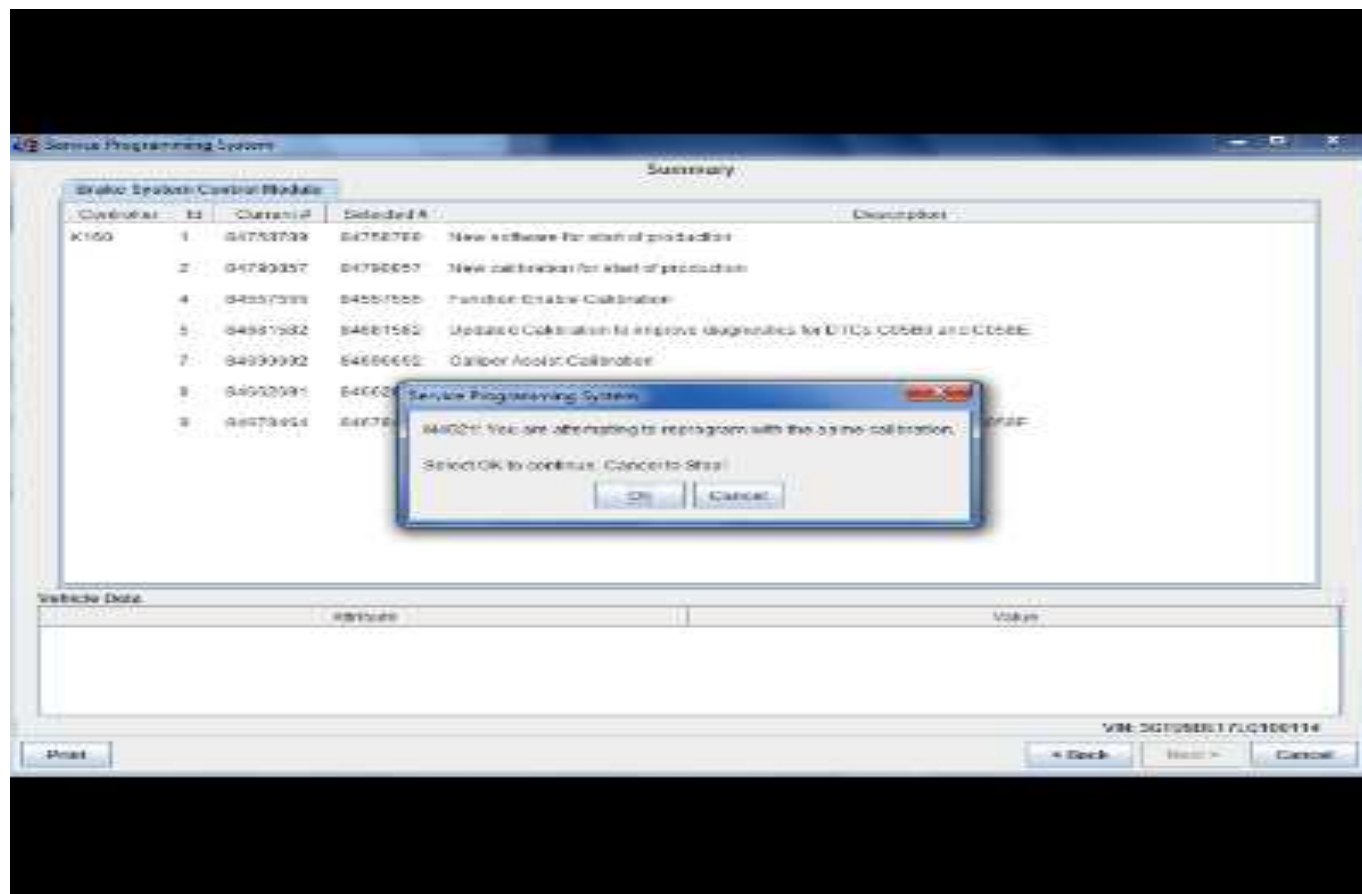
5431207

Note: If the Same Calibration/Software Warning is noted on the SPS screen, select OK and follow screen instructions. After a successful programming event, the WCC is located in the Service Programming System dialogue box of the SPS Summary screen. No further action is required. Refer to the Warranty section of the bulletin.

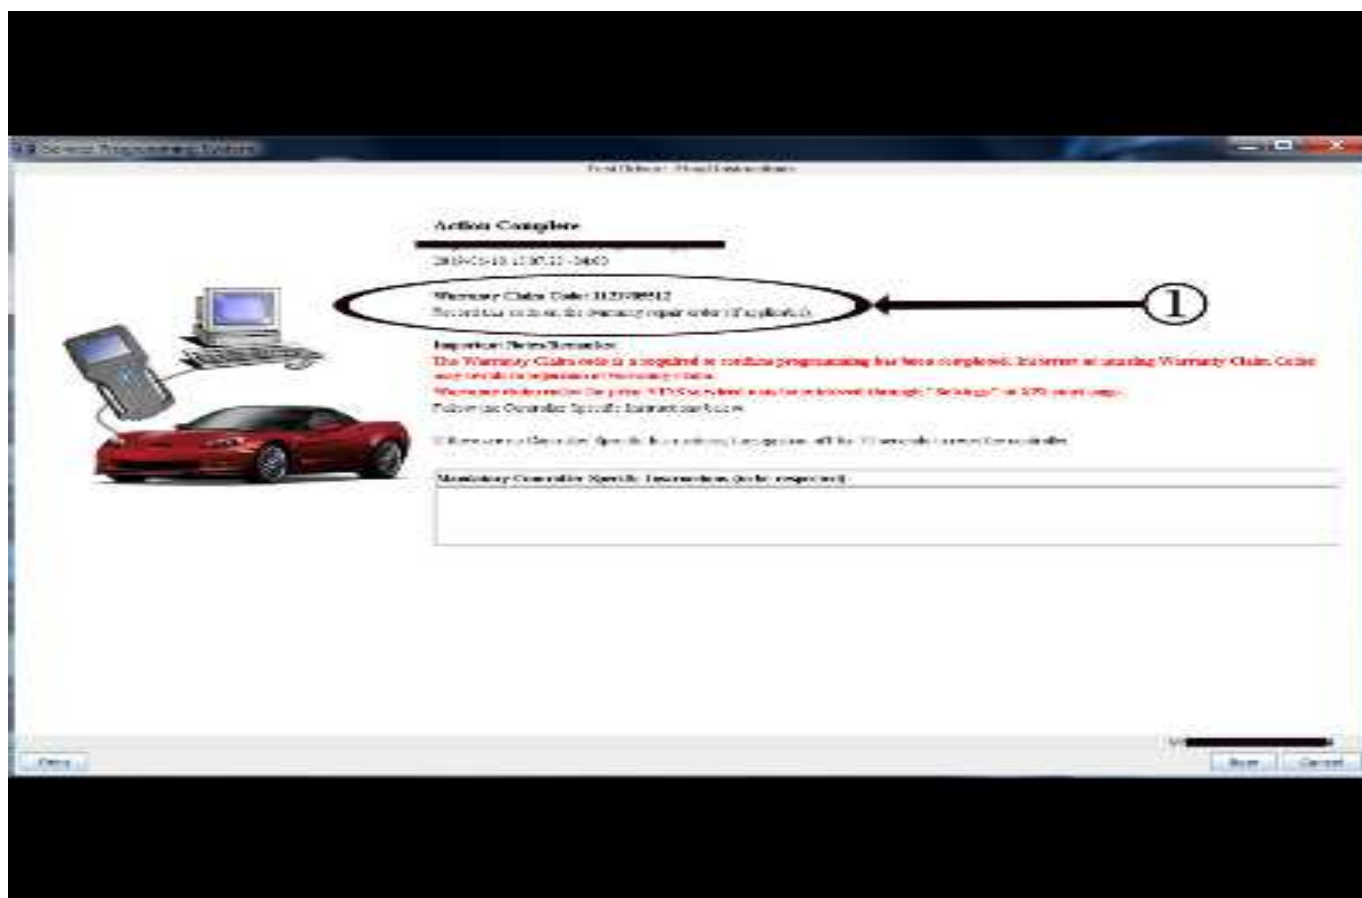
5431209

Note: To avoid warranty transaction rejections, you **MUST** record the warranty claim code provided on the SPS Warranty Claim Code (WCC) screen on the job card. Refer to callout 1 above for the location of the WCC on the SPS screen.

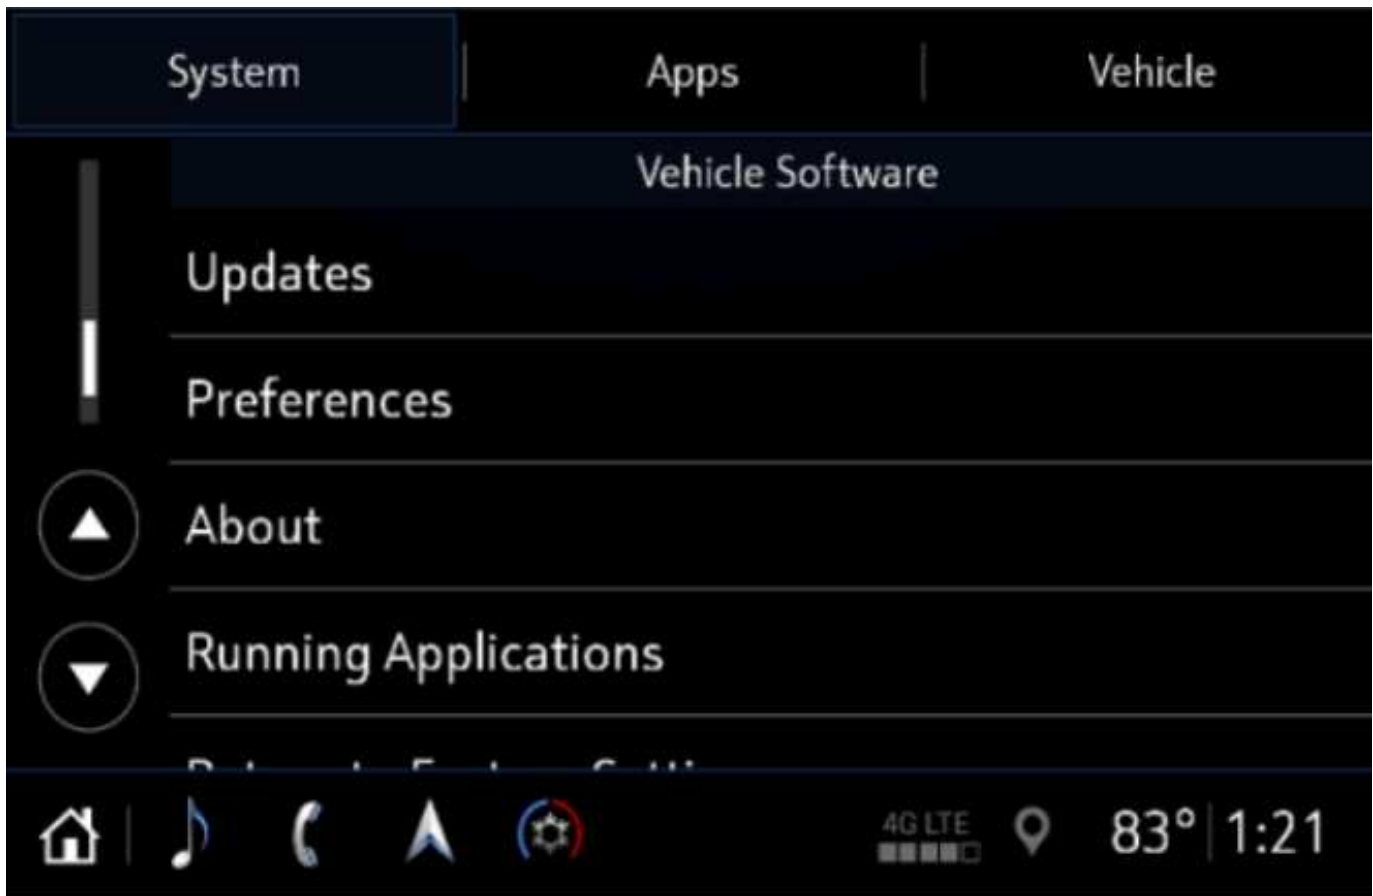
5313331

3. Insert the USB into the vehicle while in Park. On the radio screen, select "Settings," "Updates" or select "Learn More" on pop up after USB insertion.

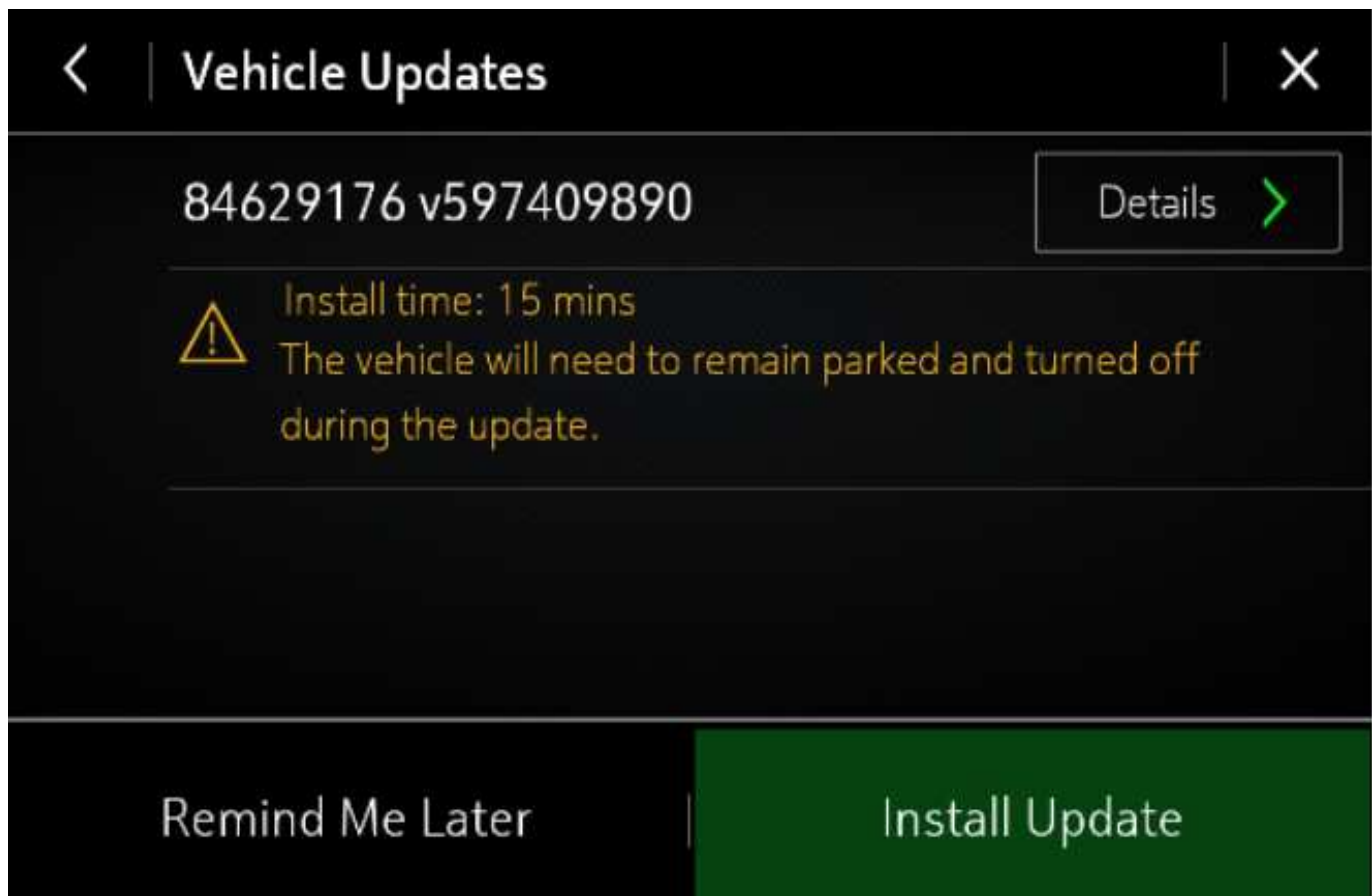
5324626

- If 22.8 or greater, reprogram the radio using SPS programming. Refer to the appropriate A11 Radio: Programming and Setup (IOS/IOU/IOT/IOR) document in SI.

- If less than 22.8 reprogram the radio using USB and SPS programming events. Refer to the appropriate A11 Radio: Programming and Setup (IOS/IOU/IOT/IOR) document in SI.
