# Service Bulletin

Bulletin No.: 18-NA-147

**Subject:** Speedometer and/or Tachometer Needle May Be Incorrect by Up to 6 Degrees

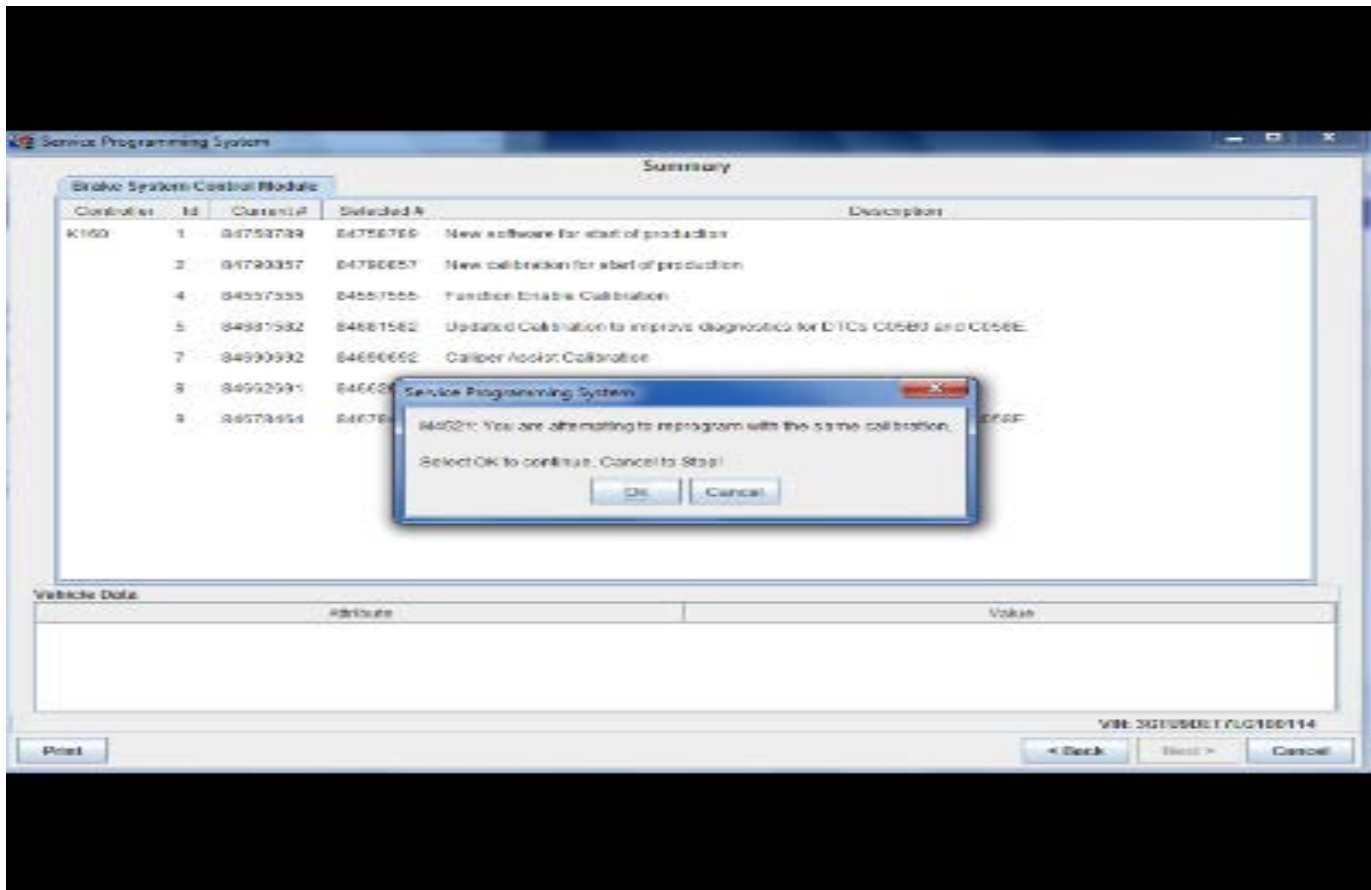
**Note:** If the Same Calibration/Software Warning is noted on the SPS screen, select OK and follow screen instructions. After a successful programming event, the WCC is located in the Service Programming System dialogue box of the SPS Summary screen. No further action is required. Refer to the Warranty section of the bulletin.

1. Reprogram the instrument panel cluster. Refer to *Instrument Cluster: Programming and Setup* in SI.
