Technical Service Bulletin

GROUP Campaign	NUMBER 19-01-036H
DATE November, 2019	MODEL(S) Ioniq (AE) HEV/PHEV/EV, Kona (OS) EV

SUBJECT ELECTRIC WATER PUMP (EWP) CAN CASE REPLACEMENT
- (CAMPAIGN T4G)

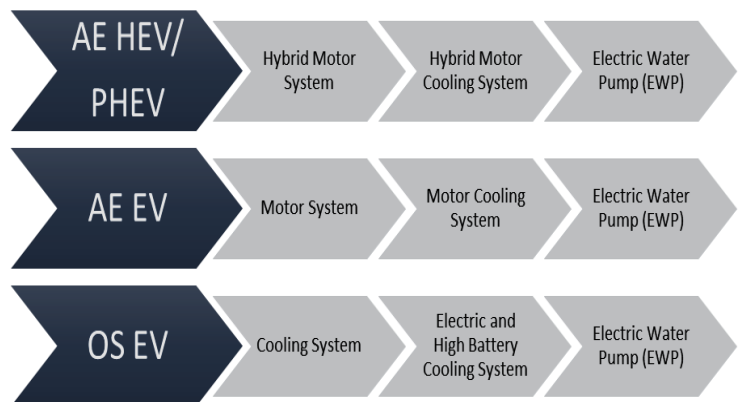
- **OS EV has 2 EWP to be removed (Electrical Devices & Battery EWP).**
- **Clamp the coolant hoses from the High Voltage Battery to reduce coolant fill and GDS bleeding time that will be needed in section-G.**

1. Carefully remove each EWP from the vehicle according to the applicable shop manual instructions.

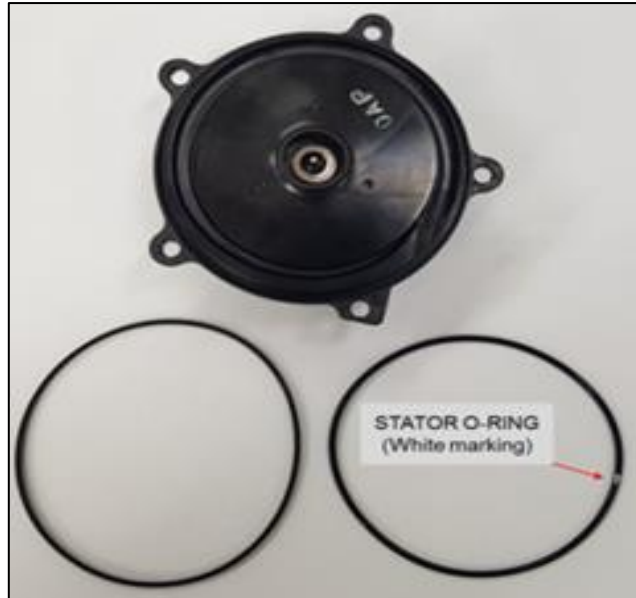
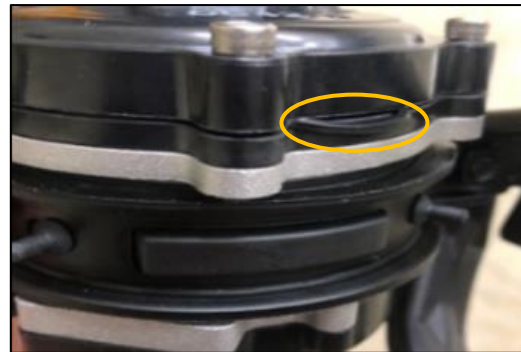
The Stator O-Ring is identified by the white marking.

Prevent any interference between the O-ring and the pump cover as shown.

2. Reinstall EWP disassembled parts in reverse order of removal.
3. Reinstall the EWP back on the vehicle.
4. Go to section **(G)** (page-11) – Fill and Bleed the Hybrid/Plug-In/EV system coolant.

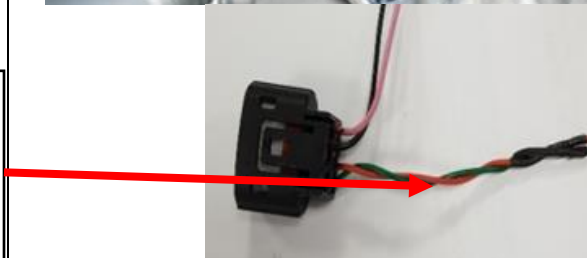
Keep the connector kit's red and green signal wire pair twisted together as this prevents electrical noise on the vehicle CAN system that can cause other issues!
