First Release

## UPPER REACTION RODS TORQUE INSPECTION

B13R (9700 us/can)

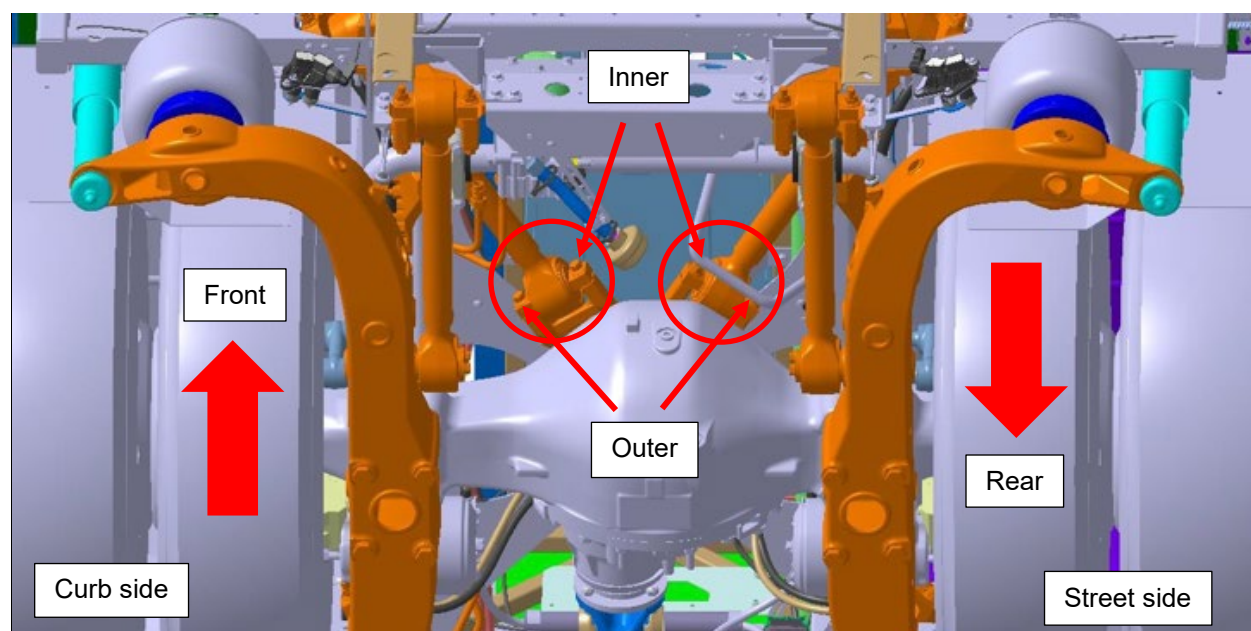
| POSITION | INNER VALUE | OUTER VALUE |
|---|---|---|
| <b>CURB SIDE</b> <u>AXLE</u> MOUNTING POINT | | |

On the vehicles affected by this bulletin, the flange bolts securing the upper reaction rods to the drive axle may not have been sufficiently torqued and may come loose.

- All loose fasteners (showing less **100Nm** (75 lb-ft) during the initial inspection) must be replaced.
- Replace bolts one by one to avoid disturbing the rod adjustment (shims could be present).
- Order bolt(s) # **984837**.
- Torque all new bolts to **275Nm +/- 45** (200 lb-ft +/- 30).
