Service Alert

2020 CX-30 SERVICE CAUTIONS FOR NEW AND REVISED FEATURES

Service Alert No.: SA-051/19

2020 CX-30

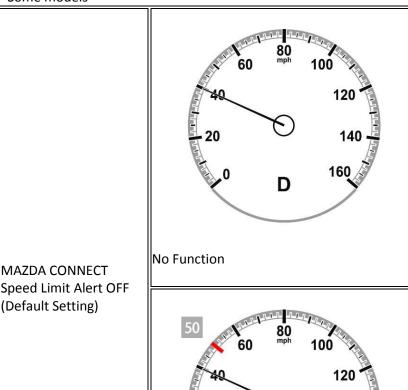
Traffic Sign Recognition (TSR) *

- 1. TSR function is only available with a dealer installed in-vehicle navigation system accessory.
- 2. TSR function requires Forward Sensing Camera (FSC) recognition or navigation SD card map data when the vehicle is driven.**
- 3. TSR function is not displayed in the Active Driving Display.
- TSR function is disabled when Apple CarPlay[™] or Android Auto[™] is connected.
