Service Update

N192273400 Positive Crankcase Ventilation Tube Loose

Release Date: November 2019

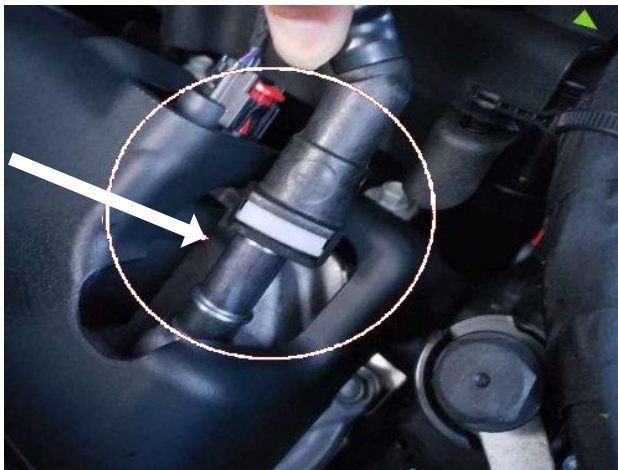
5431226

4. Gently pull the PCV Tube and ensure the connector is fully seated at the location as shown.

5. If either connector is not fully seated, push the connector until the clip is in the correct position and fully seated.
6. Remove fender covers and close hood.
