MODEL
**2016-2019MY
Optima (JFa)**

NUMBER
PS638

SUBJECT: HVAC TEMPERATURE BLEND DOOR INOPERATIVE,
TICKING AND/OR MAKING A POPPING NOISE

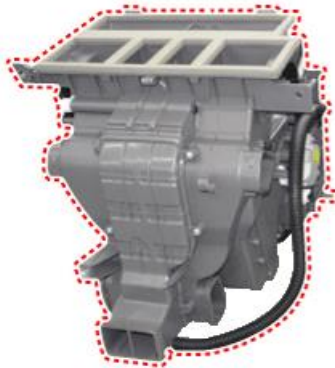
Heater and Evaporator Assembly (JFa)

This Pitstop provides information regarding an inoperative, or clicking and popping noise concern from the heater box blend door. This occurs when operating the climate control temperature on some 2016 ~ 2019MY Optima (JFa) vehicles produced prior to January 4, 2018, which may exhibit "no temperature change" due to a sticking HVAC blend door(s) caused by a black tar-like substance within the Heater and Evaporator Assembly. If such substance is found, the Heater and Evaporator Assembly will need to be replaced. Refer to the two (2) sample images shown below:
