Complaint - Cylinder Head Cover Near the Injector Holes Leaking: Subsequent work on cylinder head (180/18)

Vehicle Type: **Macan S (95B)**

Model Year: **As of 2017 up to 2019**

Subject: **Cylinder head cover**

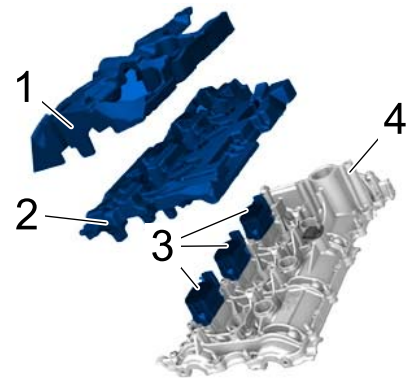
Component overview of cylinder head cover

- 1** – Insulation on top of cylinder head cover
- 2** – Insulation on bottom of cylinder head cover
- 3** – Hydraulic valve for valve lift switchover
- 4** – Cylinder head cover
