CAMPAIGN BULLETIN

VCR Engine Inspection

Reference: PC724

PC724 - 2020 ALTIMA VCR ENGINE INSPECTION

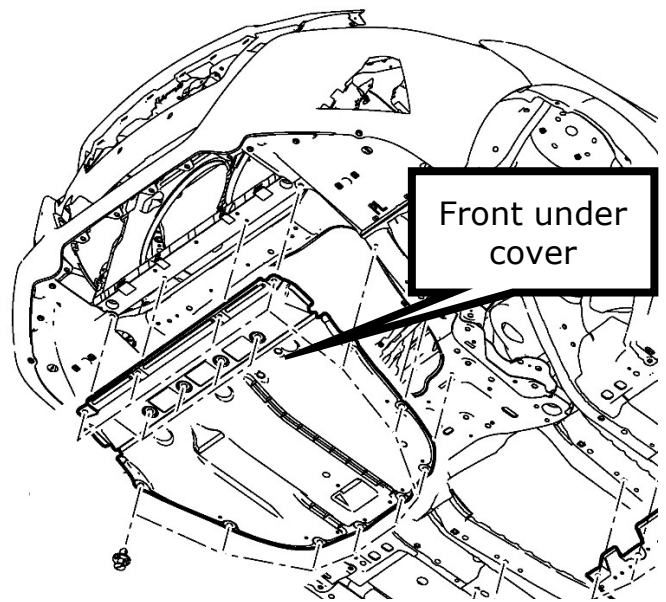
Figure 1

2. Remove the front under cover.
(Figure 1)

- Remove the front under cover bolts and clips
- Remove the front under cover

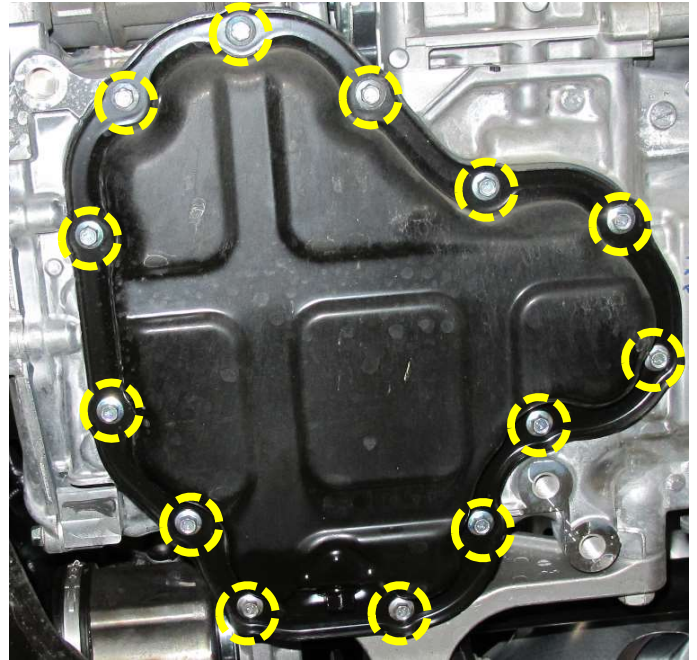
Figure 2

- Remove the (13) bolts from the oil pan (Figure 2)
- Separate lower engine oil pan from the upper engine oil pan using (J-37228) (Figure 3)

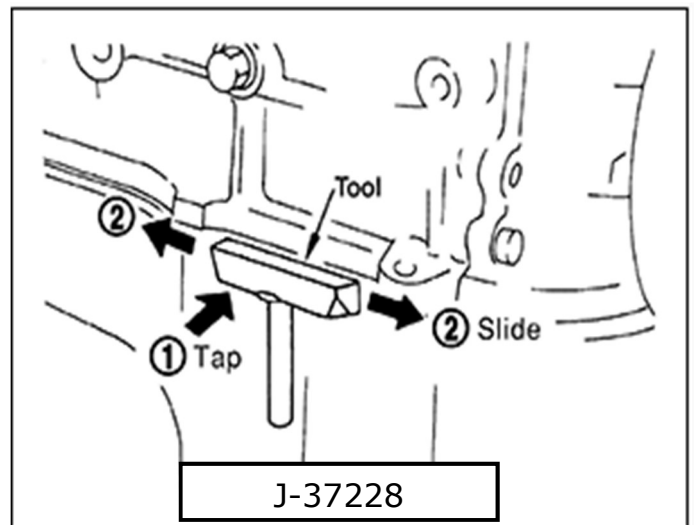
Figure 3

- Do not damage the mating surfaces.
- Do not insert screwdriver, this will damage the mating surfaces.

NOTE: Tap (1) Tool to insert it and then slide (2) it by tapping on the side of the Tool as shown.
