# Service Bulletin

Bulletin No.: 19-NA-269

Date: December, 2019

**Subject: Radio Software Version U148 Over-the-Air Update**

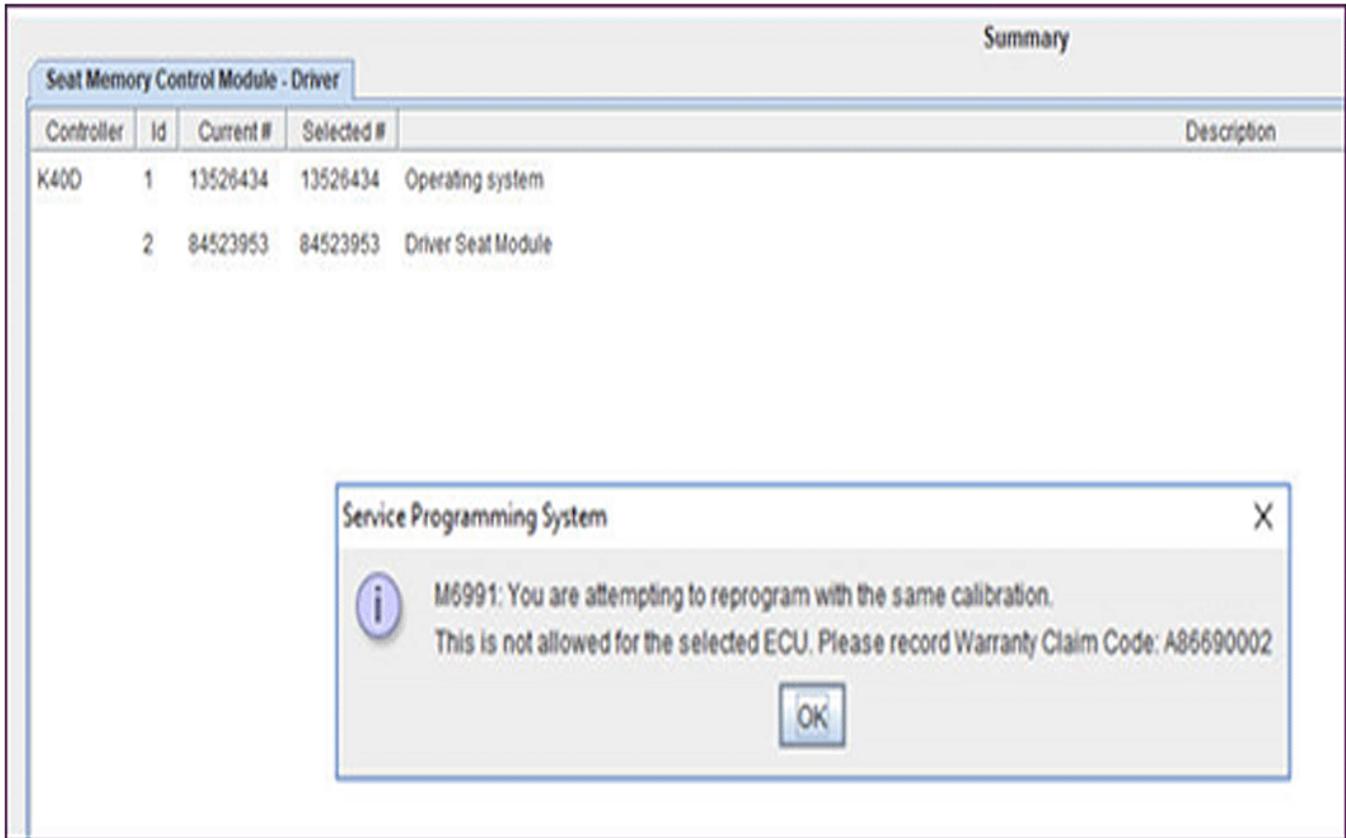
5164840

**Note:** If the Same Calibration/Software Warning is noted on the SPS Summary screen, record the warranty claim code (WCC) and select OK and follow screen instructions. After a successful programming event, the WCC is located in the Service Programming System dialogue box of the SPS Summary screen. No further action is required. Refer to the Warranty section of the bulletin.

1. Start SPS, select Radio – USB File Transfer and follow the on-screen instructions.
