Technical Service Bulletin

GROUP CAMPAIGN	NUMBER 19-01-043H
DATE DECEMBER, 2019	MODEL(S) Sonata (DN8)

SUBJECT: MAIN HARNESS & BRAKE BOOSTER INTERFERENCE
INSPECTION AND REPAIR (SERVICE CAMPAIGN T4J)

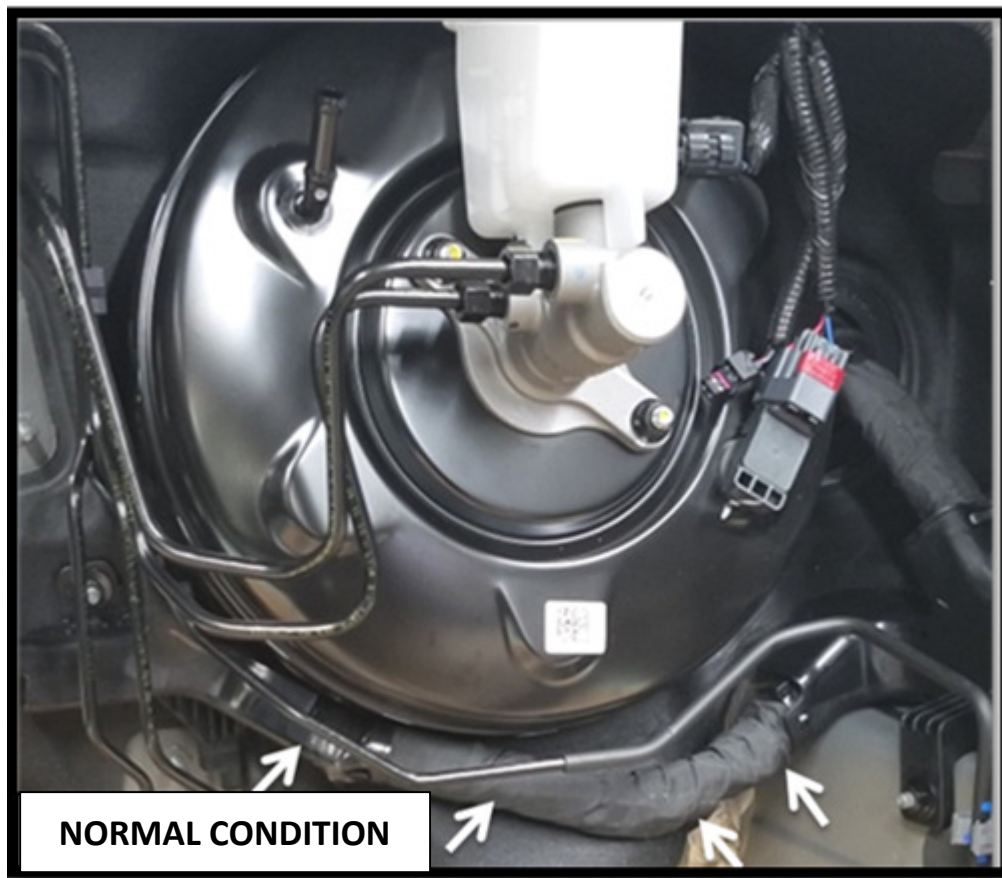
Description: This bulletin describes the procedure to inspect, and if necessary re-route the main harness adjacent to the brake booster of certain 2020MY Sonata (DN8) vehicles.
