L62X-A.04.19

Infotainment software update

Huracán EVO

2020

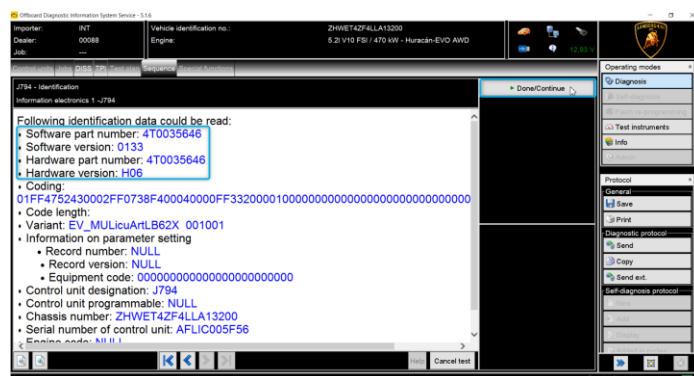
**54.** After the ECU reboot, from the Guided Functions of the ECU 5F run the function "5F - Identification" and check if the information indicated in "Software Part Number" and "Software Version" are the same shown in the following table, along with the market (the following image is used as example):

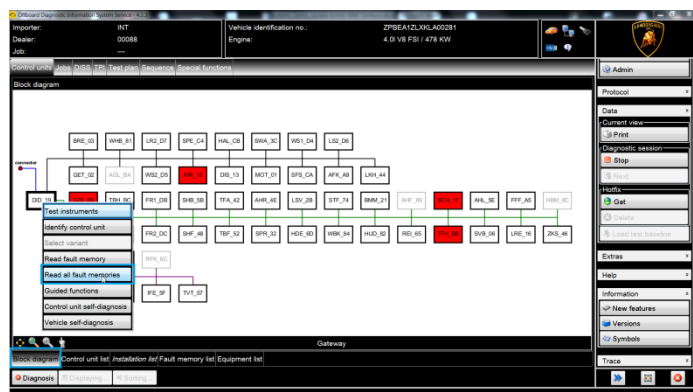
- 57.** Go back to the "Block diagram" card and select "Read all fault memories" from one of the vehi-

If after the fault memory deletion, the following fault remains "active":

### **B1ABEFO: VIN/SIM unit invalid**

the fault indicates that the eSIM (internal SIM of the Infotainment ECU) cannot be activated for the current vehicle market. In this case the fault doesn't represent a functional issue and can be ignored.

If the vehicle belongs to all other markets, not listed above, please run the relative Guided Fault Finding which is attached to the Test Plan.

*Solve any faults still present by performing the functions listed in the "Test plan". Perform the procedure "II. Fault memory deletion" again until all*

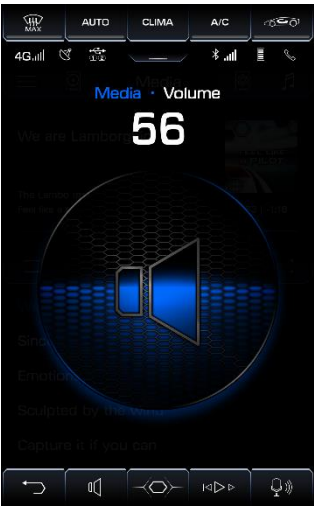
*The software 0133 of the Infotainment System introduces a modification on the volume control gesture. In particular, the following screen:*

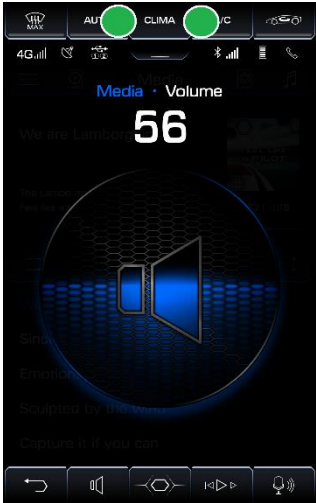
- a. *with a two fingers tap on the upper part of the screen, in the buttons area (see green indication);*

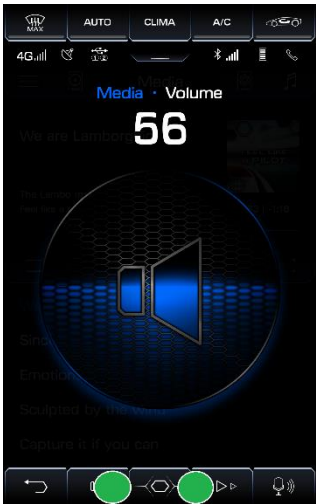
- b. *with a two fingers tap on the lower part of the screen, in the buttons area (see green indication).*

*All other functionalities remain the same as in the previous software.  
Please inform the customer about this modification.*

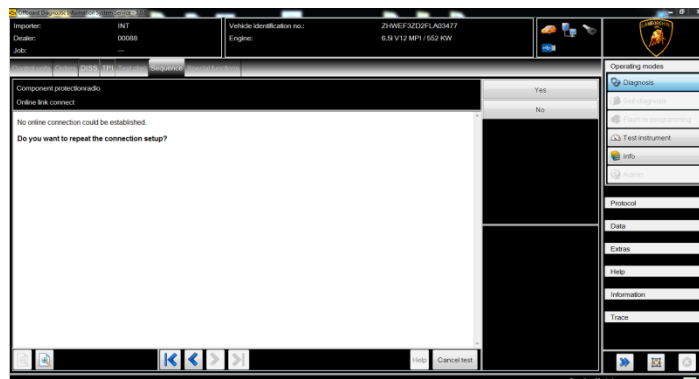
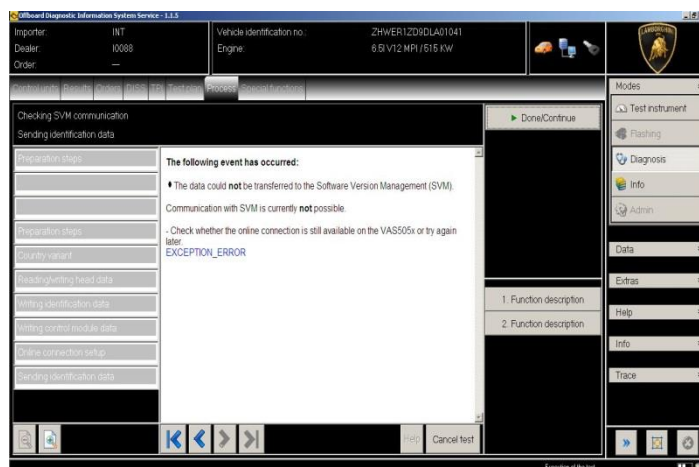
- iii. If one of the following connection errors is displayed like in the following example screenshots:

- It is not possible to connect to the central server; check that your laptop is correctly connected to the Internet and retry by clicking on "Yes" or "Done/continue", as appropriate.
